17-7295 Access Park, Gloucester

Road Safety Audit Stage 2

October 2022

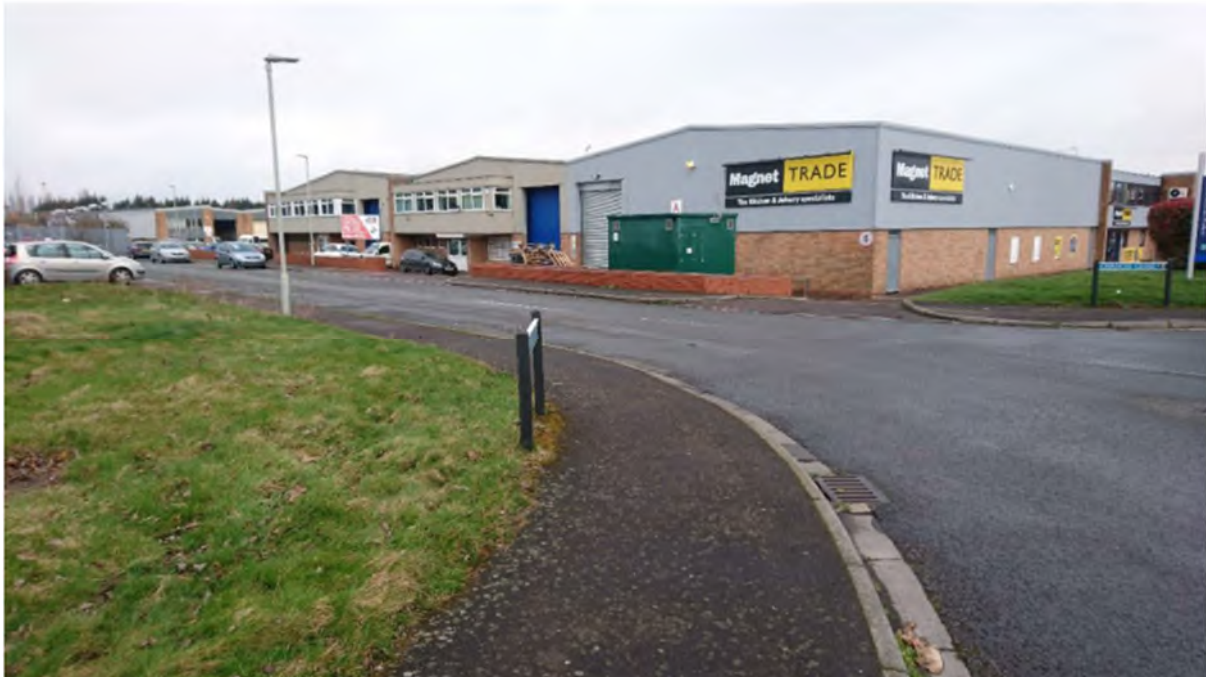
Summary: Close proximity to signalised junction may result in rear end shunt type collisions.

The existing access to the Magnet Trade car park is located close to the proposed signalised junction between Chancel Close and Eastern Avenue. Motorists turning into Chancel Close may not anticipate turning vehicles at this location, increasing the risk of rear end shunt type collisions.

Figure 1: Existing access to Magnet Trade car park.

It is recommended that the existing Magnet Trade car park access is made egress only.

The existing access to the Magnet Trade car park is the only access/ egress to the building unit, therefore the junction cannot be just egress only. The existing junction has scope to be widened to form an access/ egress junction to the building unit.

The proposed road markings can be modified to form a right turn into the Magnet Trade unit from the left turn junction from Eastern Avenue into Chancel Close, as well to have 'KEEP CLEAR' diagram 1026 to the 2 lanes that approach the proposed signalised junction to mitigate rear end shunts.

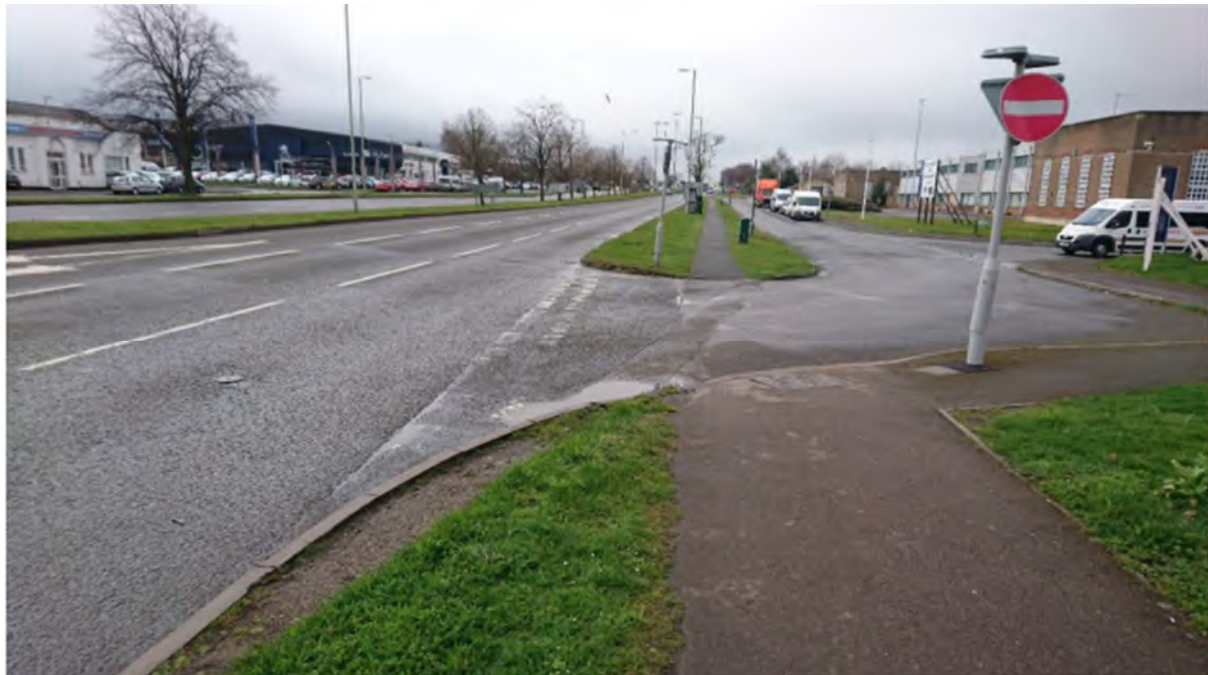
The proposed left turn lane from Chancel Close onto Eastern Avenue generally follows the existing alignment. Evidence of previous HGV kerb overrun suggests that this alignment may not be suitable for the large vehicles likely to be associated with the proposed development.

Vehicles striking the kerb have an increased risk of loss of control or the loosening of kerb material increasing the risk of secondary collisions.

Figure 2: Evidence of kerb overrun.

It is recommended that the alignment of the left turn lane is amended to ease the movement of all vehicles. Vehicle tracking should be undertaken to confirm the appropriateness of any design.

Proposed junction of Chancel Close and Eastern Avenue has been modified to suit.

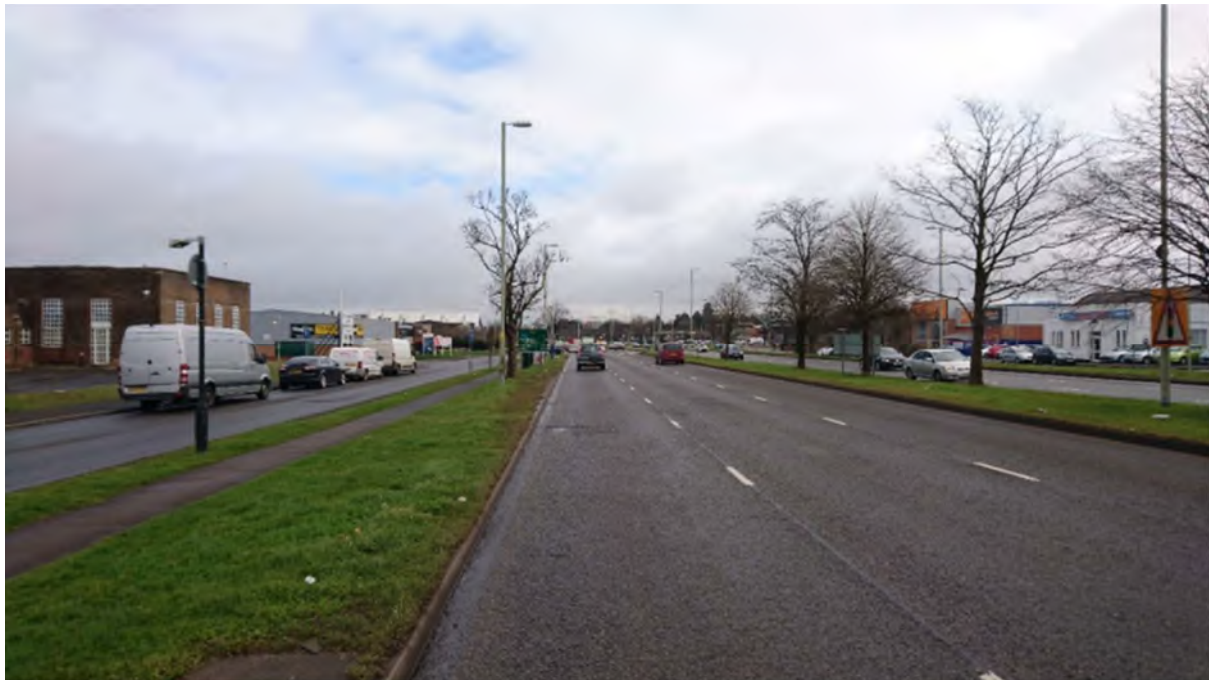
Summary: Close proximity to York Road junction may lead to 'see through' related collisions.

It is understood that following concerns raised in the Road Safety Audit for the previously agreed signalised junction, it is now proposed that the new junction and the existing junction between Eastern Avenue and York Road will be linked. The close proximity of the two junctions may create a 'see through' effect resulting in motorists observing and reacting to the second set of traffic signals increasing the risk of collisions associated with failing to appropriately stop at a signal stop line.

Figure 3: View looking towards existing Eastern Avenue / York Road junction.

It is recommended that, in addition to linking the traffic signal junctions, louvers should be installed on any signal heads that may be wrongly interpreted by approaching motorists.

We concur with the recommendations made, in addition to linking the traffic signal junctions, louvres should be added to any of the signal heads that may be wrongly interpreted by approaching motorists.

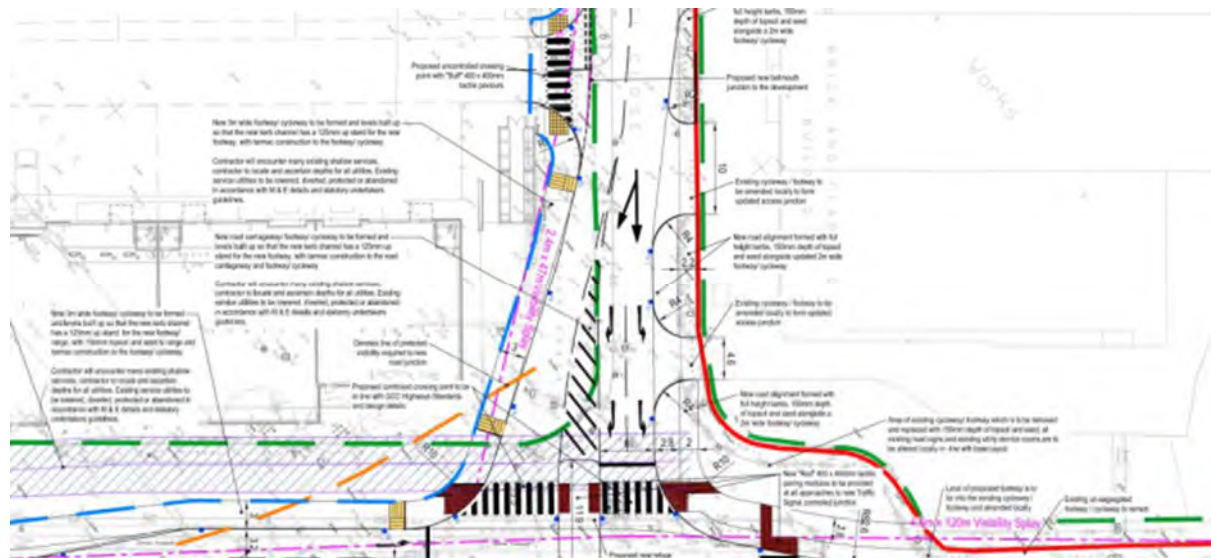
Summary: Incorrect provision of Zebra crossing markings may lead to confusion. A number of Toucan crossings and uncontrolled pedestrian / cyclist crossings are present throughout the scheme. At all of these, black and white Zebra crossing markings are proposed. The provision of such markings may lead pedestrians / cyclists to believe that the crossings are Zebra crossings and begin to cross into the path of approaching vehicles who may not be expecting to stop. This may lead to collisions between pedestrians / cyclists and vehicles.

Figure 4: Zebra crossing markings provided at Toucan and Uncontrolled crossings.

It is recommended that all Zebra crossing markings are omitted from the scheme. The crossing studs should also be omitted from the uncontrolled crossing points.

We concur with the recommendations made and have removed all zebra crossings as well as the crossing studs from the uncontrolled crossings.

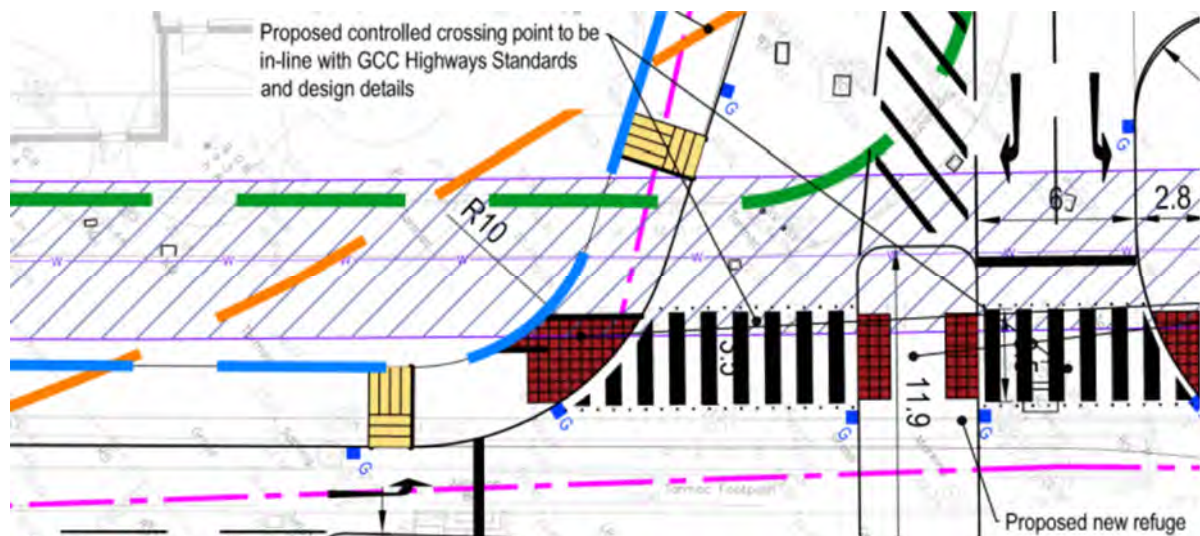
Summary: Incorrect provision of ‘Tramline’ and ‘Ladder’ corduroy tactile paving. ‘Tramline’ and ‘Ladder’ corduroy tactile paving is shown at various locations on the widened unsegregated shared use footway / cycleway. The use of ‘Tramline’ and ‘Ladder’ corduroy tactile paving indicates to users the presence of a segregated shared use facility. As such pedestrians or cyclists may wrongly believe that the other user will not be present on the footway / cycleway increasing the risk of collisions between the two user types.

Figure 5: Example of ‘Tramline’ and ‘Ladder’ corduroy tactile paving.

It is recommended that corduroy tactile paving is correctly provided in accordance with the

Department for Transport's 'Guidance on the Use of Tactile Paving Surfaces' (DfT, 2022). Given that no existing corduroy paving is present on the shared use footway / cycleways that the scheme ties into, it may be appropriate that the 'Tramline' and 'Ladder' corduroy tactile paving is omitted from the scheme to provide consistency along the route.

We agree with the later part of the recommendation that the 'Tramline' and 'Ladder' corduroy tactile paving is omitted from the scheme to provide consistency along the route, as no 'Tramline' or 'Ladder' corduroy tactile pavements are installed on the existing network.

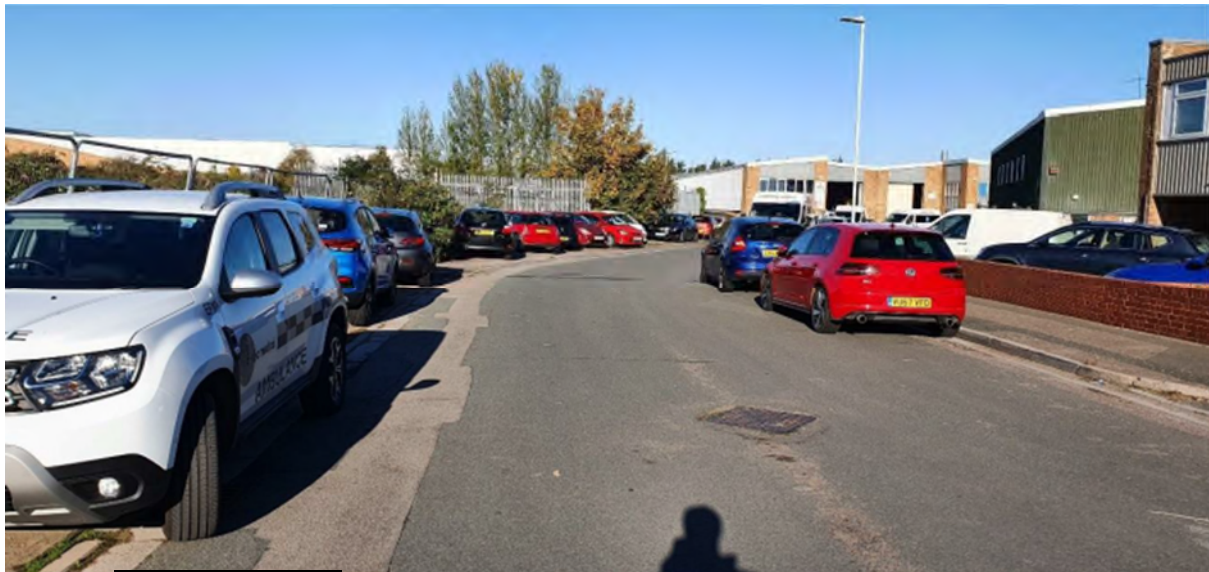
Summary: Lack of parking restrictions may hinder vehicle movements on Chancel Close. A significant level of on-street parking was observed on Chancel Close. The design drawings do not indicate that any parking restrictions will be implemented on Chancel Close. The Audit Team is concerned that continued parking at this location will hinder safe access and egress from the new development. The increased traffic flows likely as a result of the new development may also result in an increased risk of side swipe type collisions involving vehicles attempting to pass parked vehicles.

Figure 6: Existing parking on Chancel Close.

It is recommended that appropriate parking restrictions are implemented on Chancel Close.

We agree that there should be parking restrictions along Chancel Close and we have proposed the use of double yellow line road markings as diagram 1018.1 along the entirety of Chancel Close that is within our boundaries/ scope of works.

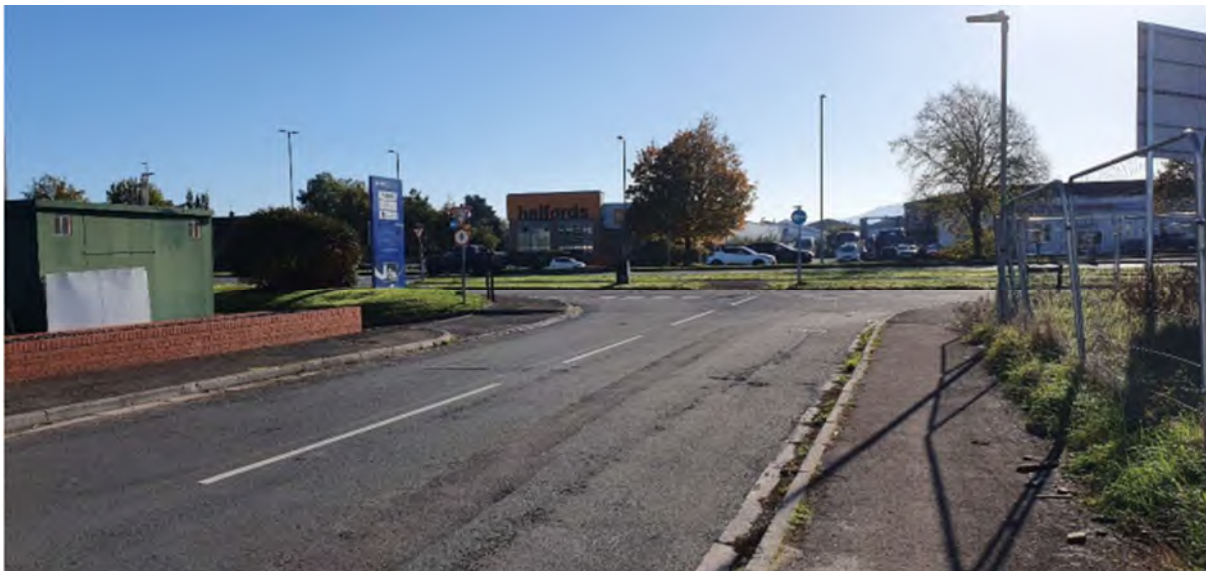
Summary: Close proximity to signalised junction may result in rear end shunt type collisions. The existing access to the Magnet Trade car park is located close to the proposed signalised junction between Chancel Close and Eastern Avenue. Motorists turning into Chancel Close may not anticipate turning vehicles at this location increasing the risk of rear end shunt type collisions.

Figure 7: Existing access to Magnet Trade car park.

It is recommended that the existing Magnet Trade car park access is made egress only.

The existing access to the Magnet Trade car park is the only access/ egress to the building unit, therefore the junction cannot be just egress only. The existing junction has scope to be widened to form an access/ egress junction to the building unit.

There is not scope within our scheme to provide a separate access only into the Magnet Trade unit car park. The only place a new access junction into the Magnet Trade unit could be built would be along Eastern Avenue, however it would be required approximately 25m to the east of the proposed crossing point on the northern bound carriageway of Eastern Avenue, which is beyond our boundaries and scope of works. This would also require the existing car park and levels to be modified as there is quite a level difference between the existing, adjoining Eastern Avenue carriageway and the Magnet Trade unit carpark.

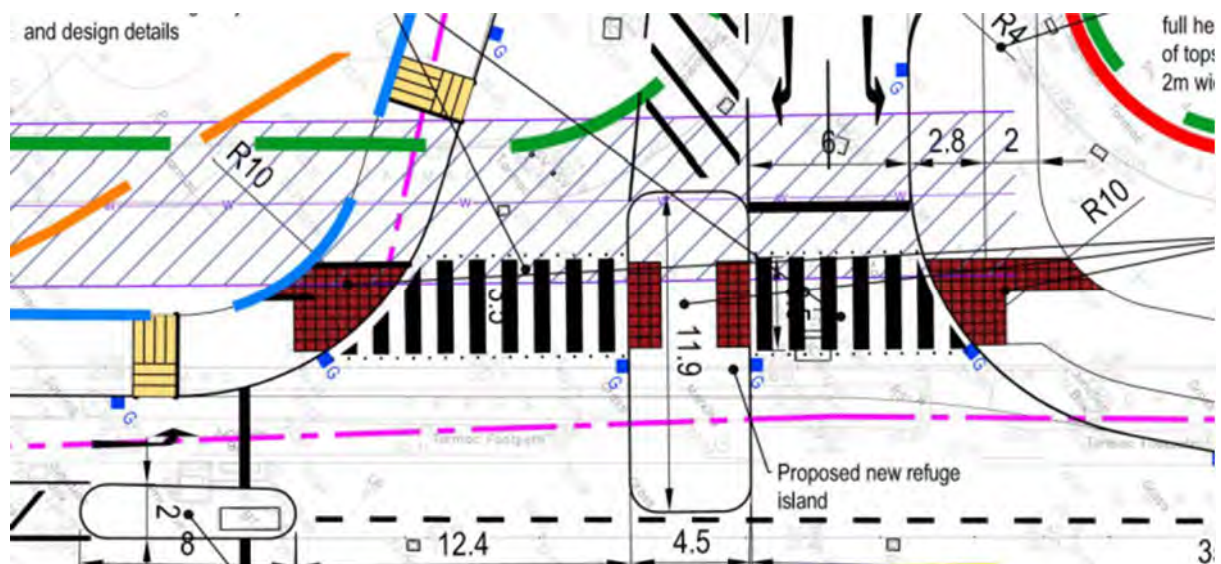
Summary: Separate 'in line' Toucan crossings may result in pedestrian / cyclist collisions. New Toucan crossings are proposed across Chancel Close. These are to be provided 'in line', However, the traffic signal staging indicates that these will operate as separate phases. Pedestrians / cyclists may mistakenly believe that the Toucan crossings are provided as a single crossing and attempt to cross in a single movement without waiting in the central island, increasing their vulnerability to being struck by passing vehicles.

Figure 8: Inappropriate provision of 'in line' crossings.

It is recommended that either a 3.0m stagger between the crossings is provided.

We concur with the recommendation and have updated the layout to show a 3.0m stagger between crossing points.

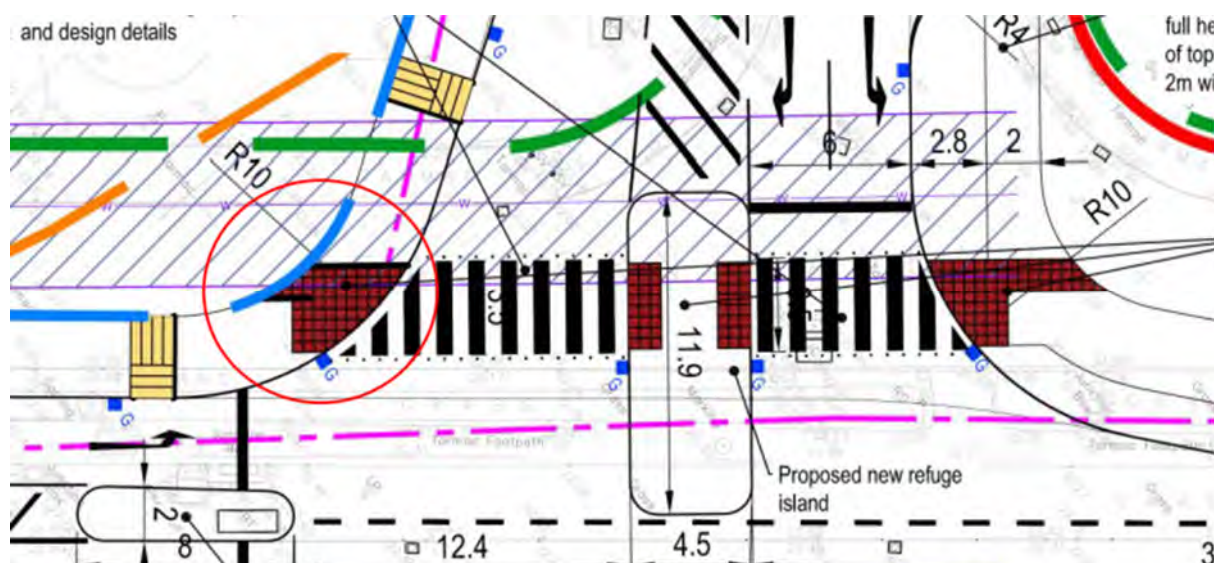
Summary: Incorrectly located stem of tactile paving may mislead crossing pedestrians / cyclists. New Toucan crossings are proposed across Chancel Close. On the southern side of Chancel Close, the stem of the 'L' tactile paving is positioned on the side furthest from approaching traffic. The stem should be provided on the side from which traffic is approaching. As such, pedestrians / cyclists, and particularly visibility impair users, may fail to correctly anticipate approaching vehicles increasing their vulnerability to being struck by passing vehicles.

Figure 9: Incorrect tactile paving arrangement.

It is recommended that the stem of the 'L' tactile paving on the southern side of Chancel Close is correctly positioned so that it is on the side of approaching traffic.

We concur with the recommendation and have updated the layout to show the correct setting out of tactile pavements, also this crossing point has been modified to have a 3.0m stagger between crossing points, in-line with the crossing point across Eastern Avenue.

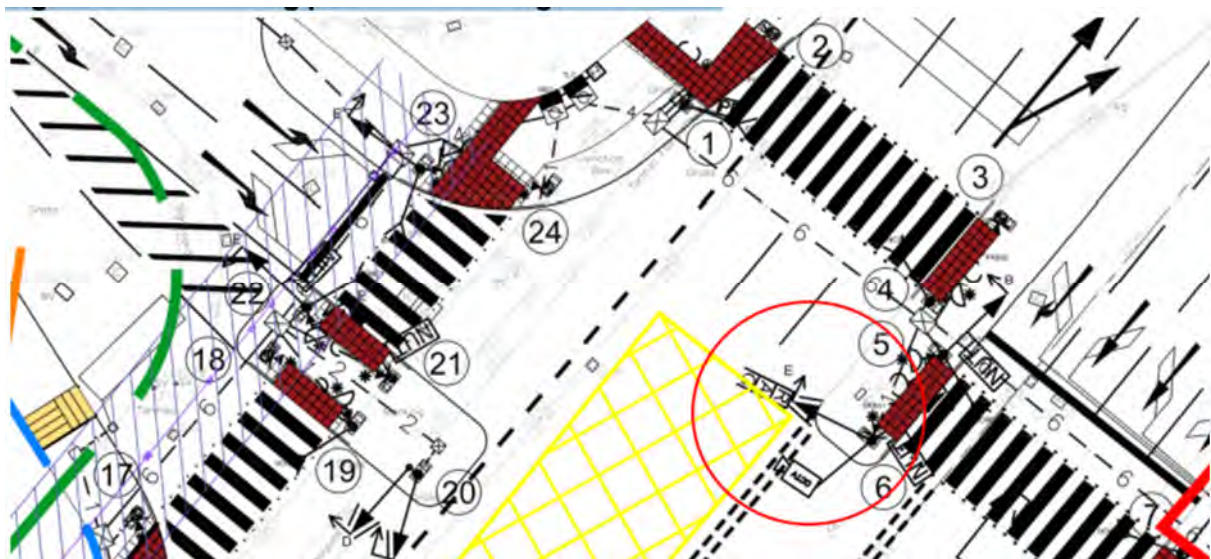
Summary: Chancel Close secondary signal shows 'left green arrow' only. Primary 'left green arrow' and 'right green arrow' signal heads are proposed on Chancel Close at its junction with Eastern Avenue. However, the secondary signal shows a 'left green arrow' only. This arrangement may lead to driver hesitation increasing the likelihood of rear end shunts.

Figure 10: Misleading provision of 'left green arrow'.

It is recommended that a secondary 'right green arrow' is also provided.

We concur with the recommendation and a secondary right green arrow should be provided.

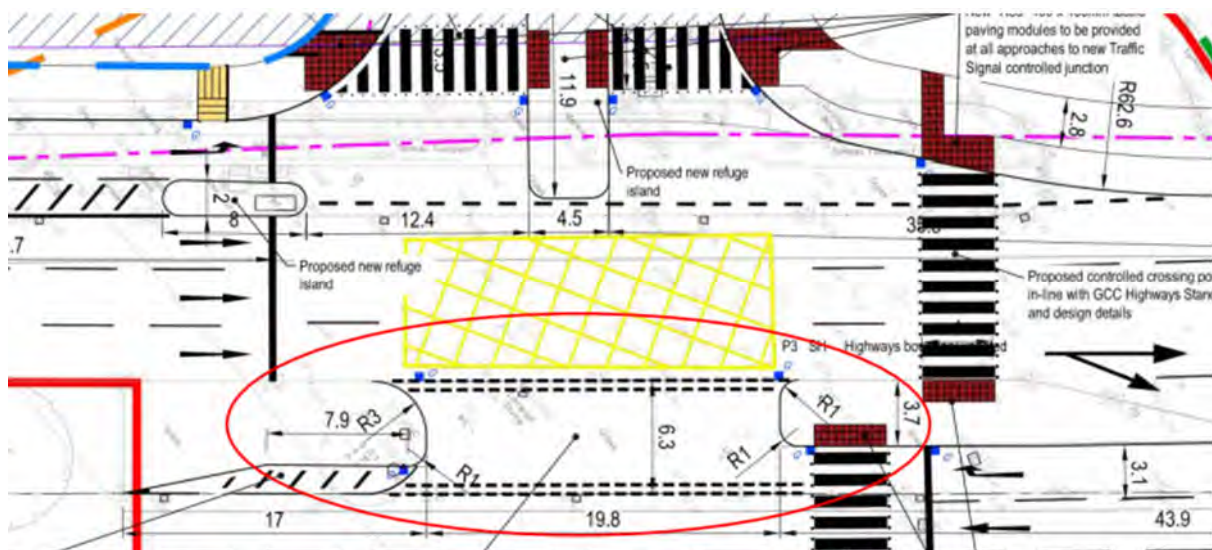
Summary: Incorrect provision of ‘Give way’ markings may lead to driver hesitancy. ‘Give way’ markings to TSRGD 2016 Diagram No. 1003 are proposed within the central reserve gap at the junction between Eastern Avenue and Chancel Close. The traffic signal staging indicates that no motorists turning right into or out of Chancel Close are required to give way at this location. The presence of such markings may result in motorists hesitating or unexpectedly braking leading to an increased risk of rear end shunt type collisions.

Figure 11: Inappropriate provision of ‘Give way’ markings.

It is recommended that the 'Give way' markings (TSRGD 2016 Diagram No. 1003) are replaced with 'edge of carriageway' markings.

We concur with the recommendation and have updated the proposed road markings to suit.

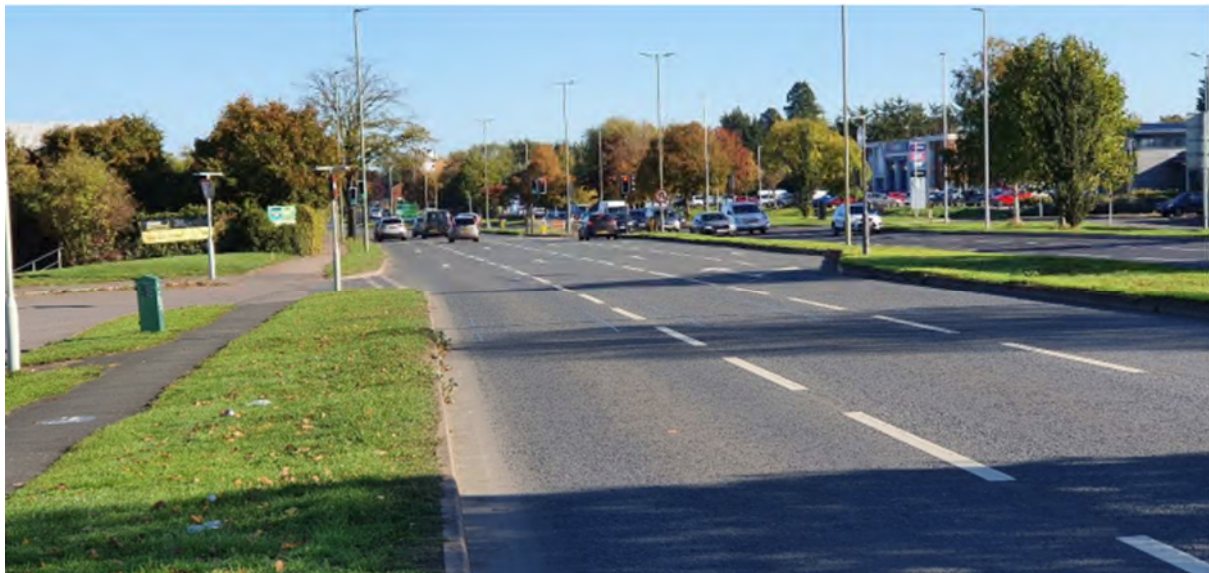
Location: Proposed signalised junction between Chancel Close and Eastern Avenue.
Summary: Close proximity to York Road junction may lead to ‘see through’ related collisions. It is proposed that the new junction and the existing junction between Eastern Avenue and York Road traffic signals will be linked. However, the close proximity of the two junctions may create a ‘see through’ effect resulting in motorists observing and reacting to the second set of traffic signals, increasing the risk of collisions associated with failing to appropriately stop at a signal stop line.

Figure 12: View looking towards existing Eastern Avenue / York Road junction.

It is recommended that louvers are installed on any signal heads that may be wrongly interpreted by approaching motorists.

We concur with the recommendation and agree louvres should be installed on any signal heads that may be wrongly interpreted by approaching motorists.

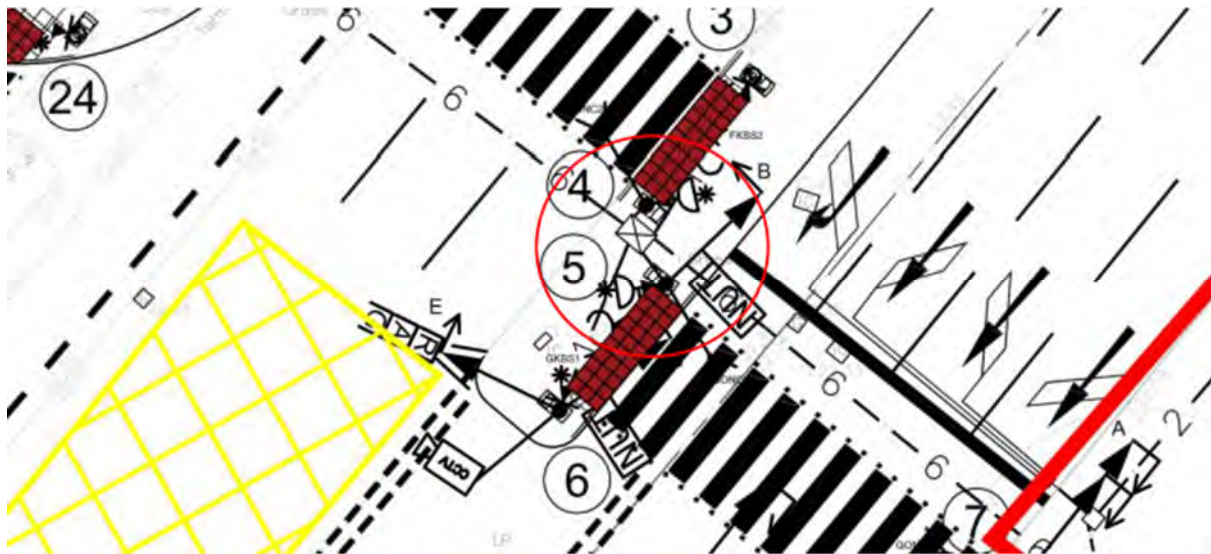
Summary: Insufficient gap between traffic signal equipment on central island. A new staggered Toucan crossing is to be incorporated across Eastern Avenue on the northern side of the new signalised junction. Though the width of the central island is stated as being 3.7m wide, the width of the 'stagger' and the position of the traffic signal equipment appears to result in a 'pinch point' that may hinder the safe movement of pedestrians and / or cyclists leading to collisions between users or with the signal equipment.

Figure 13: Proposed position of pedestrian / cyclist push button demand units.

It is recommended that a minimum 3.0m stagger between the two crossings is provided. It is noted that at a crossing such as this one, tactile paving is only required to be 800mm deep.

We concur with the recommendation and have updated the crossing point.

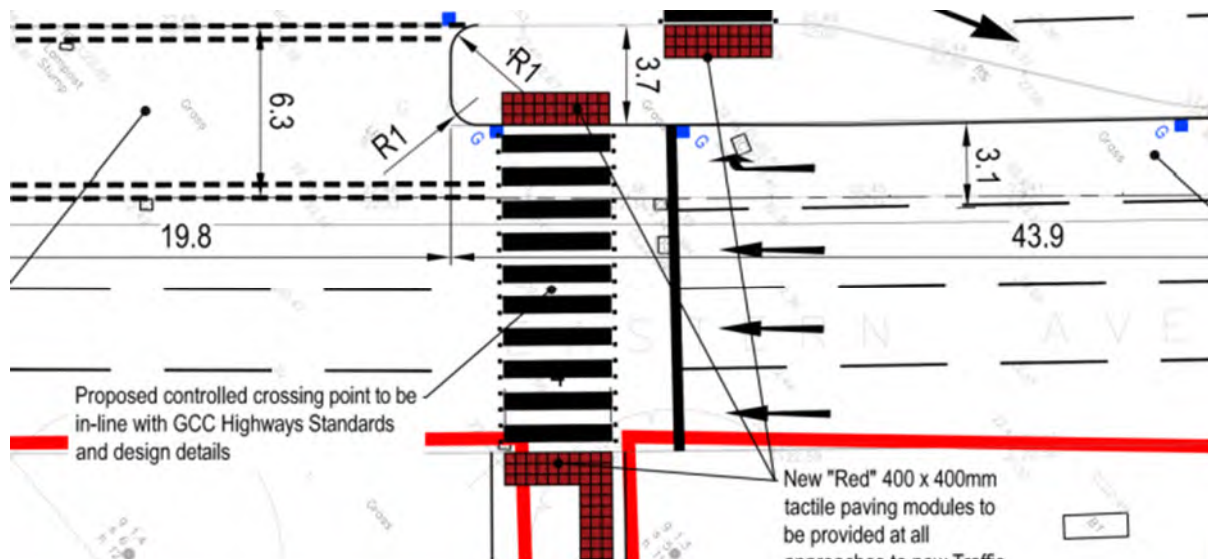
Summary: Lack of traffic island separating differently staged traffic movements may lead to rear end shunt or failure to stop collisions.

A new right turn lane is proposed on the southbound Eastern Avenue at its junction with Chancel Close. This will be separately signalled from the three existing 'Ahead only' lanes. However, no physical separation is provided between the 'Ahead only' and 'Right turn' lanes. As such, motorists may be unclear if they are required to stop, increasing the likelihood of inappropriate braking leading to rear end shunts or failure to stop resulting in turning related collisions.

Furthermore, pedestrians / cyclists using the Toucan crossing may observe right turning traffic stopping and begin to cross assuming all traffic has received a red signal. This increases the risk of collisions involving crossing pedestrians / cyclists.

Figure 14: Lack of traffic island may result in hesitation and confusion.

It is recommended that a traffic island incorporating appropriate traffic signals is provided between the 'Ahead' and 'Right turn' lanes.

We concur with the recommendation and have added a traffic island to separate the 'Ahead' and 'Right turn' lanes.

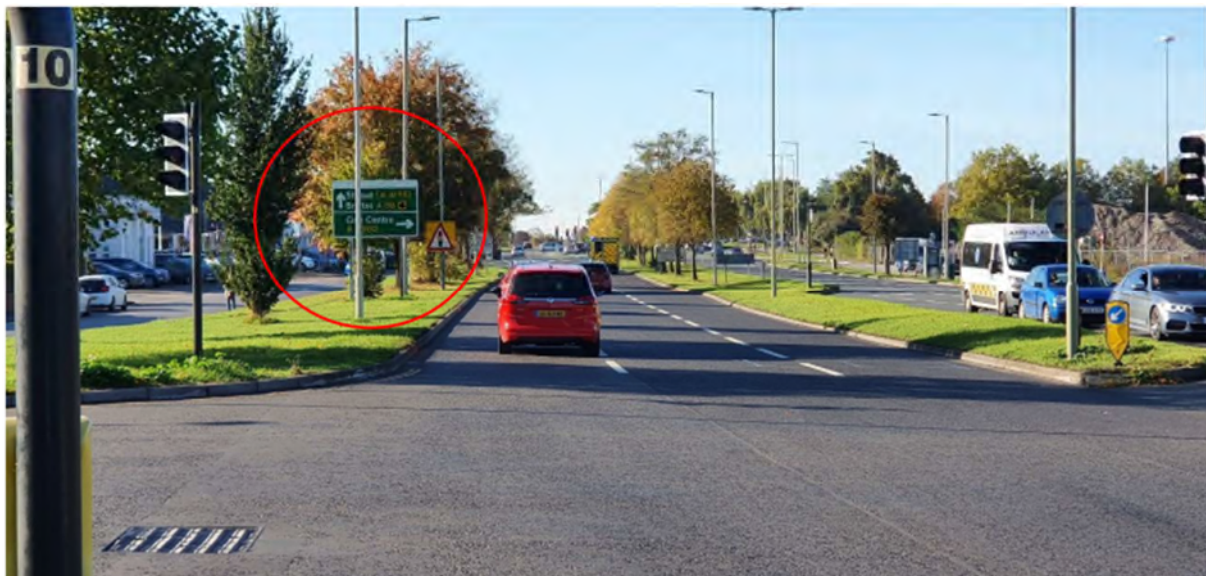
Summary: Existing sign may result in unnecessary turning movements.
An existing directional sign is located immediately before the proposed southbound Eastern Avenue stop line. This sign relates to the following junction between Eastern Avenue and Metz Way and indicates a right turn for motorists intending to continue to the City Centre. The design drawings do not indicate that this sign will be removed or relocated. Retaining the sign at this location may result in motorists turning right into Chancel Close believing it continues to the City Centre. Such movements will require additional turning manoeuvres in order for motorists to continue to the City Centre, increasing the risk of turning related collisions.

Figure 15: Existing sign for Eastern Avenue / Metz Way junction.

It is recommended that the requirement to retain the existing road sign is assessed. If the sign is deemed necessary, it should be relocated to the southern side of the new junction.

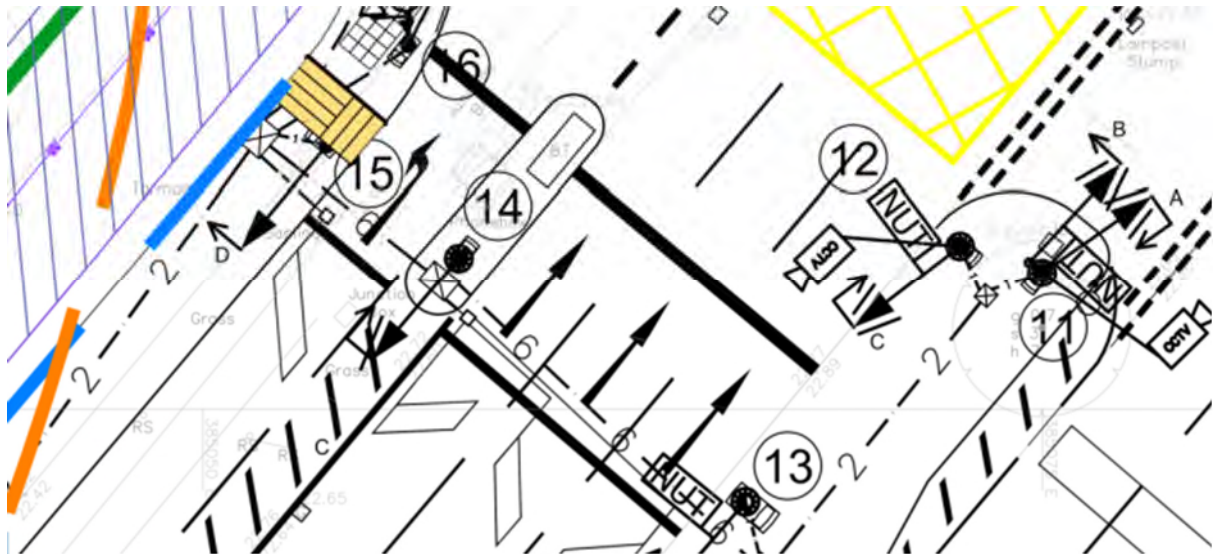
The traffic signal design drawings show two sets of Stop lines for the northbound Eastern Avenue, one in advance of the primary signal heads and one beyond them. Provision of two sets of Stop lines is likely to result in driver confusion and hesitation as the point at which to stop will be unclear. This is likely to lead to an increased risk of rear end shunt type collisions.

Figure 16: Two sets of Stop lines provide on north-eastbound Eastern Avenue.

It is recommended that the Stop lines located beyond the primary signal heads are omitted from the design. Relocate the carriageway arrow markings prior to the retained Stop lines.

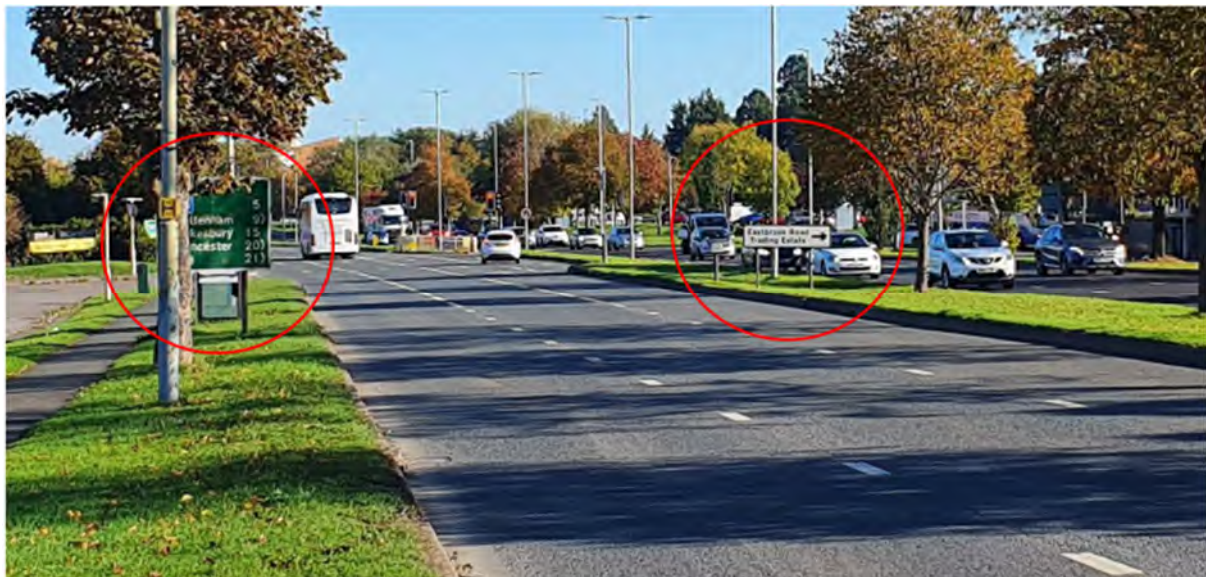
Summary: Existing road signs to be removed leading to possible driver hesitancy. Two existing road signs (Destination distances and Eastbrook Road Trading Centre) are located on the northbound Eastern Avenue. These are shown in the design drawings as being removed with no replacements. The removal of existing road signs may result in motorists having insufficient information to assist with route choice increasing the risk of driver hesitancy or late lane changing manoeuvres increasing the risk of rear end shunt or side swipe type collisions.

Figure 17: Existing signs proposed to be removed.

It is recommended that the appropriateness to remove these signs is assessed. If the signs are required, the signs should be appropriately relocated to provide relevant information to motorists.

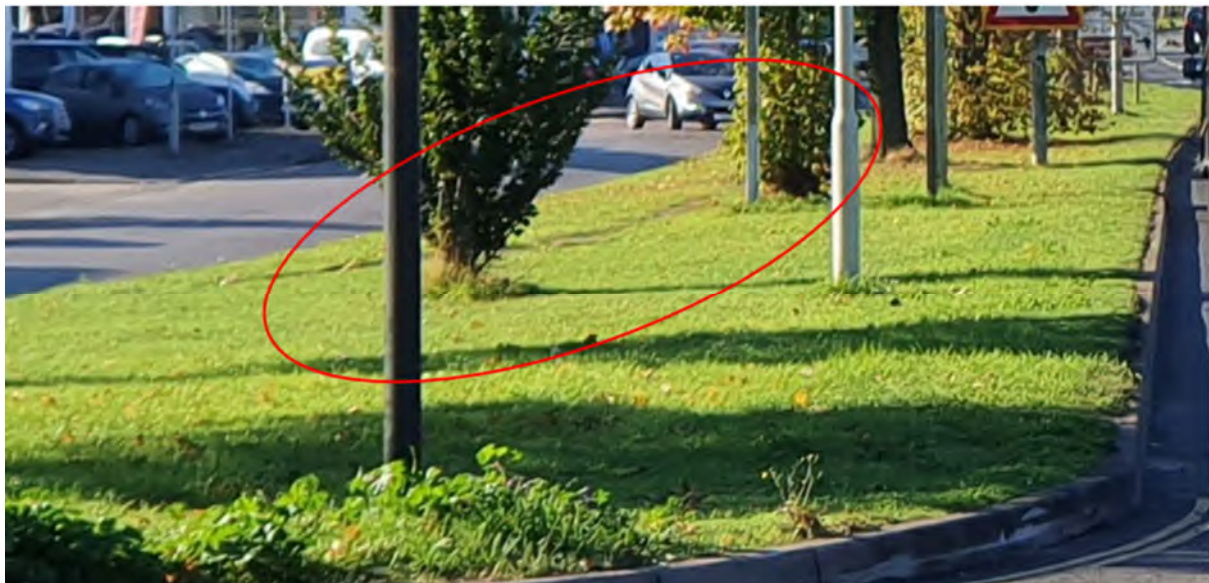
Summary: Toucan Crossing does not tie-in with appropriate facilities on eastern side. A new staggered Toucan crossing is to be provided across Eastern Avenue on the northern side of the new signalised junction. On the eastern side of Eastern Avenue, a narrow and poorly maintained footway is present between the service road and the main carriageway. This facility does not appropriately tie-in with other footways or cycleways on the Eastern Avenue service road, nor is it suitable as a shared use footway / cycleway. As such, the new Toucan crossing does not suitably tie-in with appropriate facilities on the eastern side of Eastern Avenue, increasing the likelihood of collisions involving vulnerable road users, or trips / falls should pedestrians continue along the grass verge or attempt to cross the service road via a full height kerb.

Figure 18: Lack of appropriate footway / cycleway on eastern side of Eastern Avenue.

The existing tarmac footway doesn't look like it is even maintained as the overall look of the footway is very poor, with overgrown grass covering a large portion of the footway. The existing footway is also not compliant with current regulations and is without tactile pavements at both ends where it joins/ leaves the existing carriageway, and dropped kerbs are missing from the west side where it joins/ leave the carriageway.

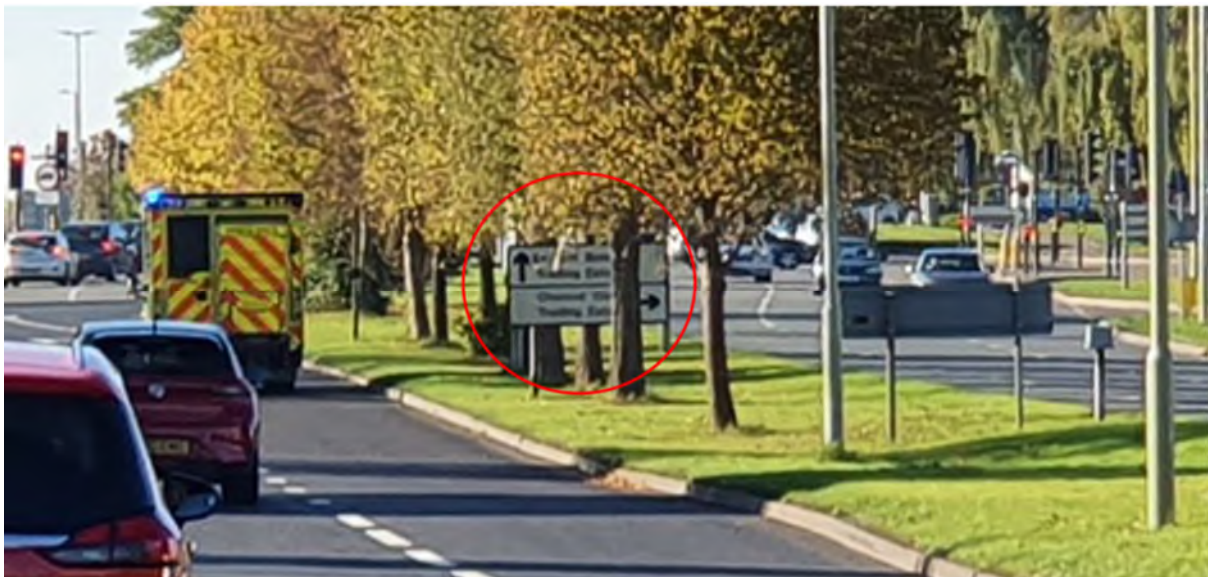
Summary: Existing sign for 'Chancel Close Trading Estate' may cause driver confusion. An existing directional sign for 'Chancel Close Trading Estate' is located within the central reserve. It appears that this sign will be retained and relates to the existing U-turn facility on the southbound Eastern Avenue carriageway immediately prior to its junction with Metz Way.

Whilst this facility is to remain and therefore the sign is still appropriate, its position is likely to be visible from the right turn lane at the new junction at Chancel Close. As such, motorists turning right into Chancel Close may wrongly believe they are turning at the wrong location and attempt to continue ahead from the right turn lane. This may lead to side swipe type collisions.

Figure 19: Existing sign indicating 'Chancel Close Trading Estate'.

It is recommended that, if needed, the sign is appropriately relocated to provide relevant information to motorists.
