Appendix B

Approved dismantling sequence and extents

# Hutton + Rostron Environmental Investigations Limited

Hutton + Rostron Environmental Investigations Limited carried out a site visit to Bakers Quay, Gloucester on 14 May 2020 in accordance with instructions from Adrian Goodall by email dated 13 May 2020 11:54 with attached Order Form. Drawings provided by the client were used for the identification of structures. For the purpose of orientation in this report, the entrance to the building was taken as facing east onto High Orchard Street

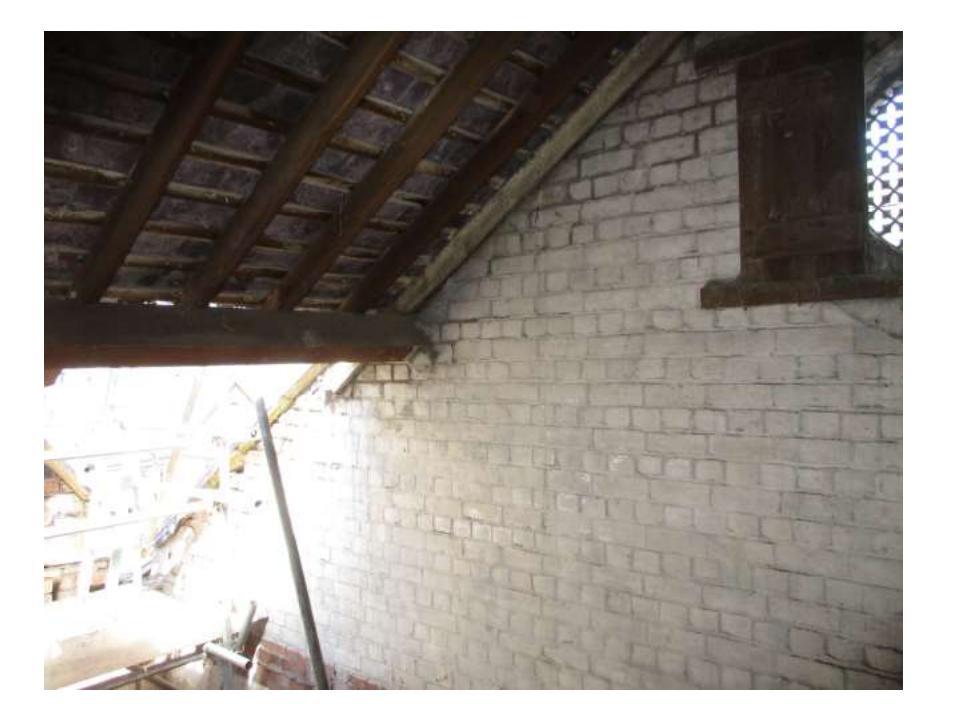
## Fig 9 :

Interior, roof; showing a view of the north-west corner. A large part of the timber roof structure was not in place which was allowing water into the structure which may be hastening timber decay in this area

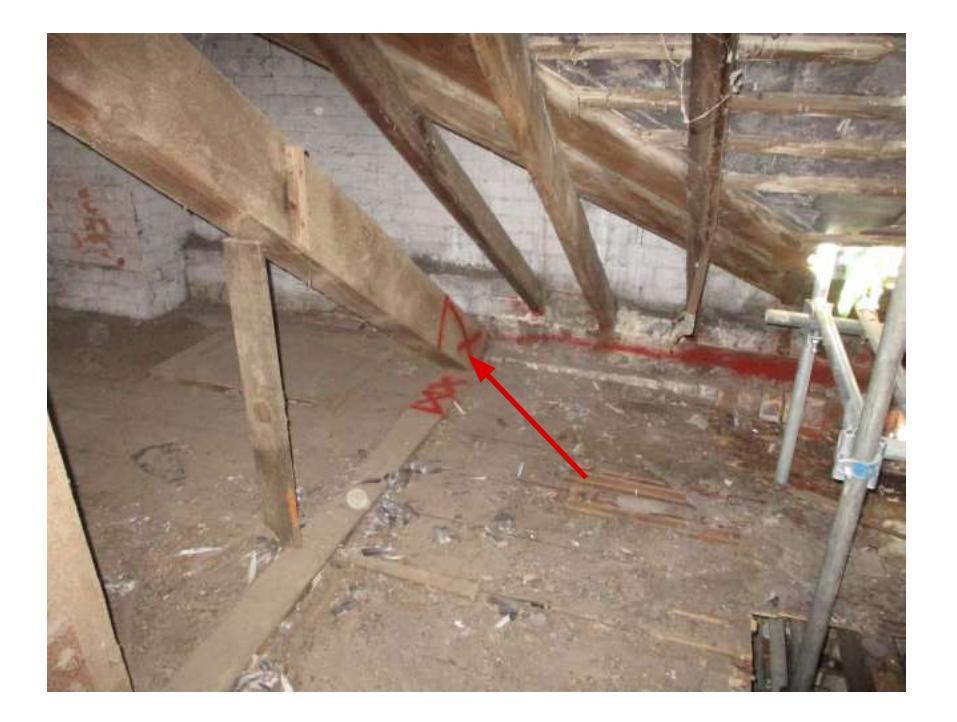
## Fig 11 :

- d) Structural decay to 1no. principal rafter foot and 1no. tie beam bearing end at the middle of the west pitch both for a length of approximately 500 mm each

Interior, roof; showing a view of structural decay to the principal rafter bearing end and tie beam bearing end at the middle of the west pitch

be isolated from the masonry by way of an appropriate plastic damp-proof membrane, plastic packing pieces or hangers, ensuring there is an air-gap between the end grain and the masonry. All repairs should be under the direction of the Structural Engineer and/or Conservation Officer

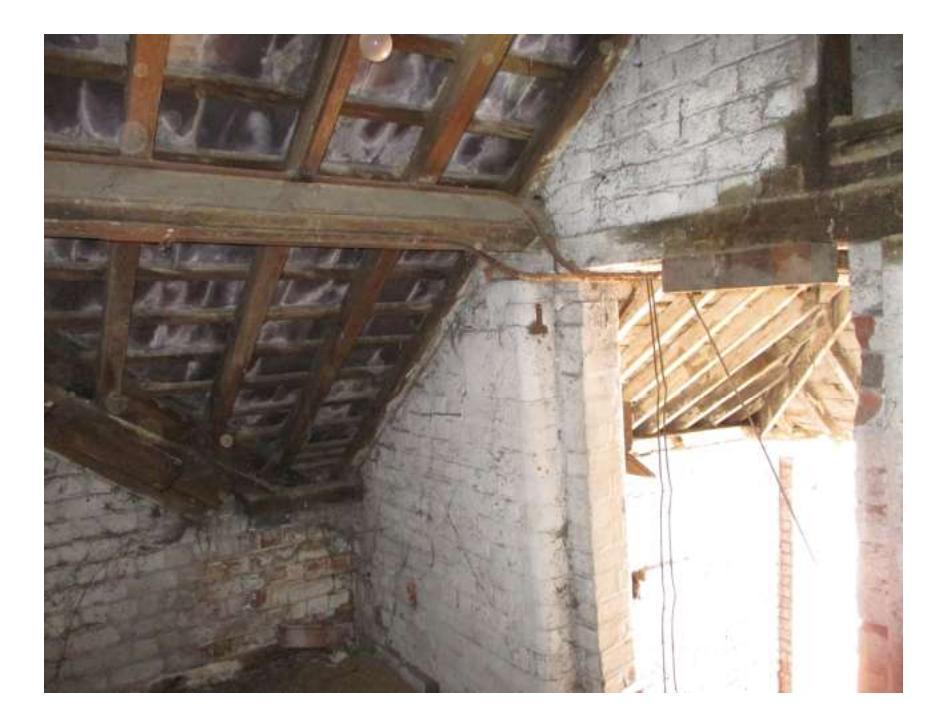
#### Fig 13 :

Interior, roof; showing a view at the south-west corner where timbers were found to be free from structurally significant decay on inspection

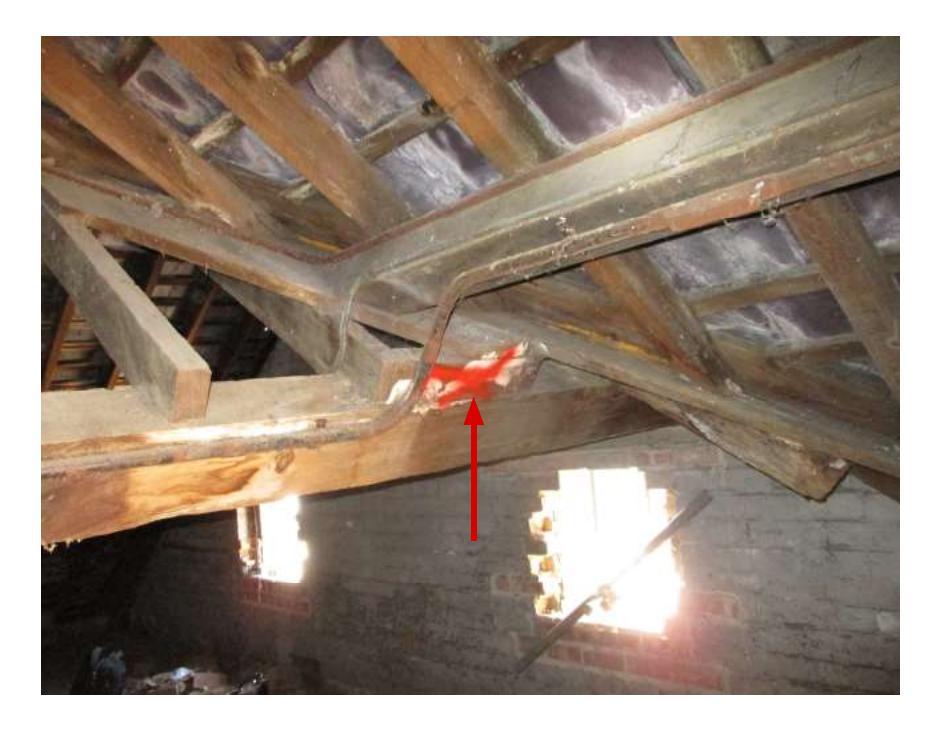
## Fig 14 :

- c) Structural decay to the mid-section of 1no. valley rafter for a length of approximately 300 mm and to 1no. purlin for a length of 300 mm at the southwest corner

Interior, roof; showing a view of structural decay to approximately 300mm of valley rafter and 300mm of purlin at their mid-sections

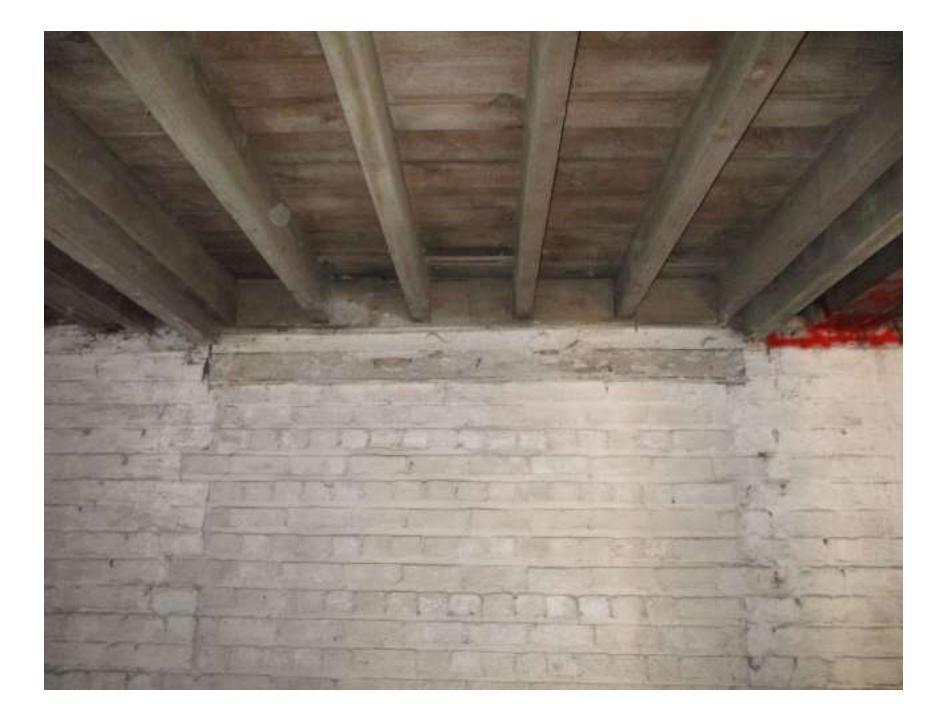
## Fig 17 :

Interior, third floor structure from below; showing a view of the floor structure towards the south-east corner. Joists and plate were found to be free from structural decay at the time of the survey. However, moisture contents were around 20 per cent leaving them vulnerable to decay in the future

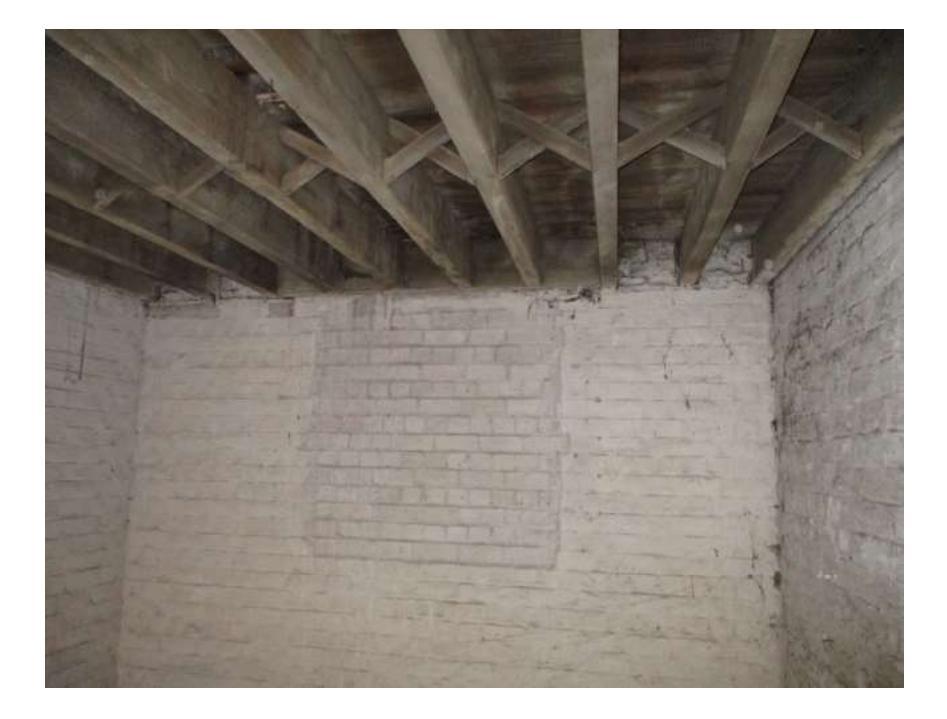
#### Fig 19 :

Interior, third floor structure from below; showing a view of the floor structure at the north-east corner. No structurally significant decay was identified on inspection

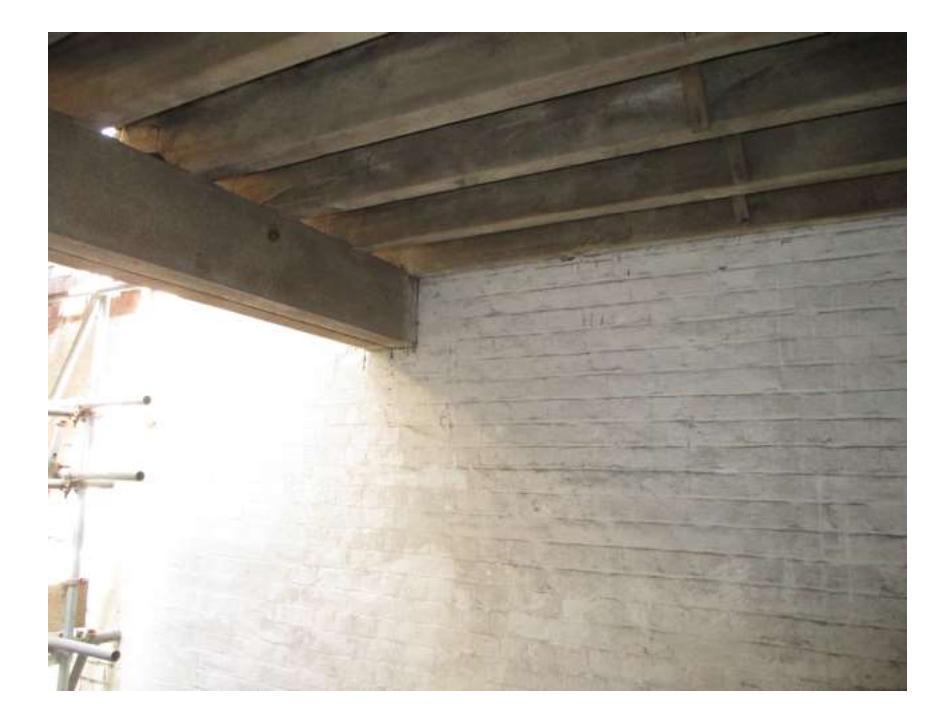
## Fig 21 :

Interior, third floor structure from below; showing a view of one of the twin elements primary beam at the north end. There was no structurally significant decay identified to the bearing ends of this beam

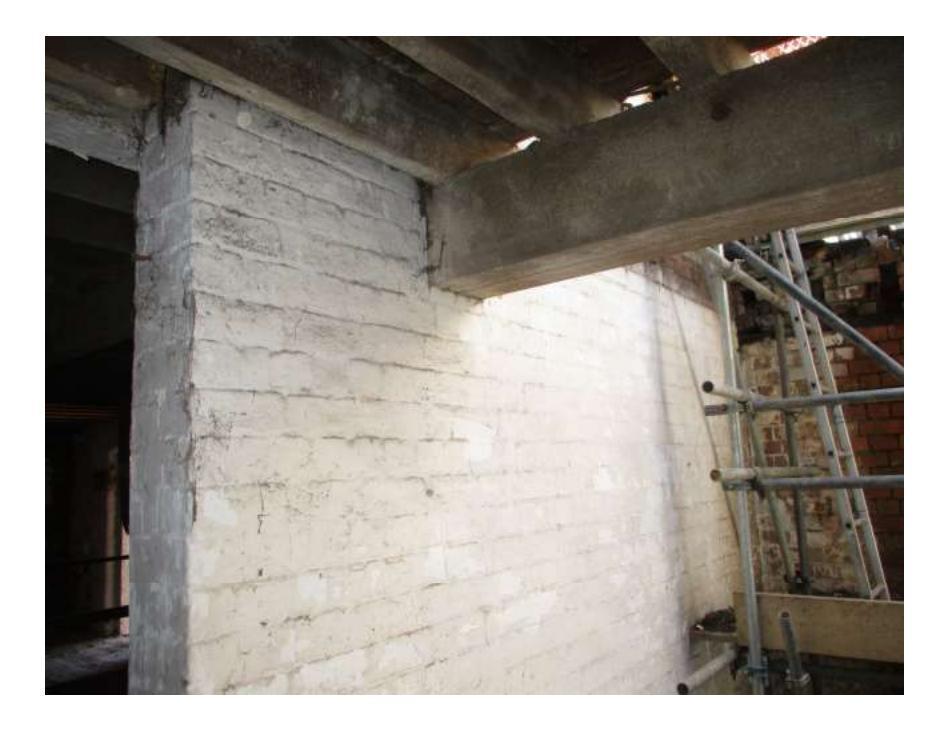
# Fig 22 :

Interior, third floor structure from below; showing a view of bearing end of single element primary beam. There was no structurally significant decay at the time of the survey

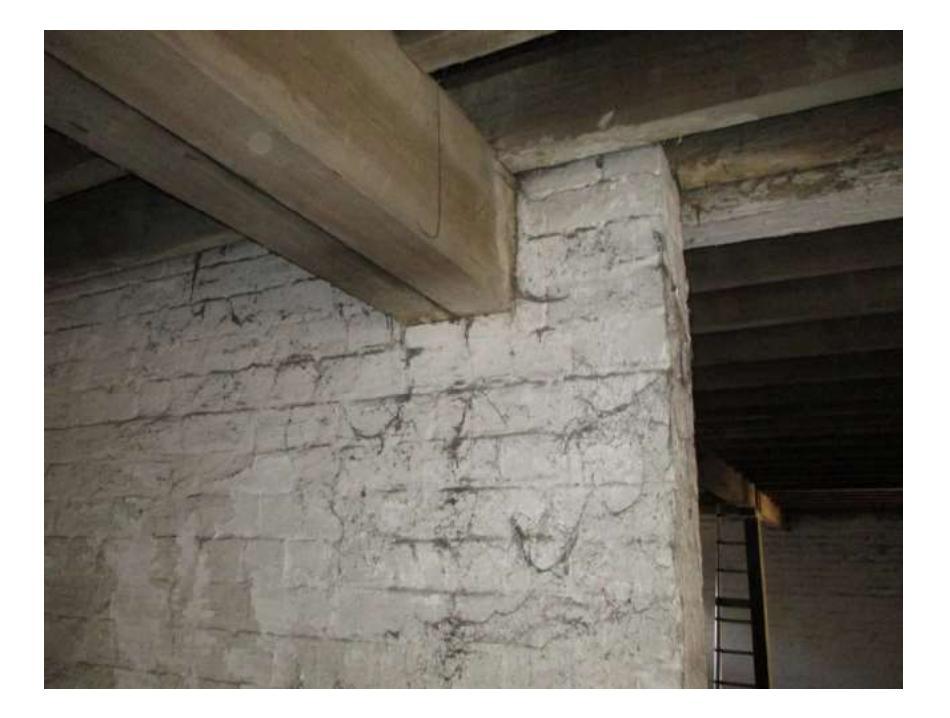
#### Fig 23 :

Interior, third floor structure from below; showing a view of the twin element primary beam where no structurally significant decay was identified on inspection

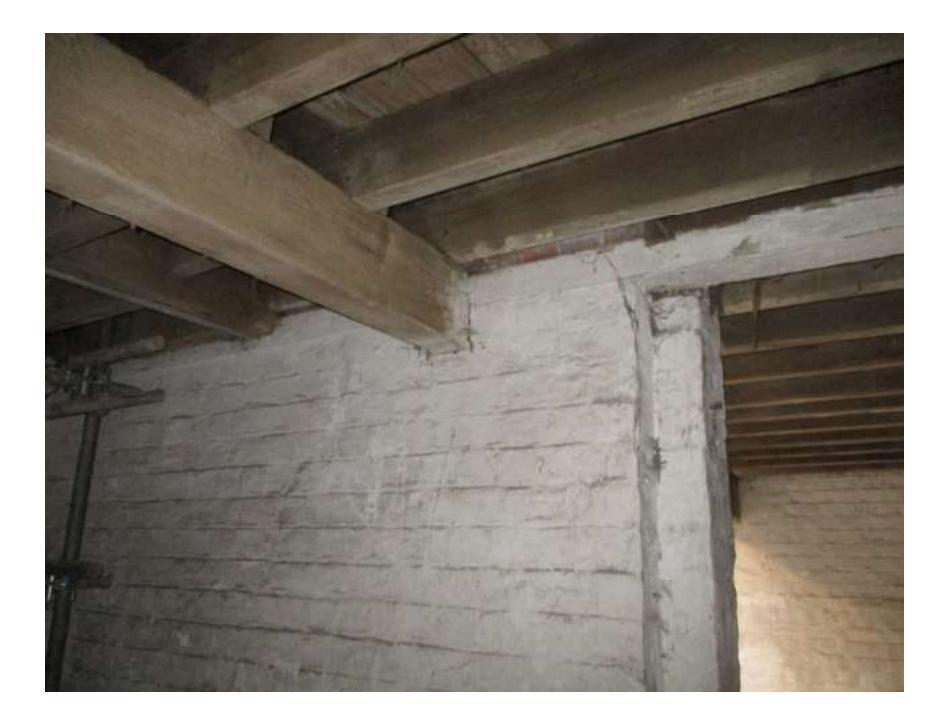
# Fig 26 :

Interior, third floor structure from below; showing a view of a primary beam bearing into a wall where no structurally significant decay was identified

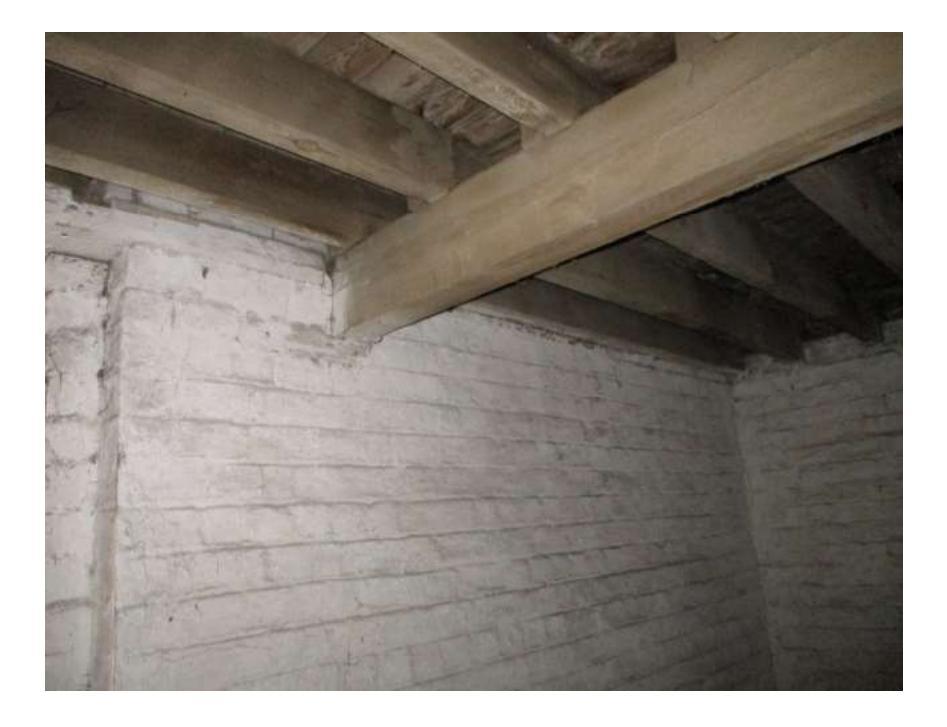
## Fig 27 :

Interior, third floor structure from below; showing a view of a primary beam bearing into a wall where no structurally significant decay was identified

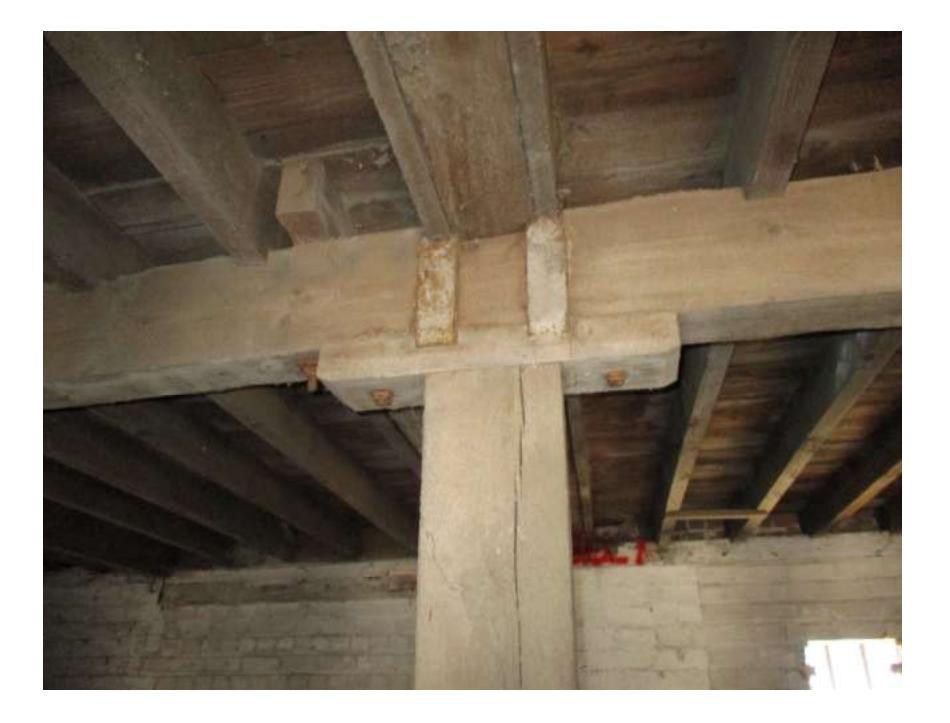
## Fig 29 :

Interior, third floor structure from below; showing a view of the timber post and primary beam in the centre of the room

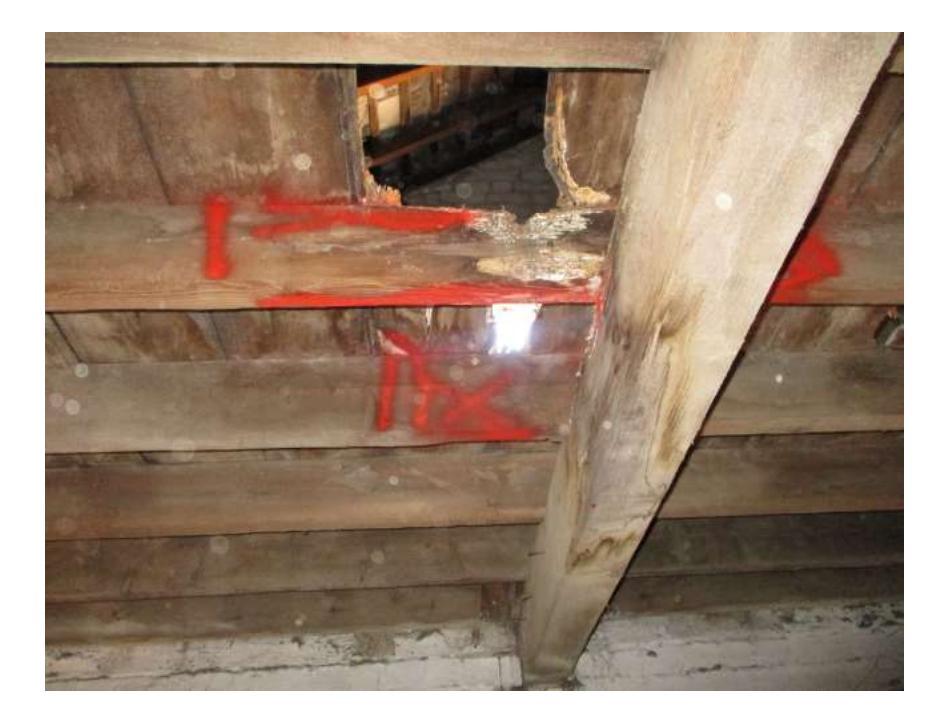
## Fig 31 :

Interior, third floor structure from below; showing an alternative view of the timber decay described in fig. 30 above

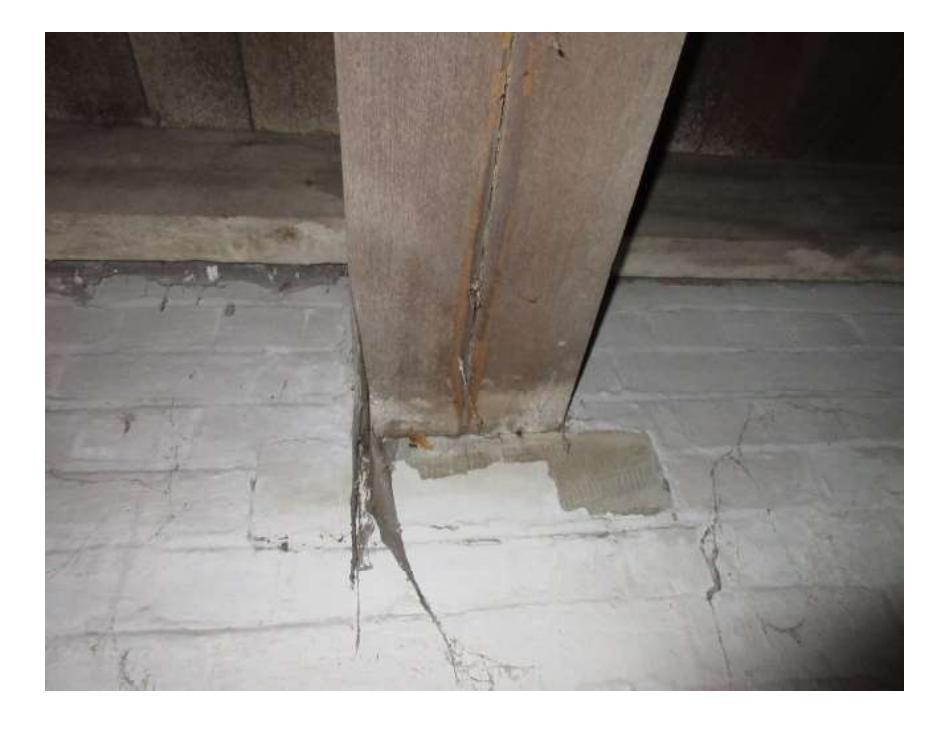
#### Fig 37 :

Interior, second floor as seen from below; showing a close-up view of a twin element primary beam bearing into the masonry wall sat on top of a stone pad. There was no timber decay identified in this area

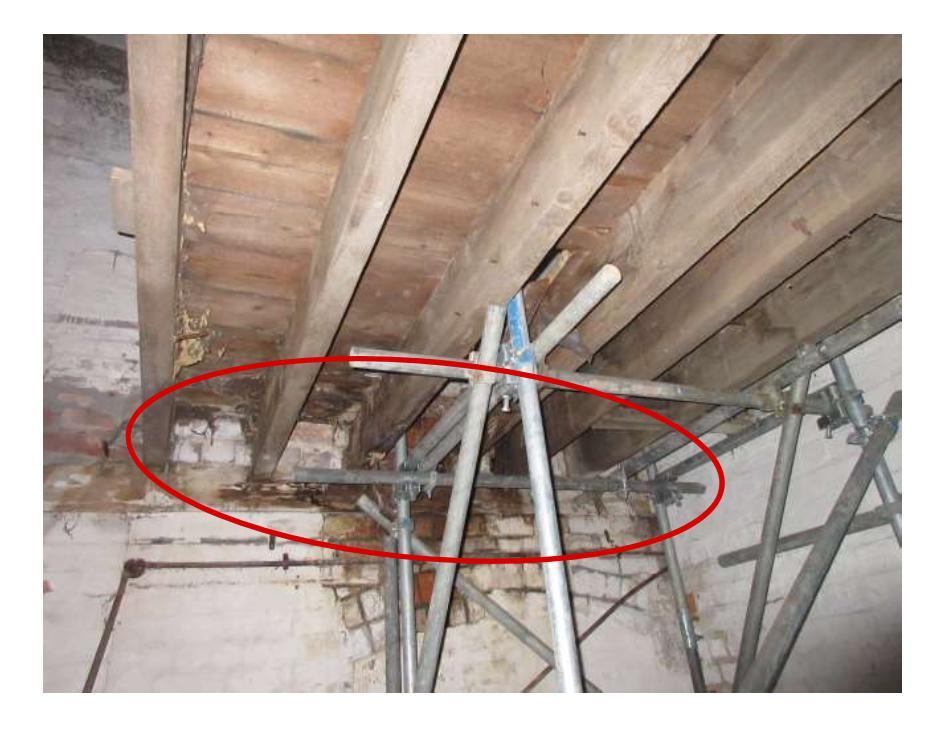
## Fig 42 :

Interior, second floor as seen from below; showing a view of a large section of decayed floor joists already identified prior to H+R's site survey

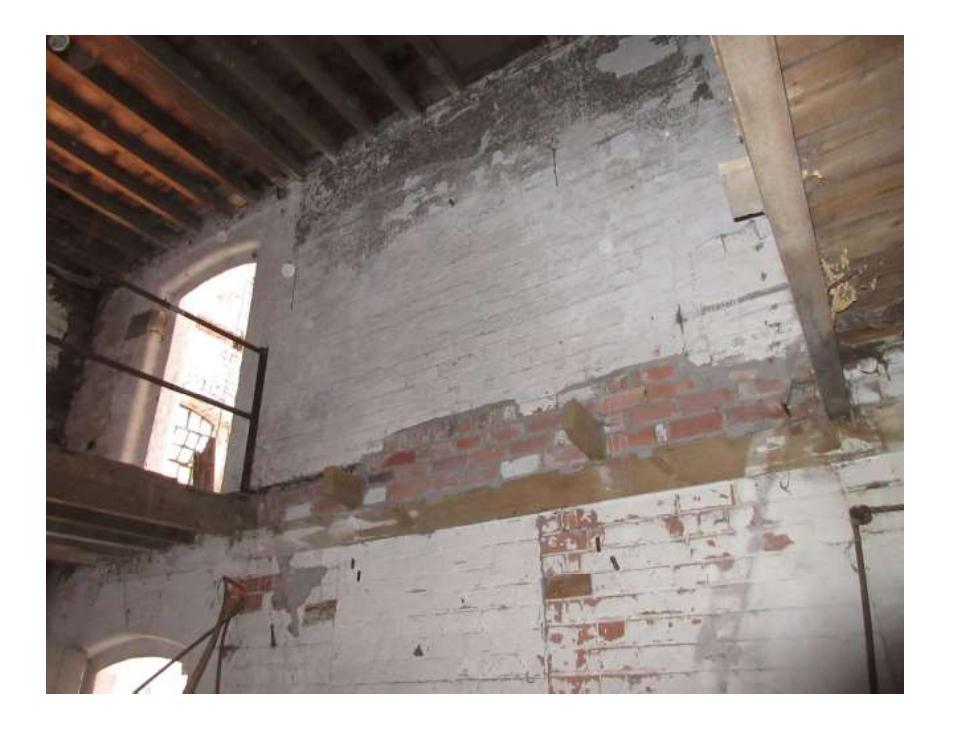
#### Fig 43 :

Interior, second floor as seen from below; showing a view of a large section of timber flooring that had been removed prior to H+R's survey

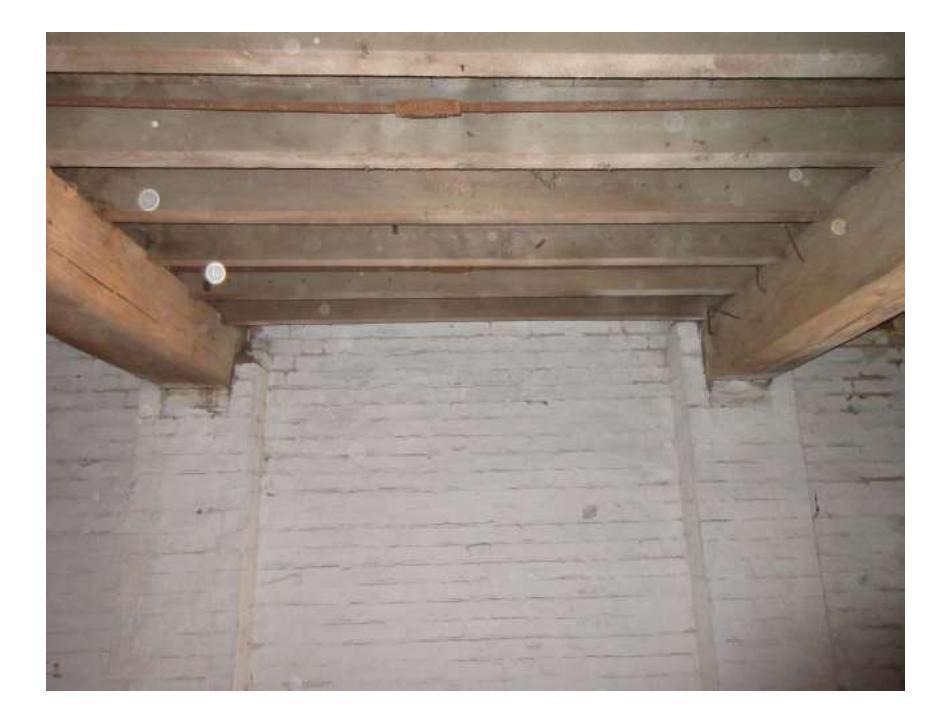
## Fig 45 :

Interior, second floor as seen from below; showing a view of the two primary beam bearing ends at the south wall both of which were free from structurally significant decay

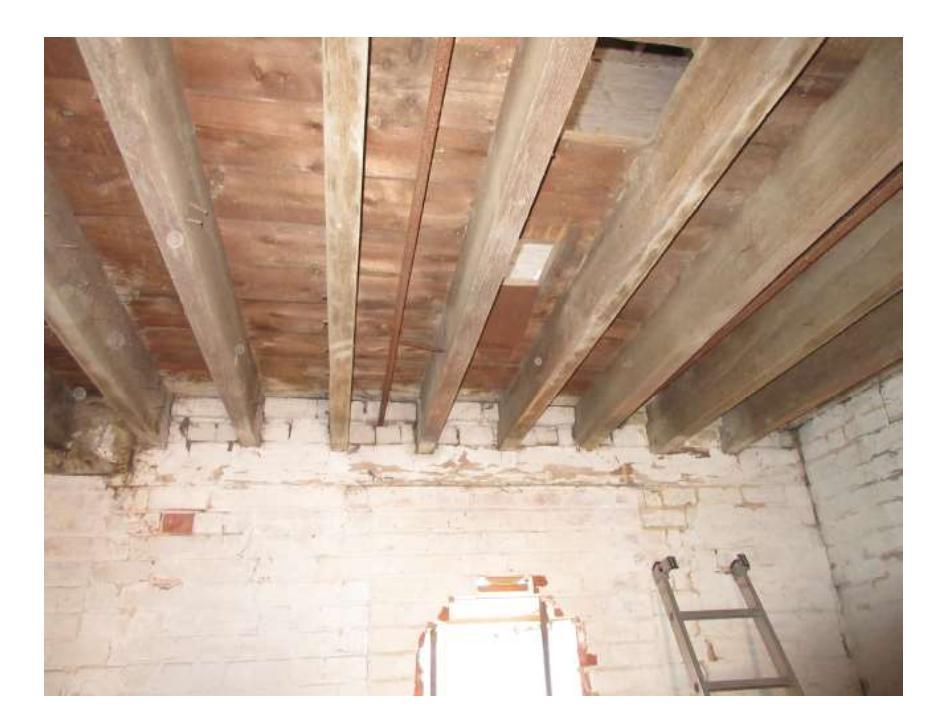
# Fig 46 :

Interior, second floor as seen from below; showing a view of the floor joists at the south-east corner which were free from structural decay at the time of survey

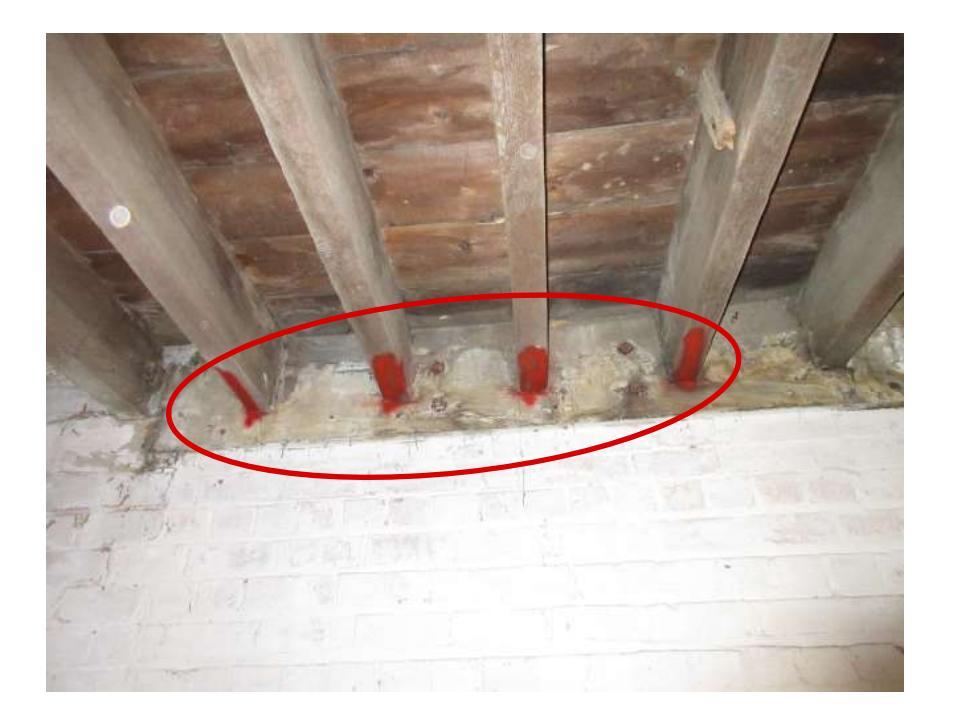
#### Fig 47 :

Interior, second floor as seen from below; showing a view of 4 no. floor joist bearing ends at the middle of the east wall. These had succumbed to structurally significant decay and will need repair

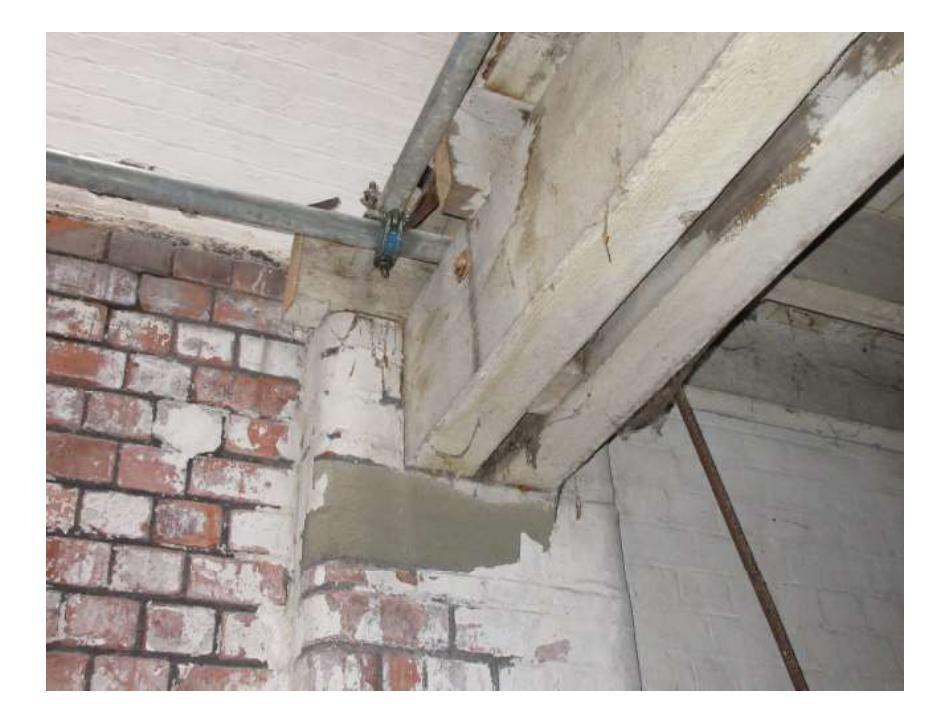
## Fig 51 :

Interior, first floor as seen from below; showing a view of a twin beam primary beam at the north-west corner. There was no structurally significant decay identified at the time of the survey. However, deep moisture contents were found to be around 30 per cent leaving the timber very vulnerable to decay starting

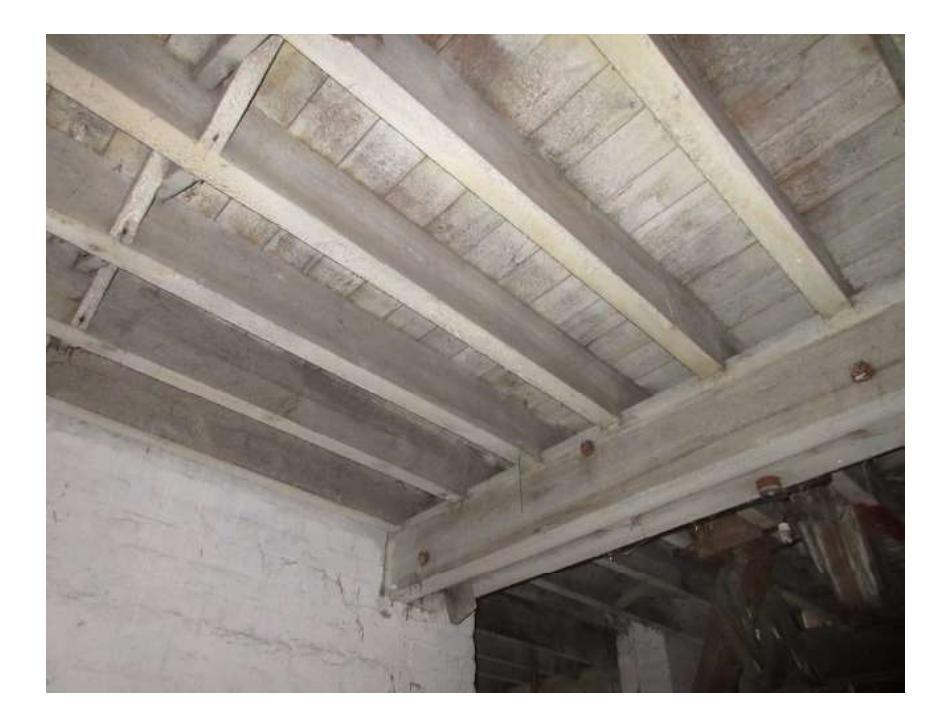
#### Fig 53 :

Interior, first floor as seen from below; showing a view of primary beam and floor joists at the north end, all of which were free from structurally significant decay

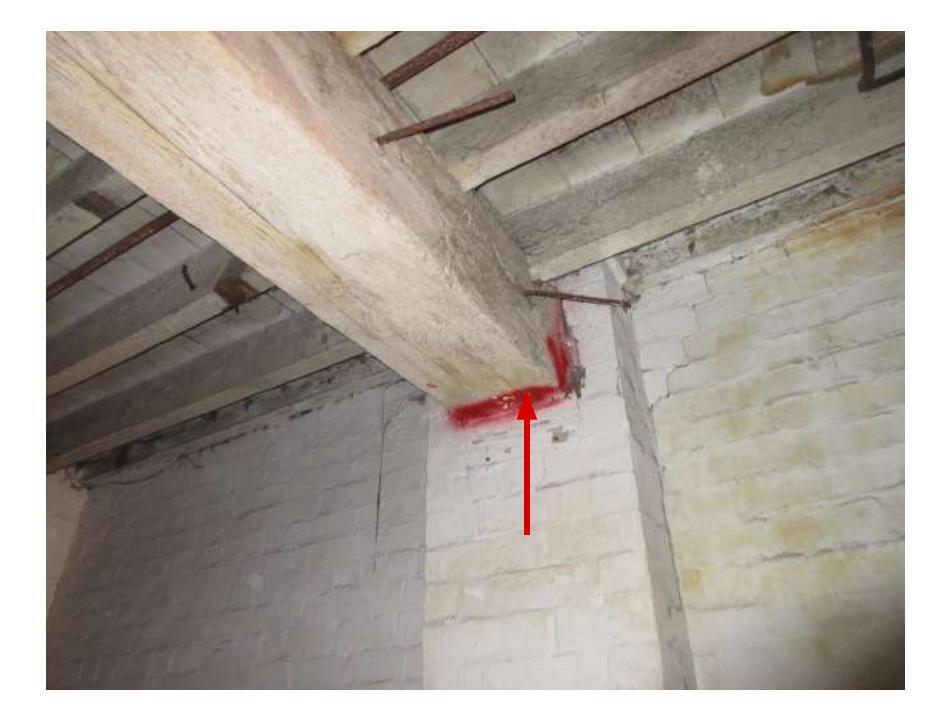
## Fig 57 :

Interior, first floor as seen from below; showing a view of structural decay to the bearing end of the primary beam at the south wall

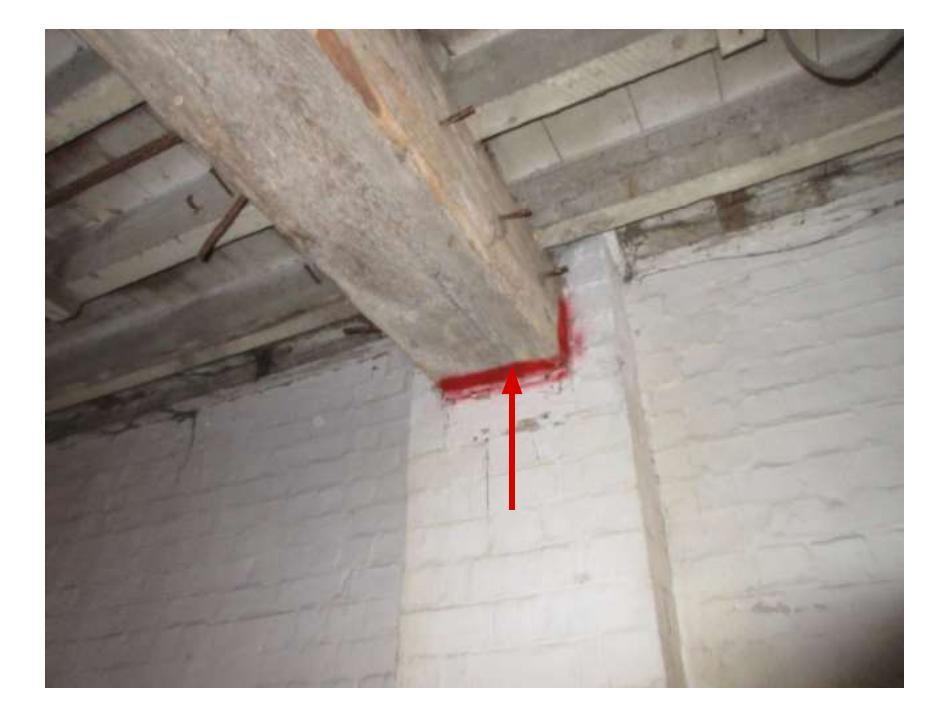
#### Fig 58 :

Interior, first floor as seen from below; showing a view of structural decay to the bearing end of the primary beam at the south wall

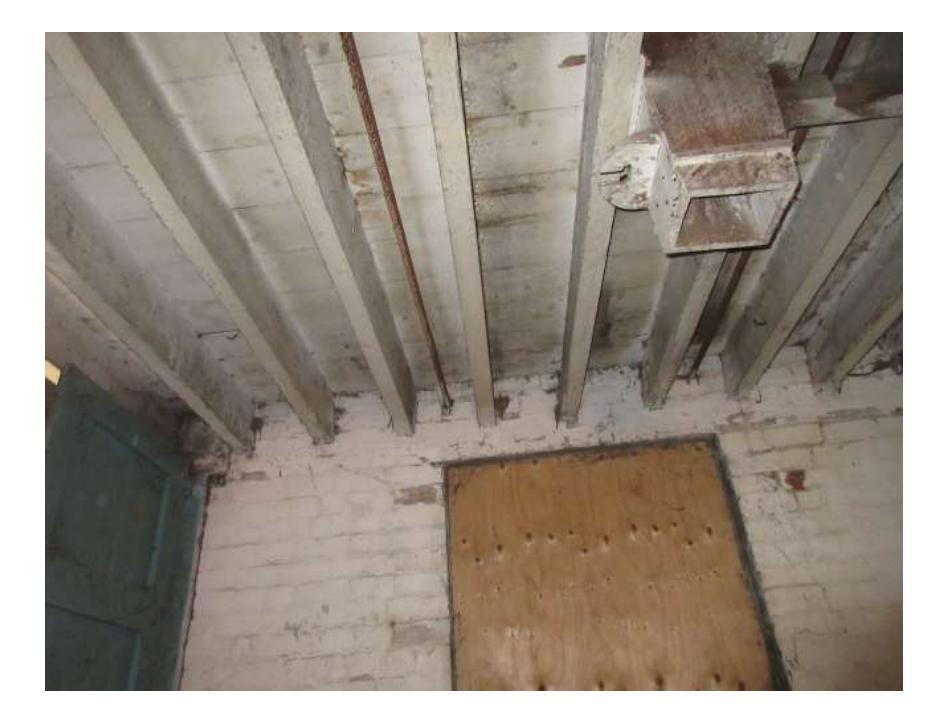
#### Fig 59 :

Interior, first floor as seen from below; showing a view of the timber floor structure at the south-east corner. All timbers were found to be free from structurally significant decay at the time of the survey

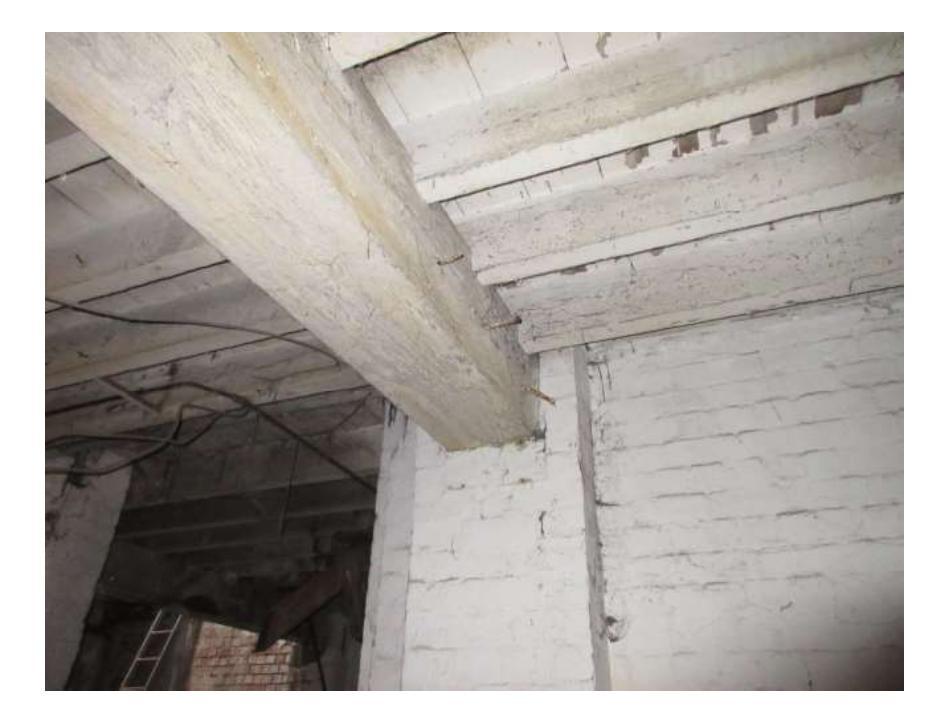
## Fig 61 :

Interior, first floor as seen from below; showing a view of the bearing end of the single element primary beam. This was free from structurally significant decay at the time of the survey

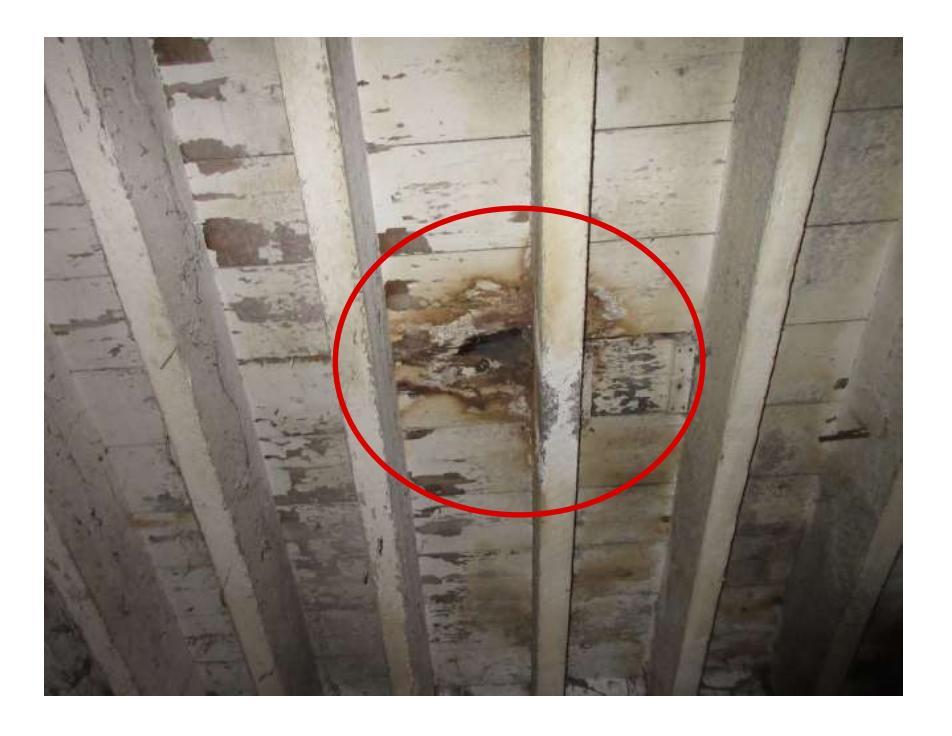
#### Fig 62 :

Interior, first floor as seen from below; showing a view of superficial decay to the underside of the floorboards. Upon inspection this had not extended to structural decay of the floor joists
