SUB23 Land Adjacent to Ski Centre

Site Historic Environment Assessments for Strategic
Assessment of Land Availability (SALA)

January 2016

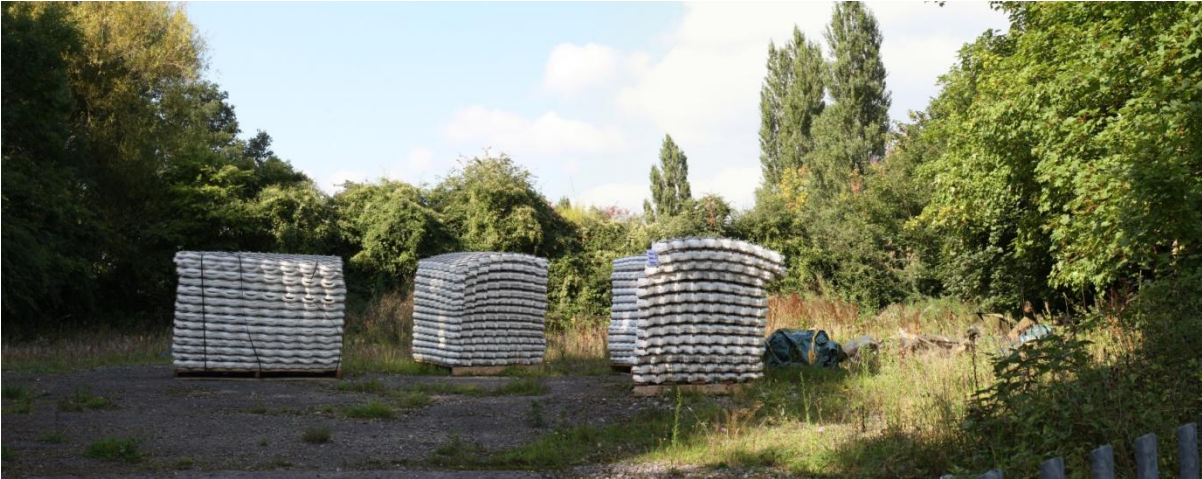
Plate 1: View into the SUB23 site from the south east

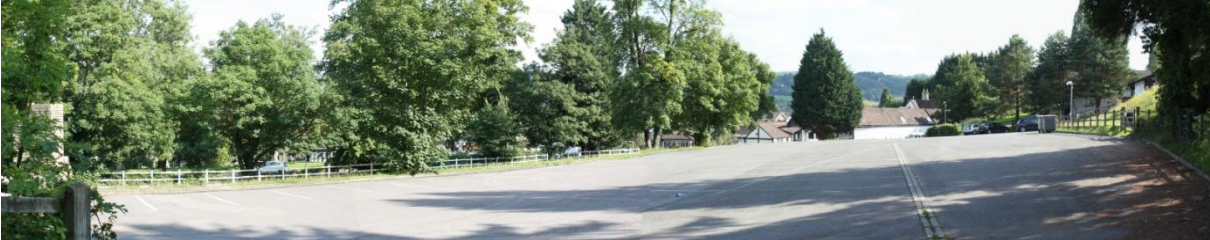
Plate 2: View from the south east corner of the SUB23 site looking south east

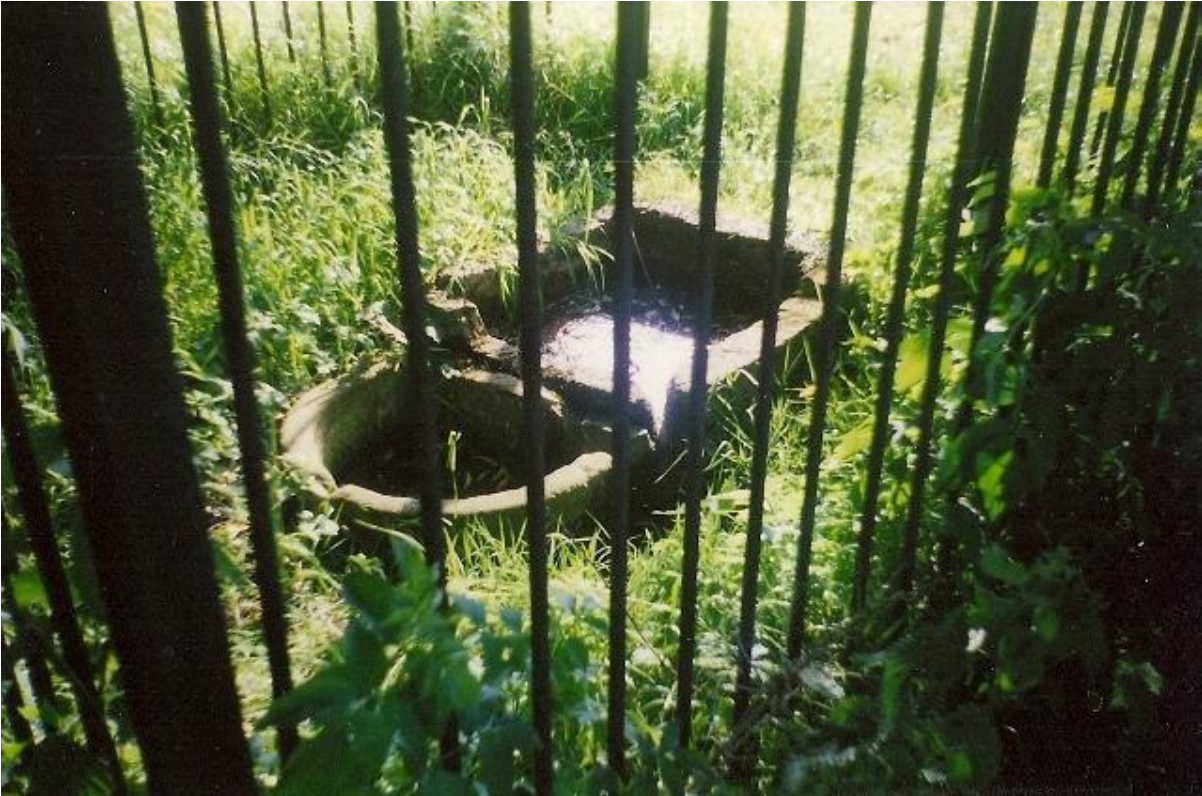
Within the SUB23 site is GUAD1151, the recorded observation of a medieval well. The Red Well, or Chalybeate, is a natural spring that feeds into a square limestone trough with a smaller semi-circular basin used as an overflow. It is called 'red' due to the large amount of iron in the water which has left behind red deposits on the trough and surrounding ground. The Red Well is also recorded on the

NMR as monument number 115297. It was used by Llanthony Priory and is believed to date back to the 11th century.

Plate 3: The Red Well

- Full recording of the Red Well, a heritage asset of high local importance, in line with relevant guidance produced by Historic England (EH 2006) and the ClfA (ClfA 2014e). This should be carried out whether the Red Well is at risk from proposals or not, in order to further understand this heritage asset and its setting.

The Red Well should be avoided by all development, in order to retain the locally significant and historically important heritage asset. This has been marked **red** on Figure 5. A radius of 25m surrounding the Red Well should also be left intact, in order to retain the setting of the heritage asset. This area has been marked **red** on Figure 5. This could be achieved by including the Red Well and its surroundings as an area of open space within a development.

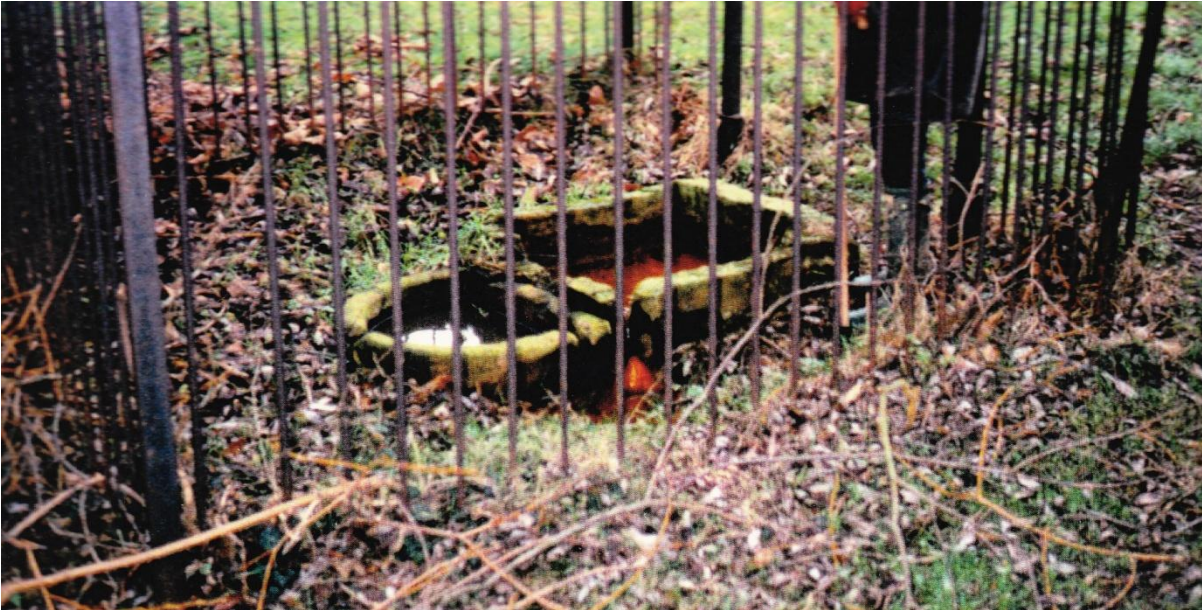
Plate 4: The Red Well

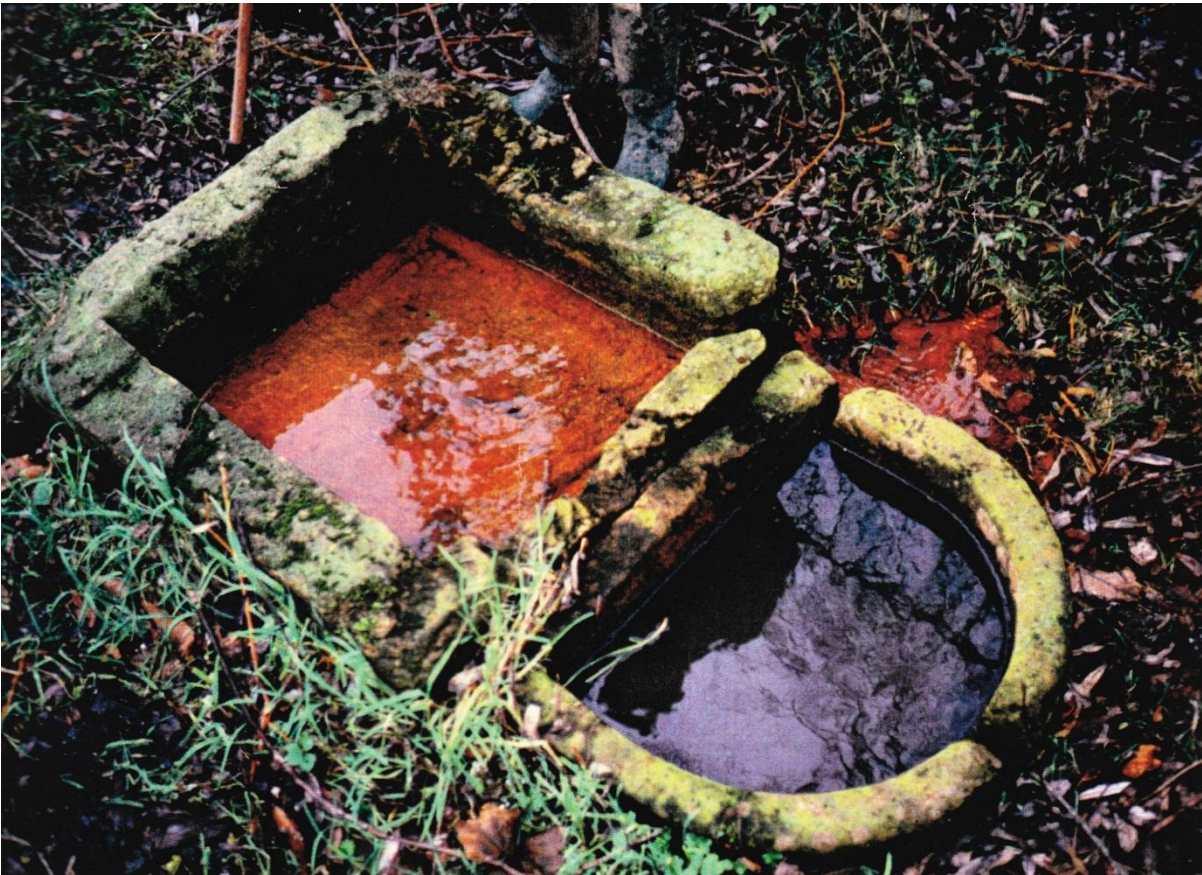
Plate 5: The Red Well

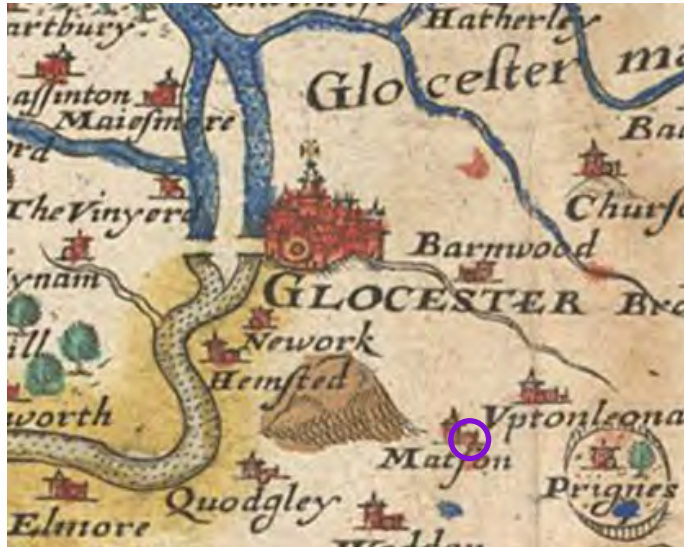
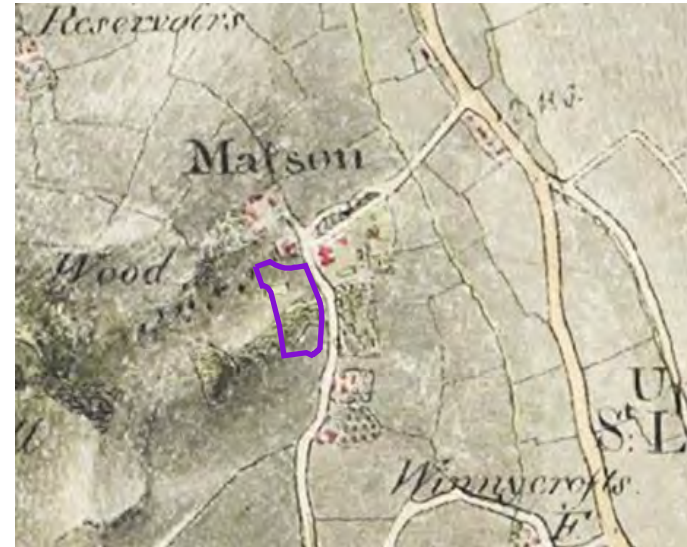
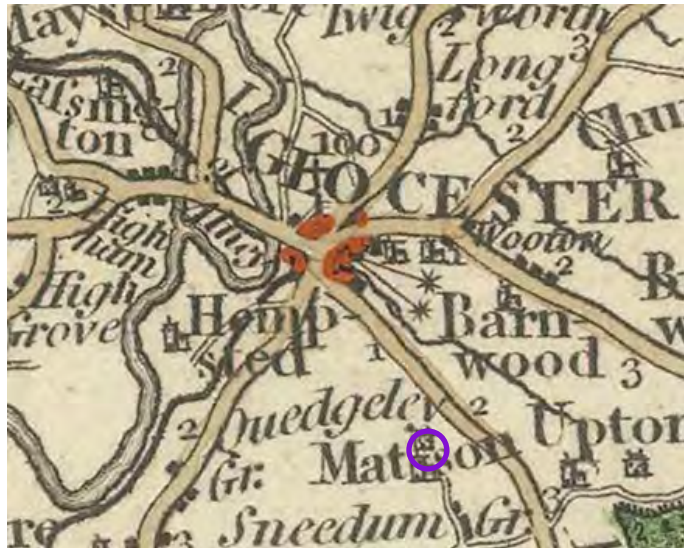
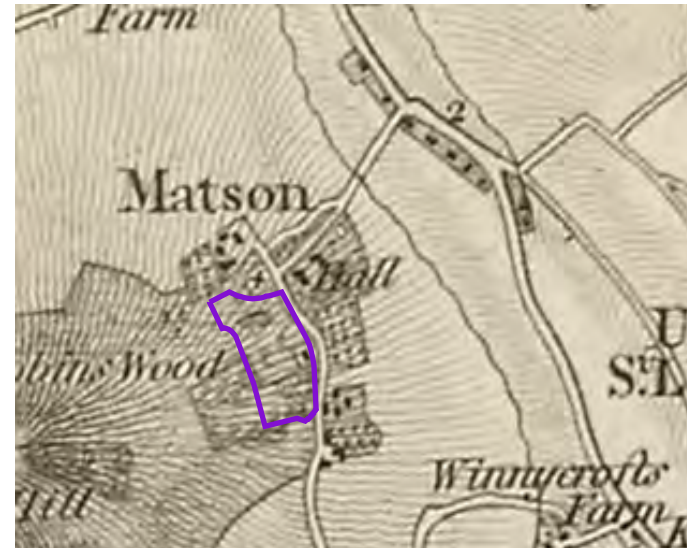
Figure 3 - Historical mapping

Historic mapping (Figs 3 and 4) shows the uses and changes in the land the SUB23 site. The earlier maps, such as the 16th century Saxton maps, merely show that there was a church at Matson; they do not even show roads. Likewise, the 1794 Cary map shows no detail but does at least show that there was a large house at Matson. The 1811 Dawson mapping was the first survey of what became the Ordnance Survey. For Matson this shows the church and Matson House and also a plot of land that looks like a plantation (Fig 3). These features can also be seen on the 1828 Ordnance Survey (Fig 3). The first detailed mapping of 1884 (Fig 4) shows that the plot of land forming the SUB23 site included a reservoir, the Red Well and a large number of deciduous trees. The 1903 Ordnance Survey (Fig 4) still shows the reservoir and Red Well although the number of trees has decreased. The shading of the SUB23 site matches that surrounding Matson House to the east and suggests that the site was used as park land for Matson House. Nothing changes within the SUB23 plot of land on the 1924 and 1946 maps (Fig 4). Despite the different scale of the 1952 map (Fig 4) the plot of land is still the same. The SUB23 site still contains a reservoir and the Red Well.
