<b>Site:</b>	Bakers Quay, Gloucester, GL2 5QZ
<b>Client:</b>	Kinsler & Partners LLP
<b>Job Number:</b>	784-B034511
<b>Survey Type(s):</b>	Bat Roost Assessment
<b>Date of Survey(s):</b>	12 <sup>th</sup> April 2022
<b>File Location:</b>	<a href="#">\\ds-dc-vm-101\Data\Projects\784-B034511 Bakers Quay\60 Project Output\61 Work in Progress\BRA March 2022\</a>

## INTRODUCTION

Tetra Tech was commissioned by Kinsler & Partners LLP (the “client”) on 28<sup>th</sup> January 2022 to provide a Bat Roost Assessment (BRA) to assess the potential for the site to support bats, at High Orchard Street warehouse and the Brick Kilns, Gloucester Quays, GL2 5QZ, centred at SO826179 and shown on the site location plan (Figure 1), hereafter referred to as the ‘site’. The site comprised of the remains of Malthouse 1 kiln area, Malthouse 2, Malthouse 2 Kiln area and High Orchard Street Warehouse.

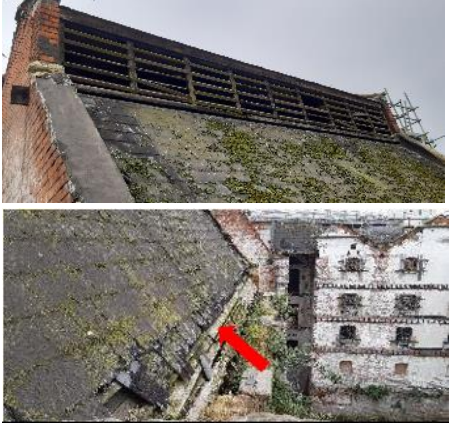
Feature name	Description	Potential Roost Feature	BRA	Photograph
Malthouse 2 Kiln	Kiln with intact roof	Louvered vents on roof provides access to internal space, gaps between tiles and sarking board on roof. Internally building has been stripped/floors removed	Moderate

The High Orchard Street Warehouse and the kiln of Malthouse 2 kiln area have been assessed as having **moderate** bat roost potential. Therefore, in accordance with the BCT Guidelines, **two nocturnal surveys** (i.e. one dusk emergence and pre-dawn one re-entry) should be undertaken between May and September, inclusive with at least one survey between May and August. The aim of the surveys will be to confirm the presence or likely absence of roosting bats. Any bat activity will be recorded during the surveys and static detectors (three) will be placed on each floor of the of the High Orchard Street warehouse, left in place overnight and retrieved in the morning to give evidence of any bats using the internal space without requiring a surveyor on each floor of the building during the survey.

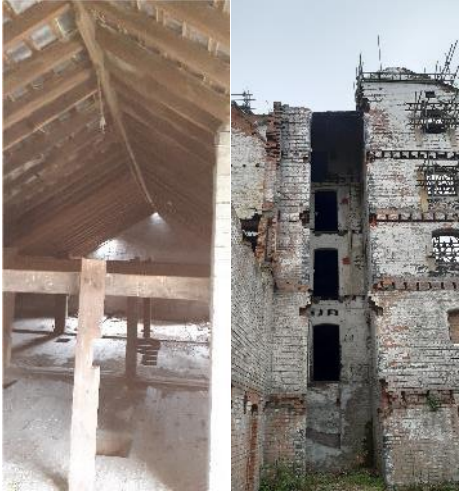
High Orchard St Warehouse	Roof intact, internal floors intact with occasional holes in floorboards but staircase is missing and has been replaced with a scaffold tower internally	Missing brickwork/joist holes, cracks and missing mortar Multiple access points to the internal space	Moderate

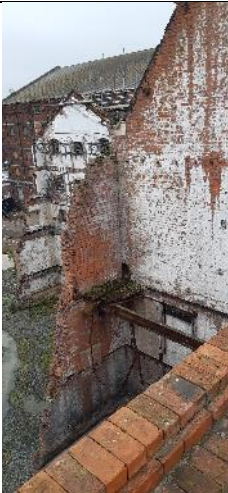
Malthouse 1 Kiln Wall	High walls on southern, eastern and northern ends	Numerous missing brickwork/joist holes, cracks and missing mortar	Low

The remaining walls of Malthouse 2, Malthouse 2 Kiln area and Malthouse 1 Kiln area have been assessed as having **Low** bat roost potential. Therefore, in accordance with the BCT Guidelines, **a single** emergence (dusk) or a single re-entry (pre-dawn) survey should be undertaken between May and August, inclusive. The survey will confirm the presence or likely absence of roosting bats.

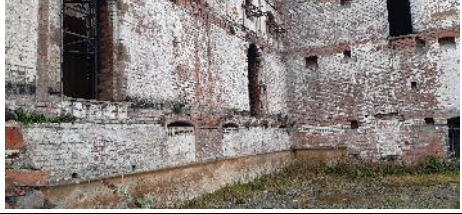
Feature name	Description	Potential Roost Feature	BRA	Photograph
Malthouse 2 Wall	High walls on southern and eastern ends	Missing brickwork/joist holes, cracks and missing mortar, bricked-in archways	Low

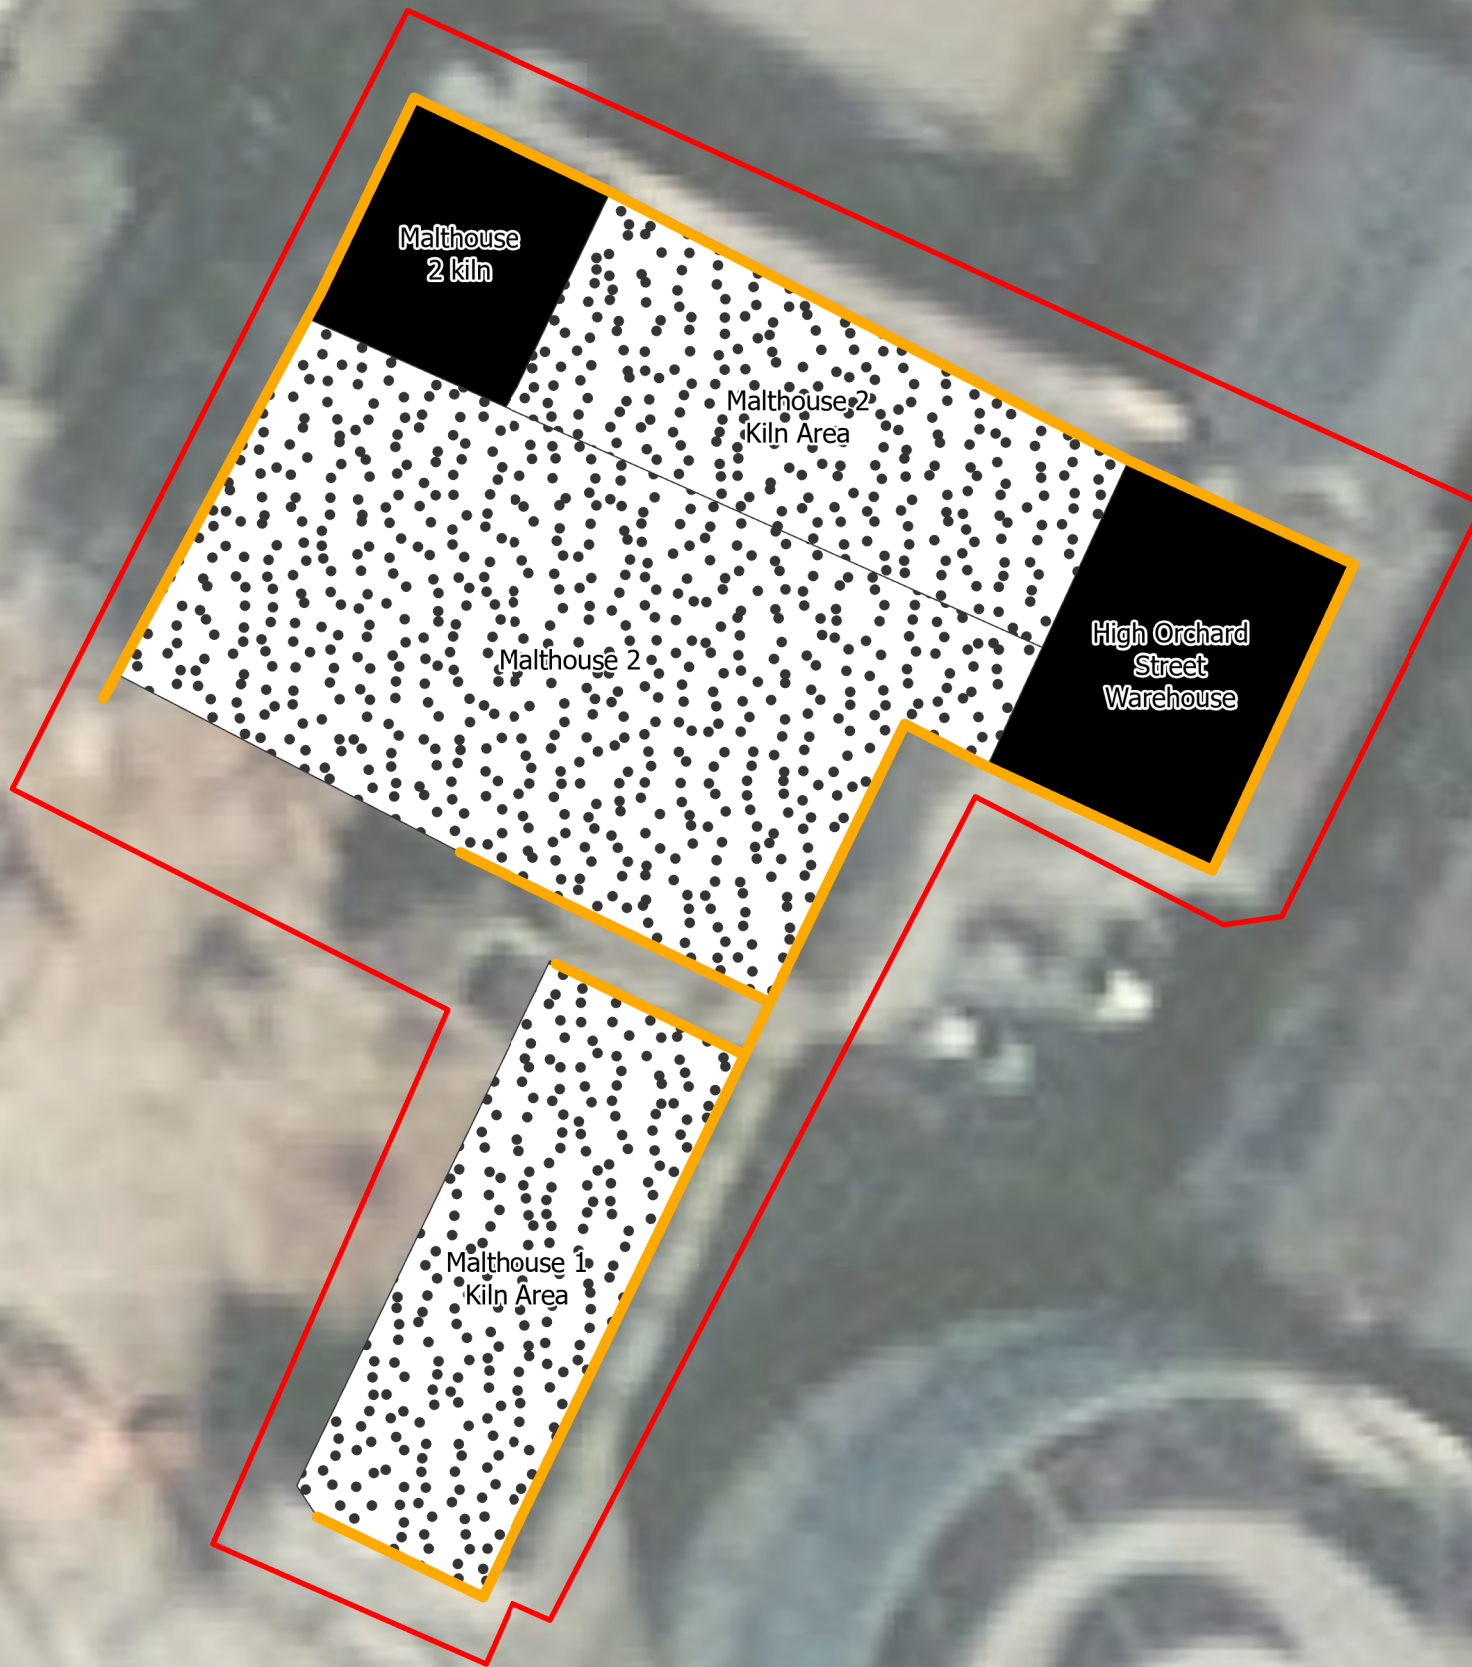
Figure No. 1  
Revision No. A

# Site Map

- Site boundary
- Bare ground (demolished building)
- Section of retained building
- High walls
