Downings Malthouse Baker's Quay, Gloucester

Heritage Assessment

CA Project: CR0989

Historic Building Recording Addendum

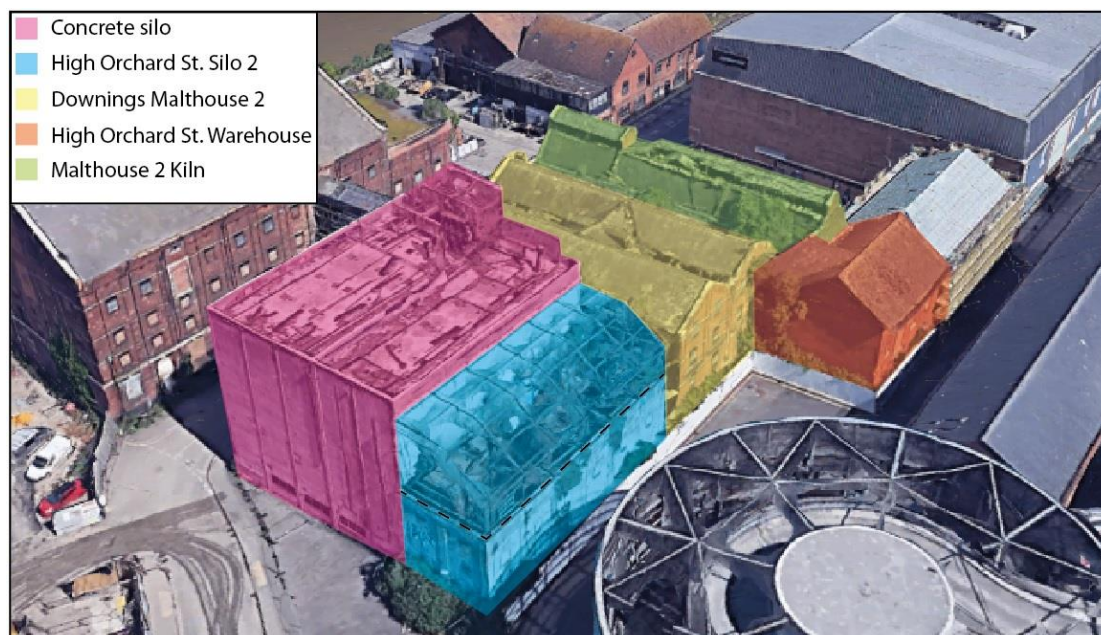
Photo 1 **Aerial overview of the Downings Malthouse building complex**

- 4.1. Downings Malthouse forms the main built presence of the Site. In 1876 a malthouse was built known as 'Malthouse 1', with a second building known as 'Malthouse 2' added in 1895. The designation includes an earlier warehouse building (High Orchard Street Warehouse) which was on the Site prior to 1876 when the Site was part of the wider timber yard. All three parts of the Listed Buildings which fall within the Site are shown in Photo 1. In 1960, Malthouse 1 was replaced with a modern Concrete Silo which is not included within the listing. Photo 1 below offers an overview of the building's of the Site.

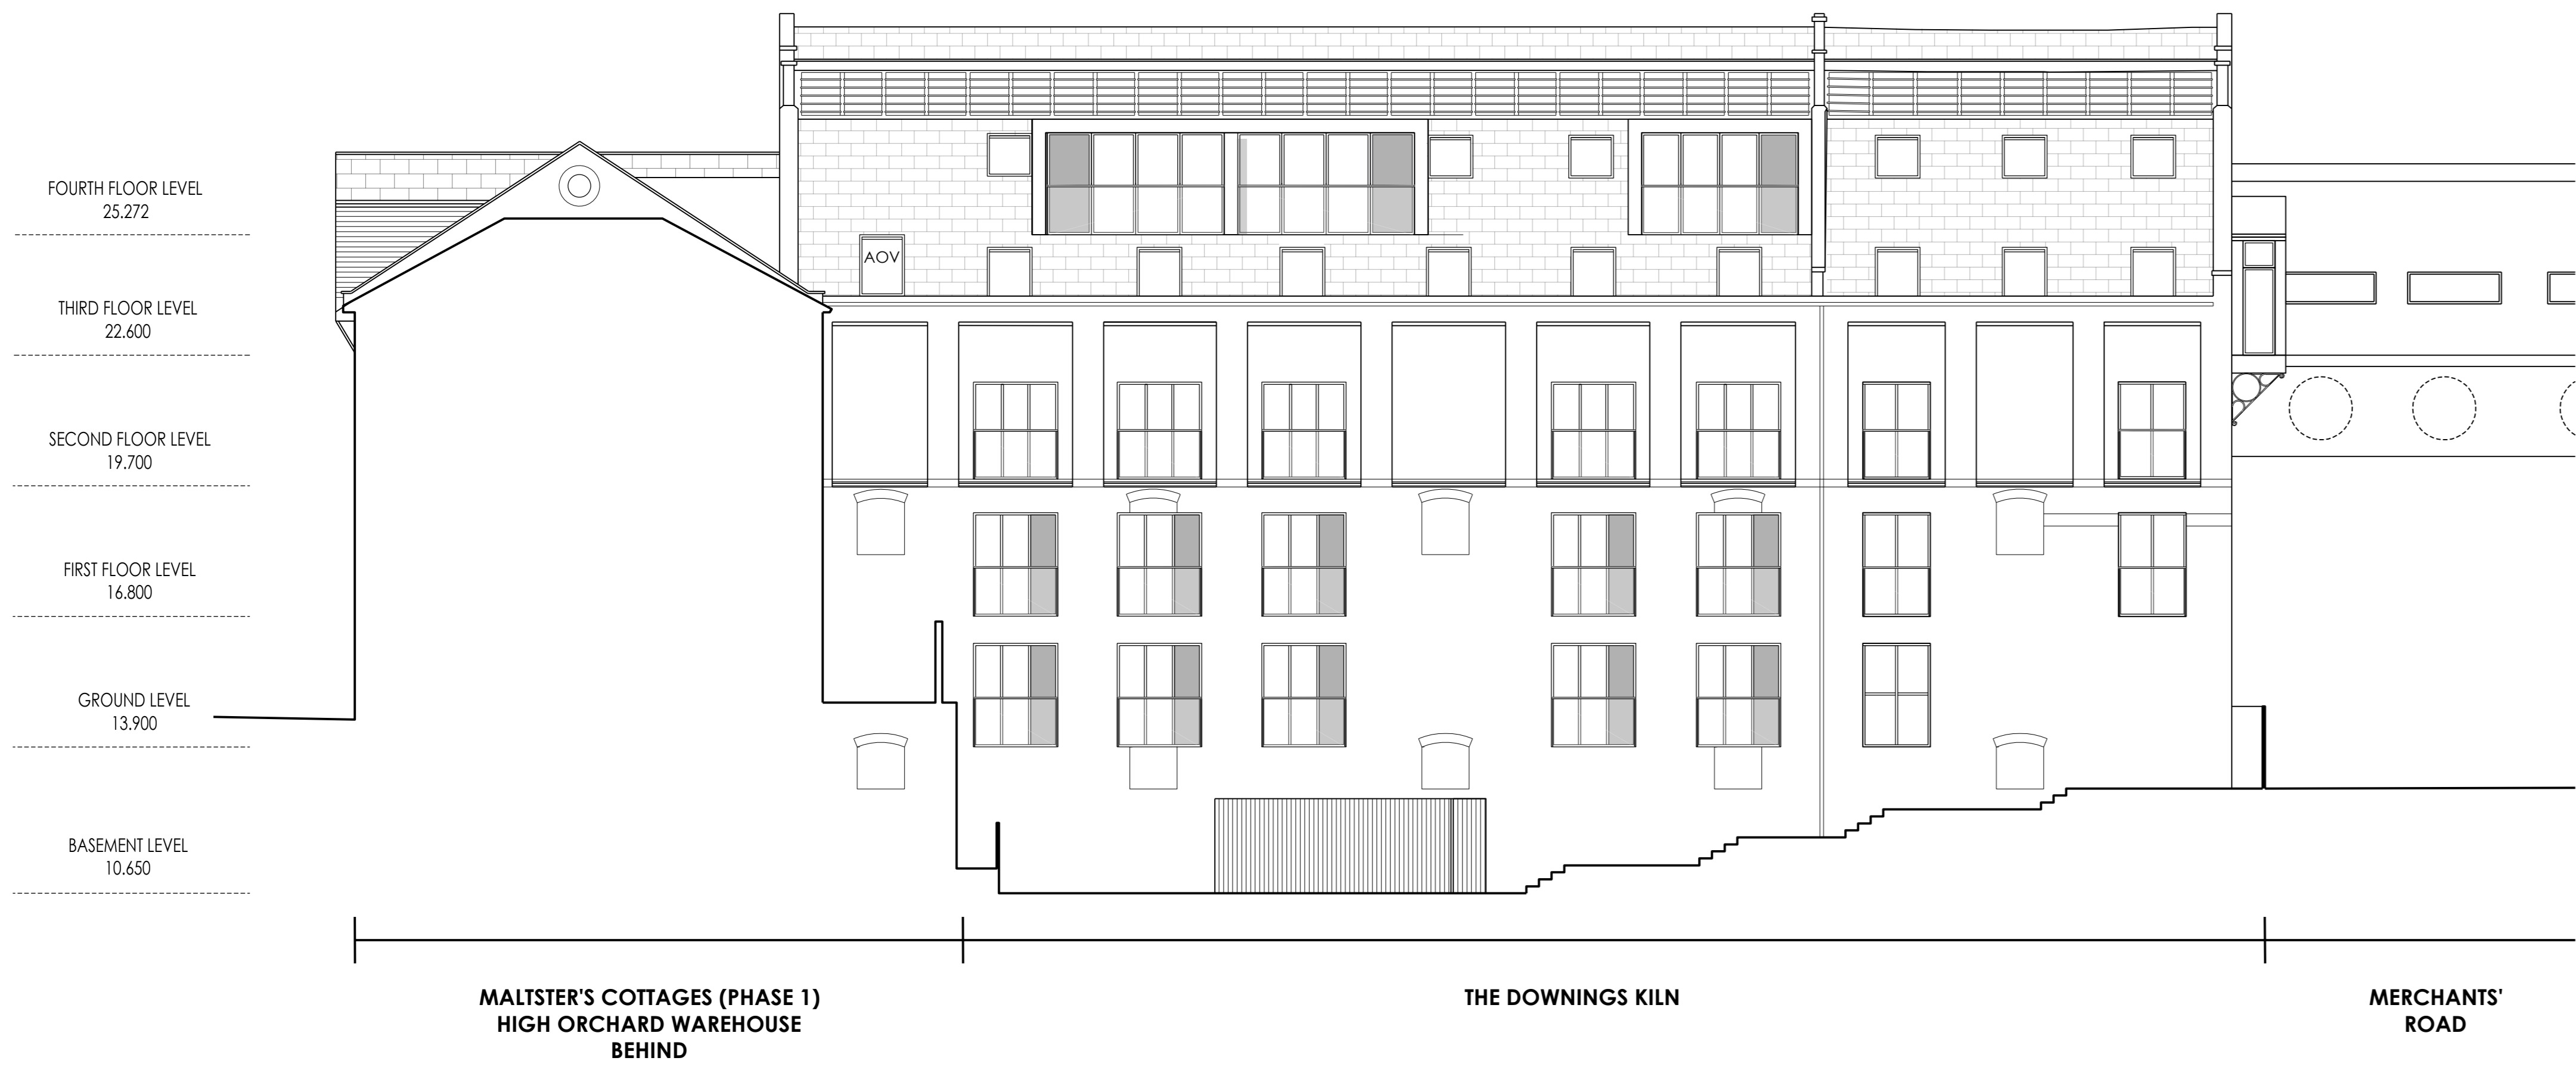
Proposed North-East Elevation

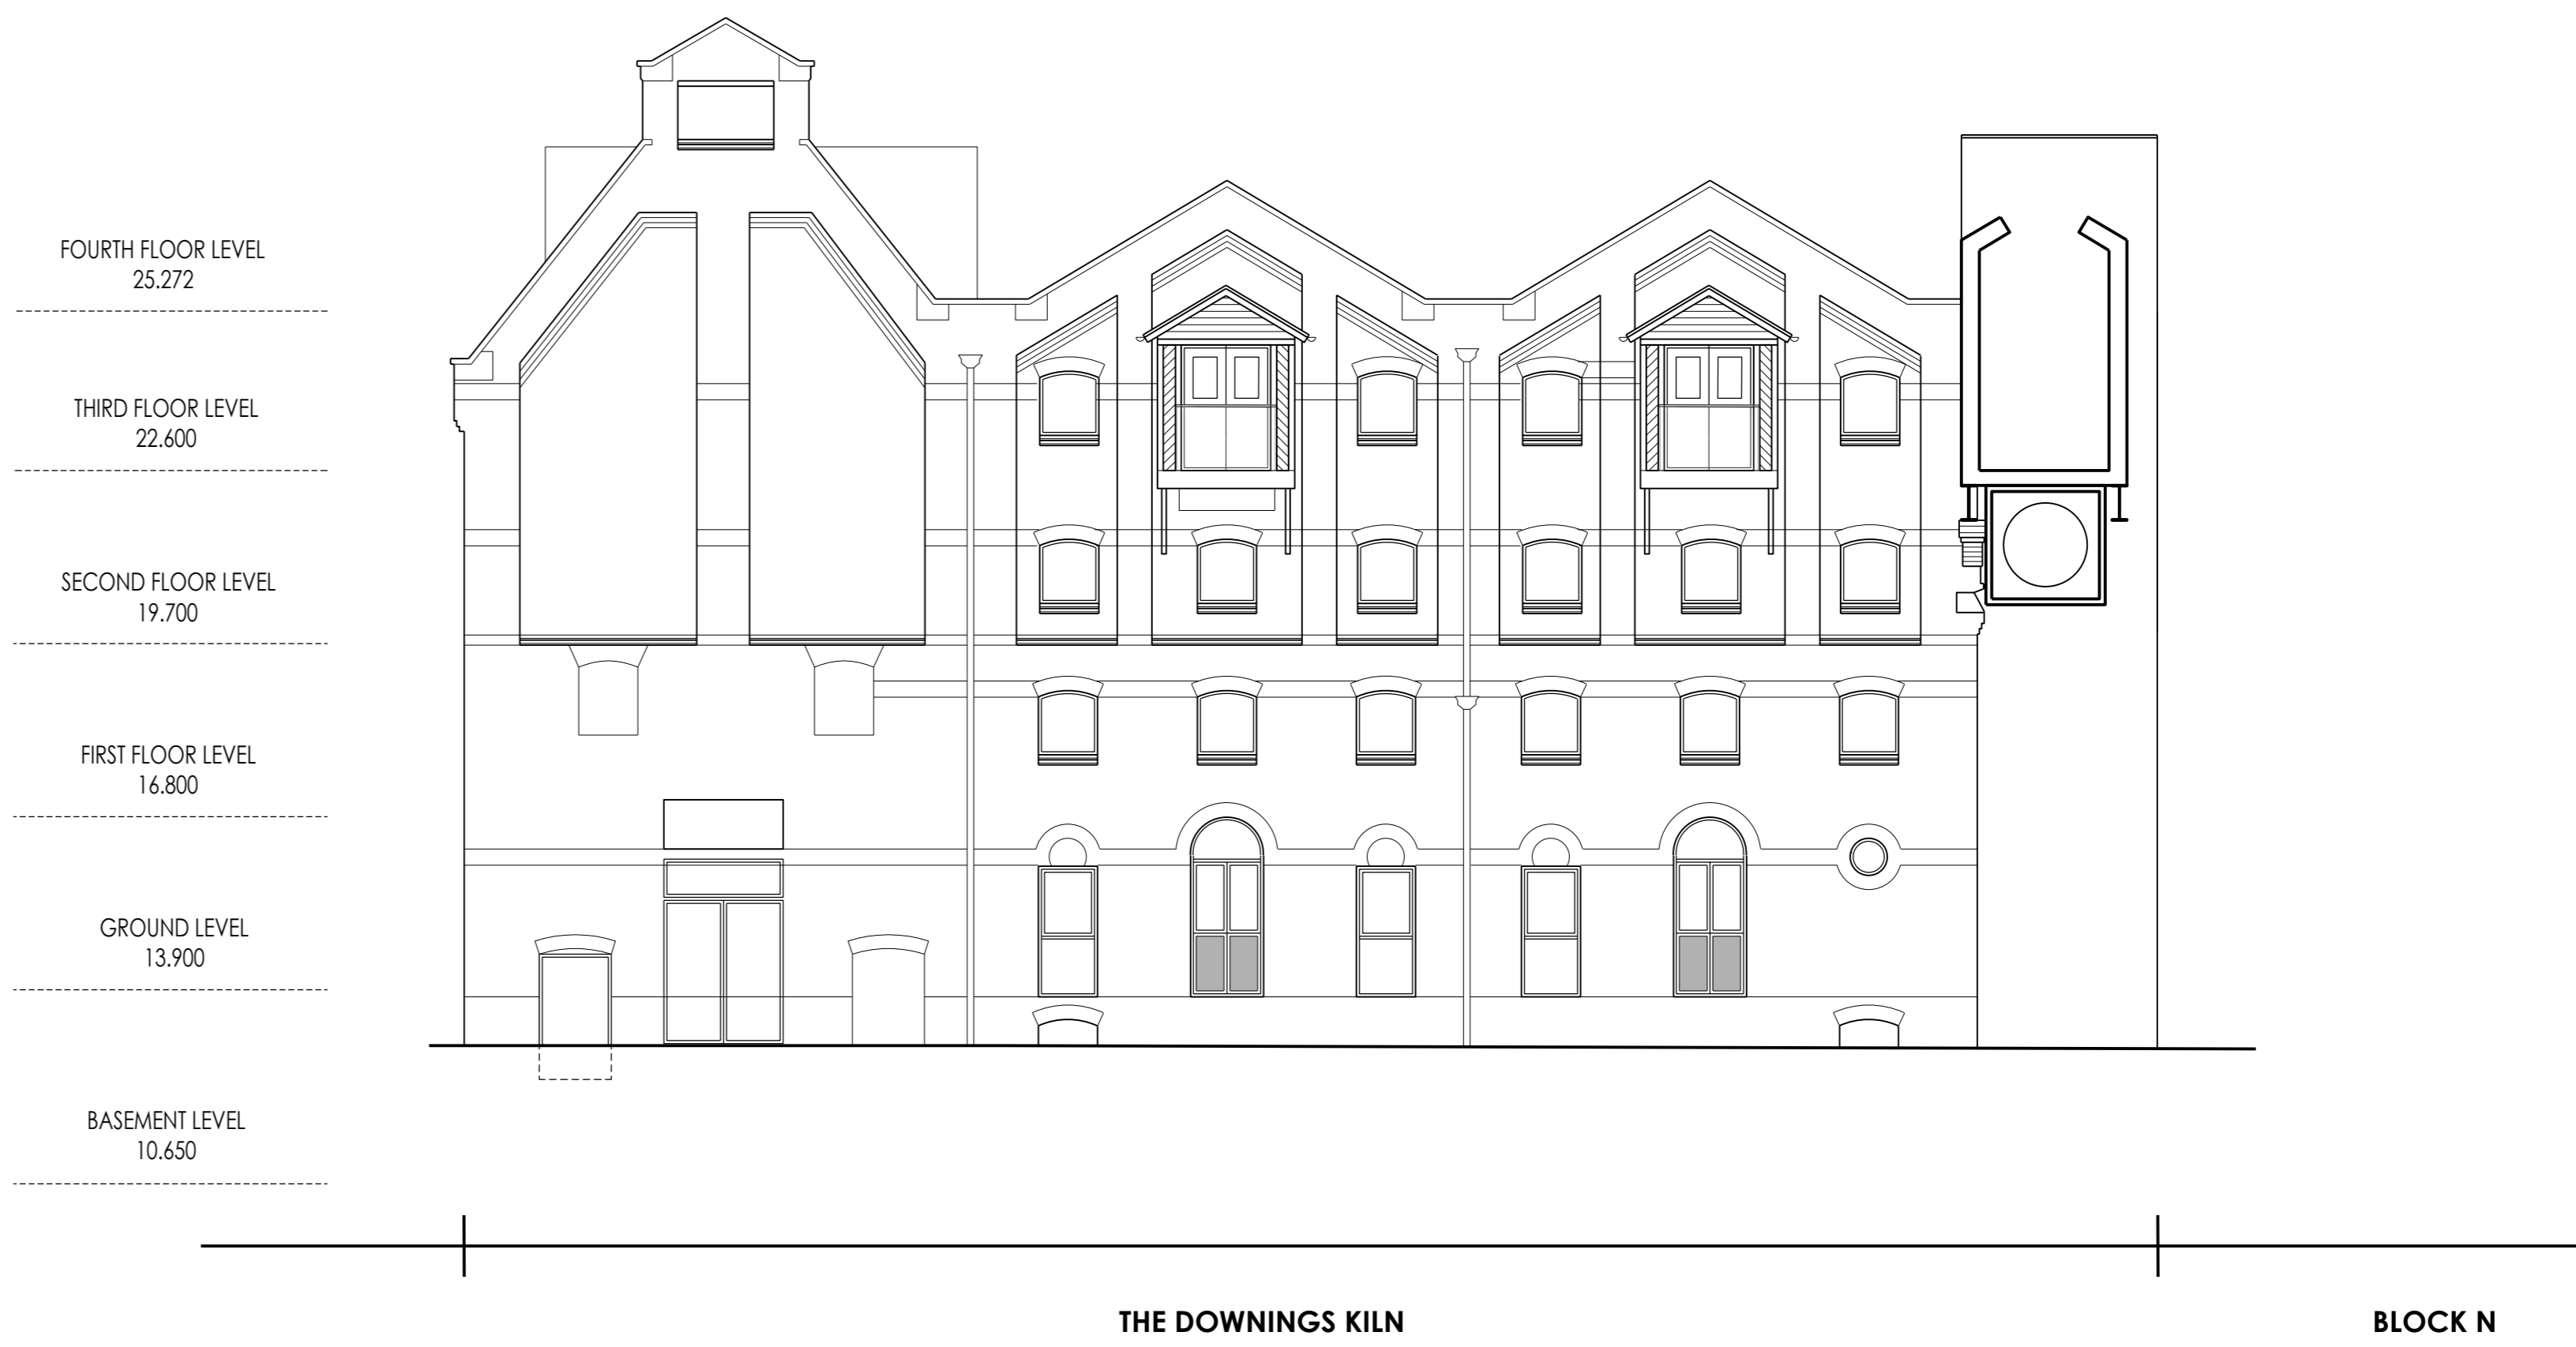
Proposed North-West Elevation

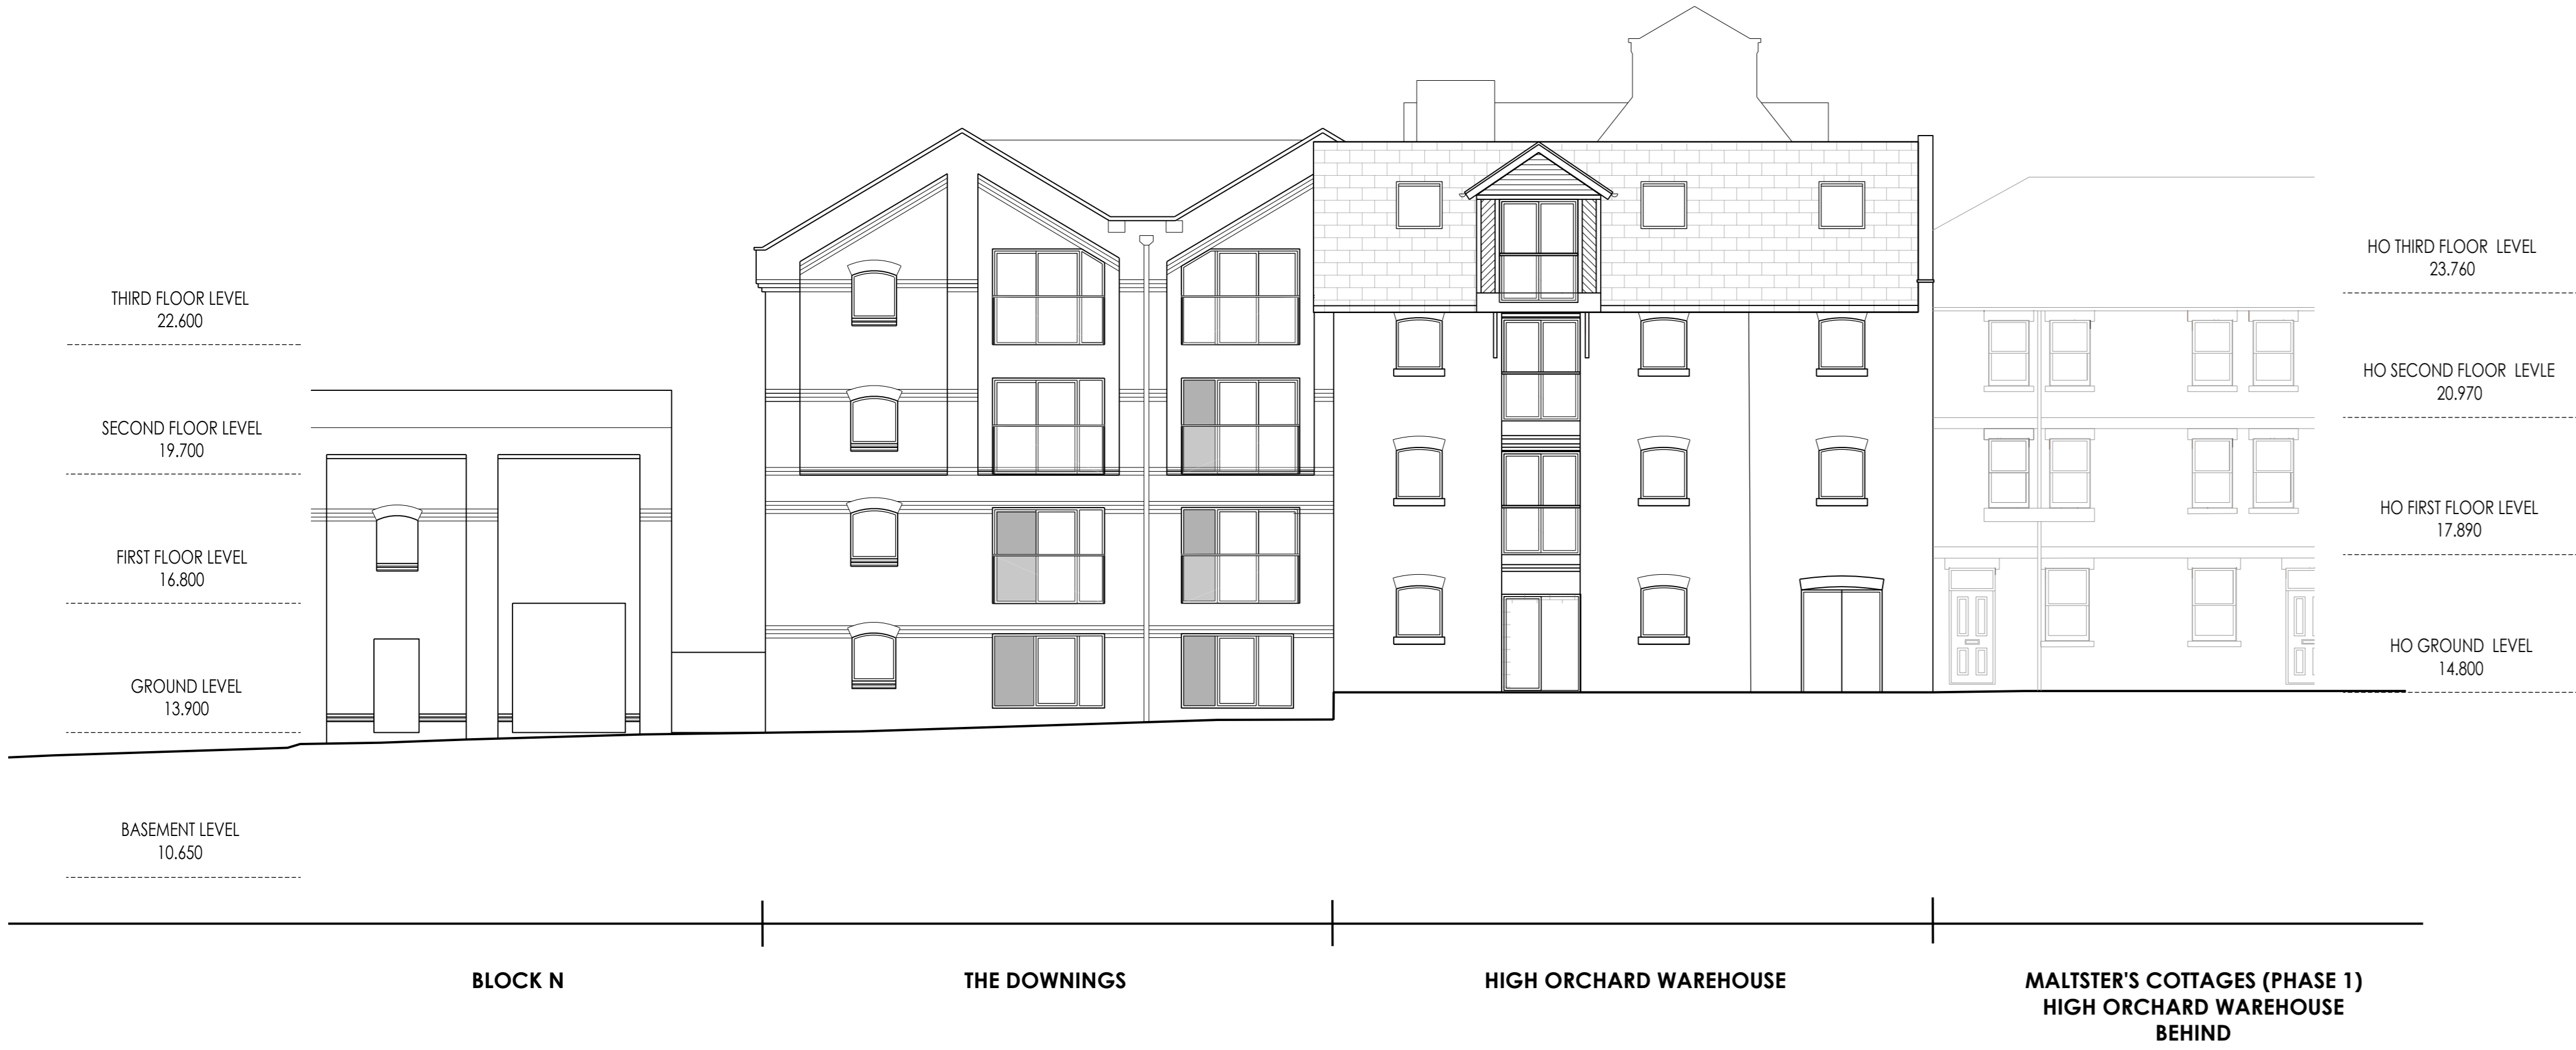
Proposed South-East Elevation

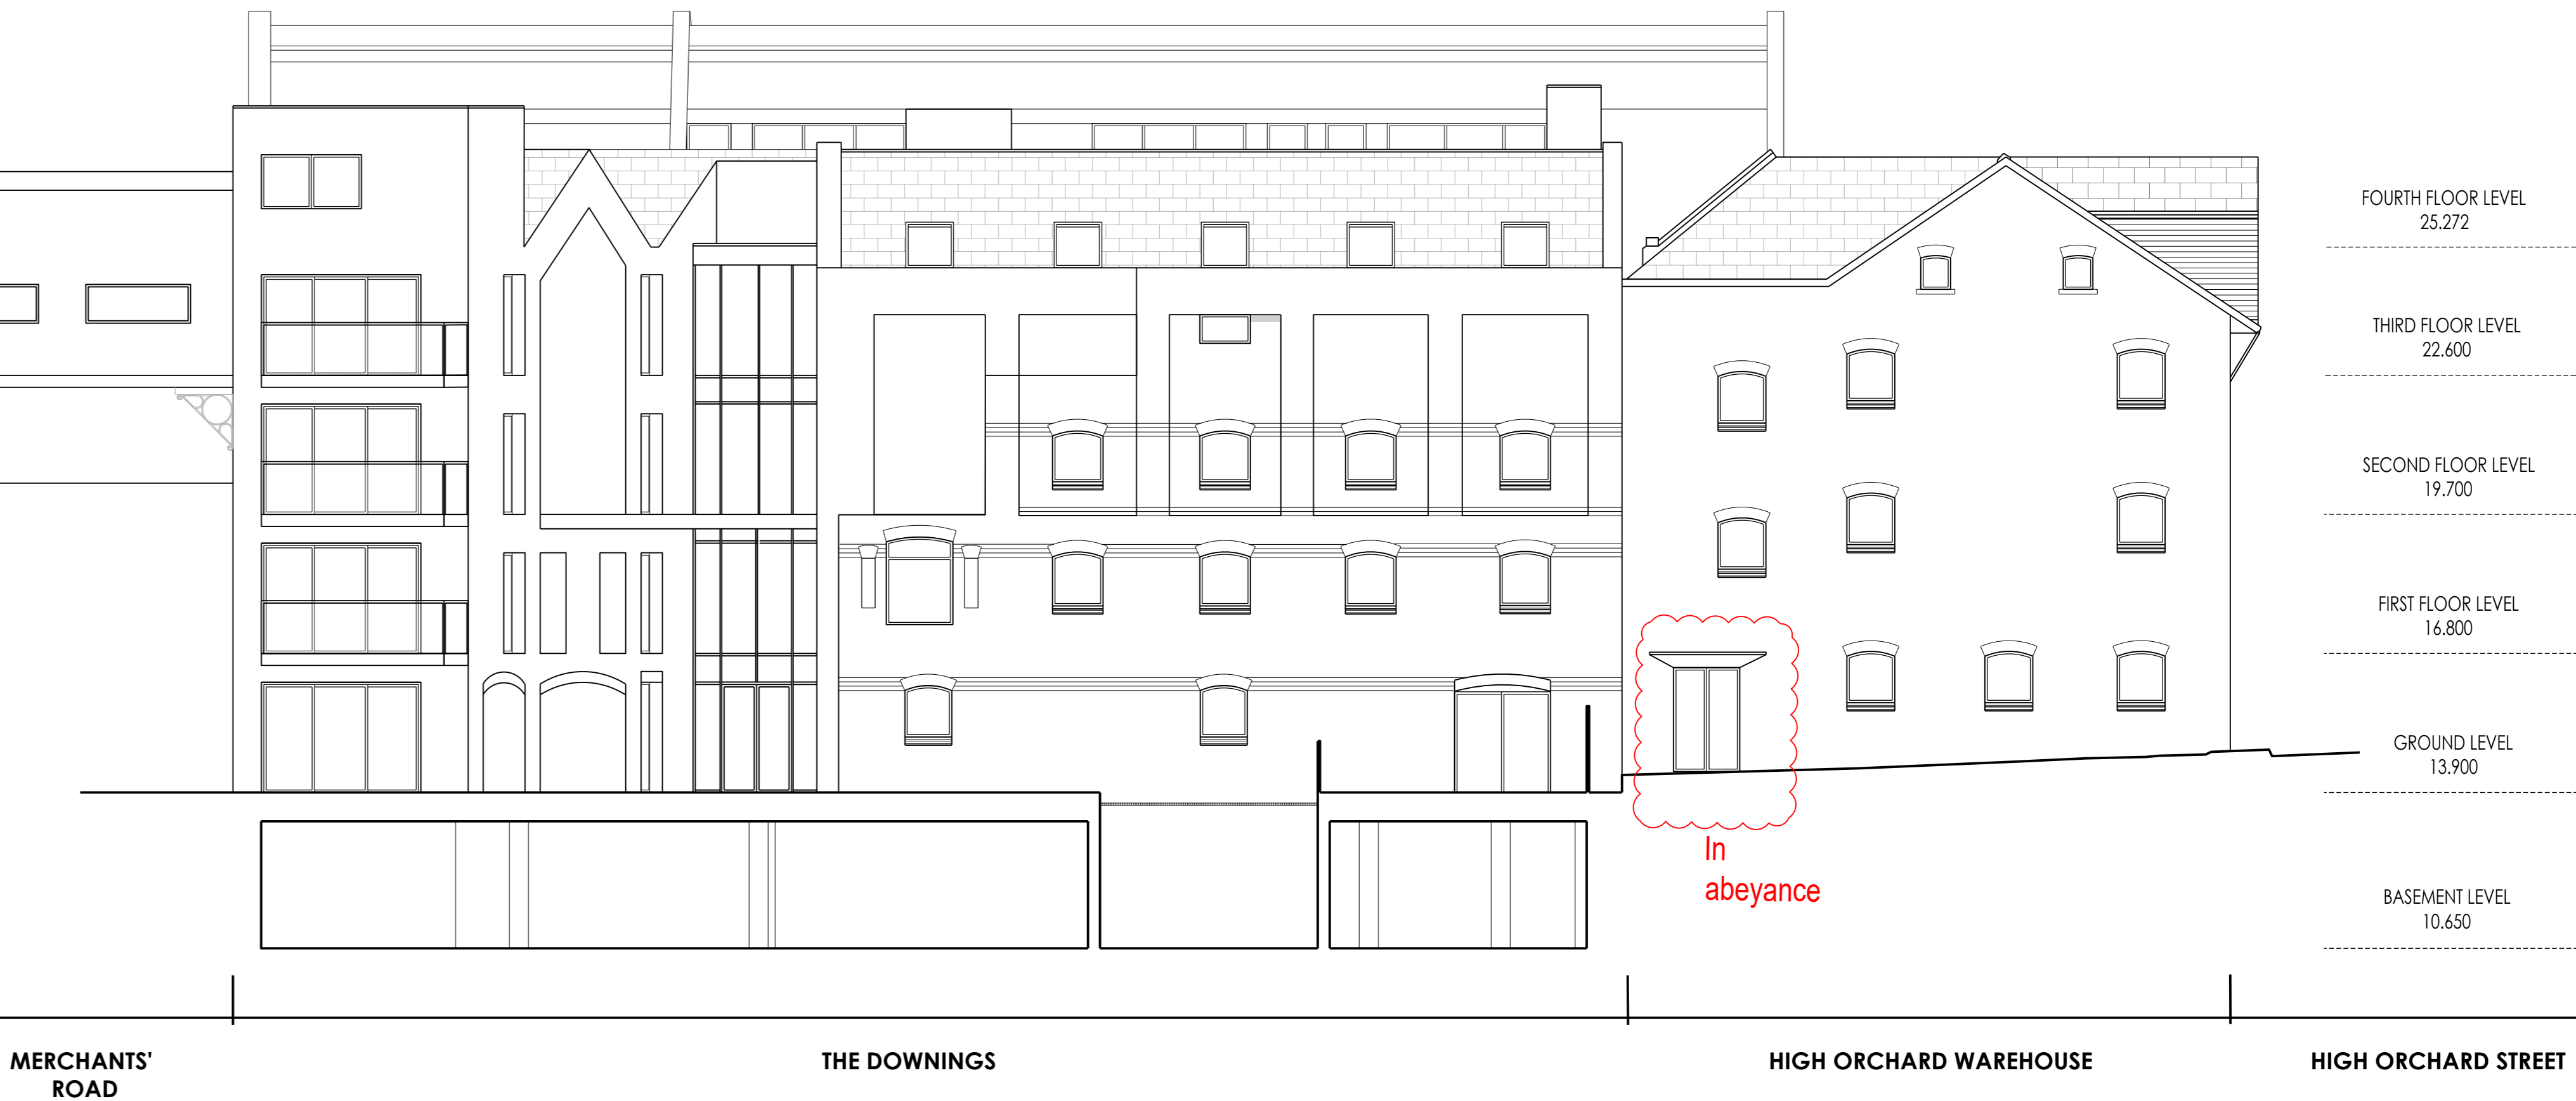
Proposed South-West Elevation

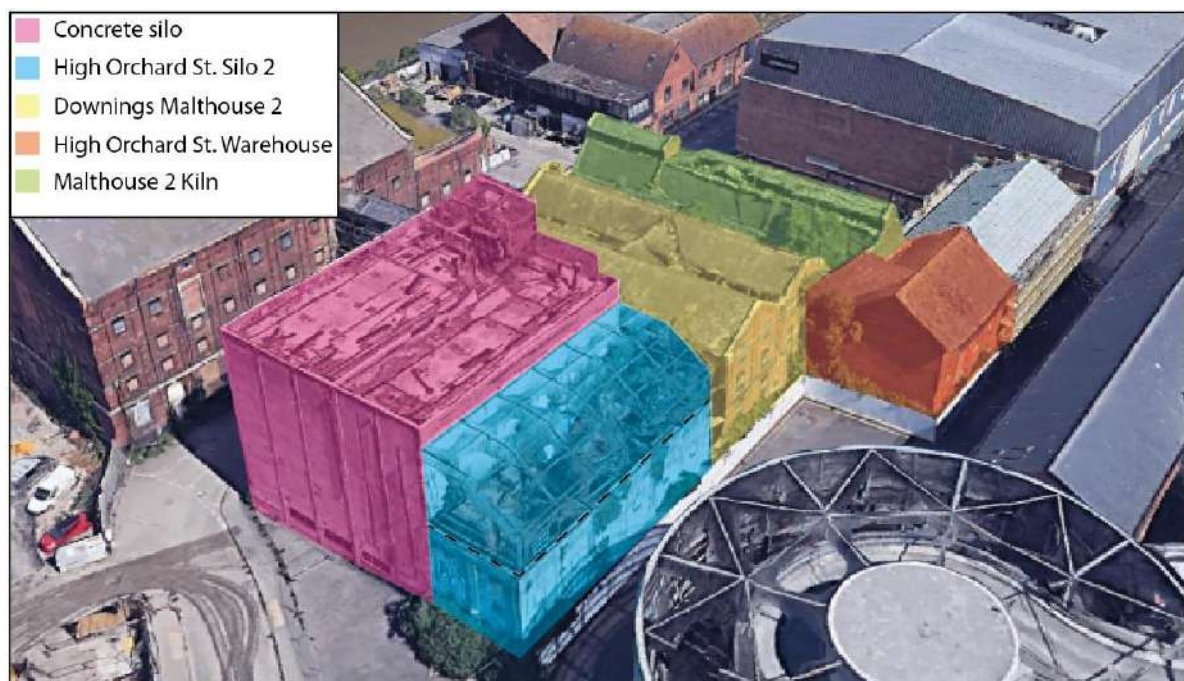
Fig.1 Aerial view of the buildings, highlighting each building under assessment *Image from Google Earth (Map data: Google). Image taken 2017, Accessed April 2019. Copyright 2020 Google'*

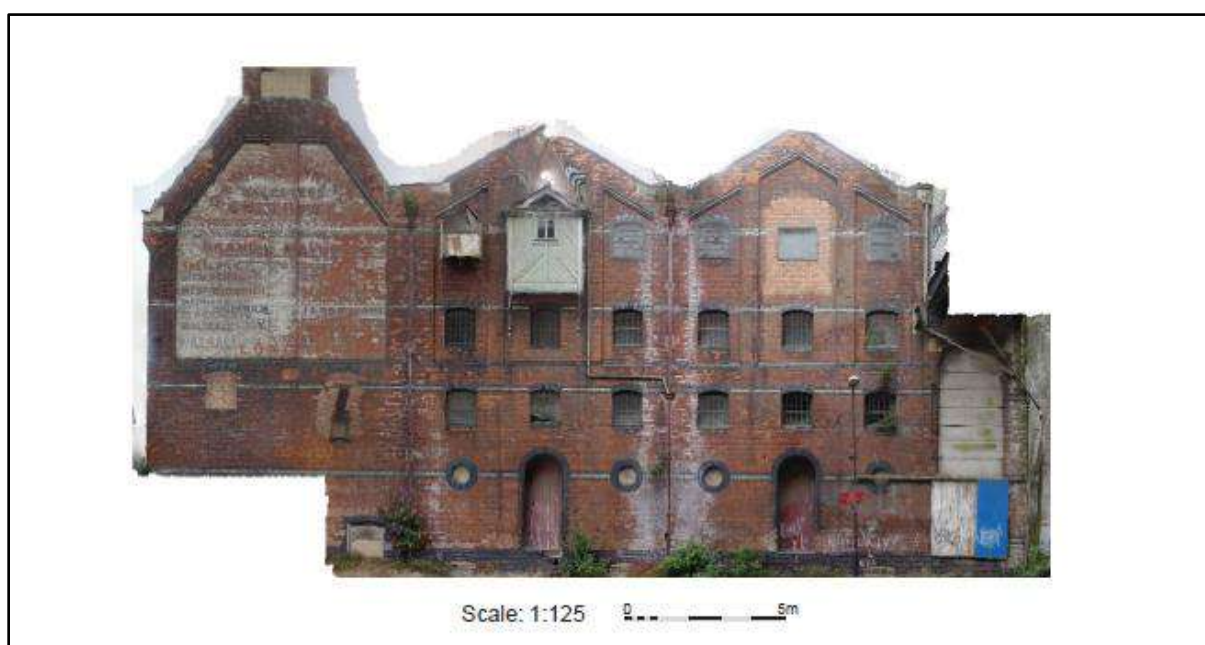
Fig.3 Photogrammetric rendition of the western elevation of Malthouse 2 and Kiln (far left; reproduced from the 2018 Final Report, where it is provided at scale)

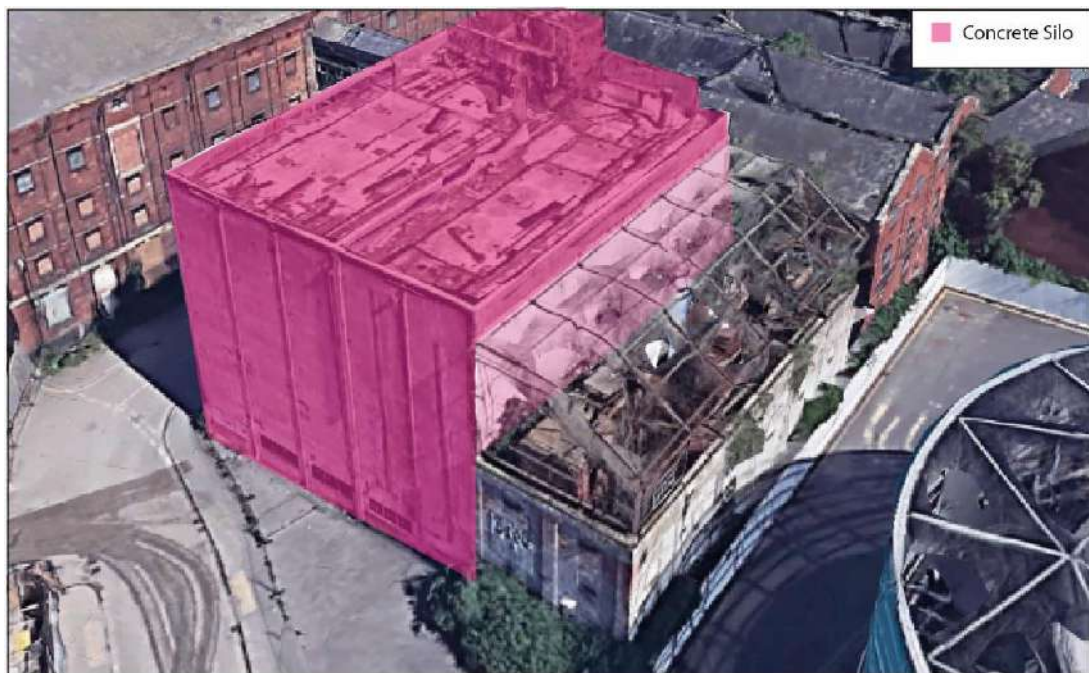
Fig.4 Aerial view of the silo

- 2.2. The silo is a concrete box which incorporates the northern and western walls of the 1876 maltings within its eastern wall. A row of windows with steel frames lights the ground floor on the south and west elevations. Between the hoppers are 20 concrete cruciform piers in four north/south rows of five that must rise to support the flat concrete roof. Another row was placed against the retained Victorian brick wall on the east. Figs.4 and 5 gives an overview of the exterior of the silo

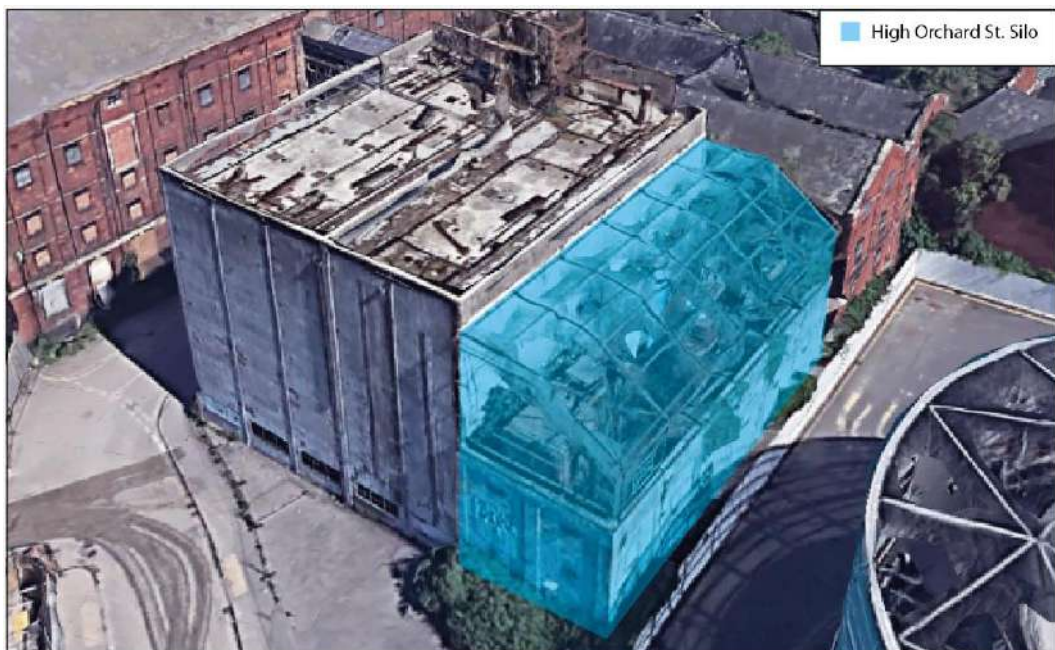
Fig.9 High Orchard Street Silo

- 3.1. This building, which sits adjacent to the concrete silo as seen in Fig. 9, comprises the shell of the original 1876 kiln block and is now occupied by the most recent phase of the grain handling machinery. The original maltings, as seen in historic images of the site, was built for George and William Downing and designed by Capel N Tripp and built by Joseph Meredith (Conway-Jones & Higgs 2008). It had a distinctive set of circular cowl chimneys as seen in Fig.10. This building under assessment is basically the ground and first floor shell of that kiln, altered, according to Conway-Jones and Higgs, to house a barley dryer, though it is not clear whether the current machinery seen within the building undertook that task or whether this was a later insertion.

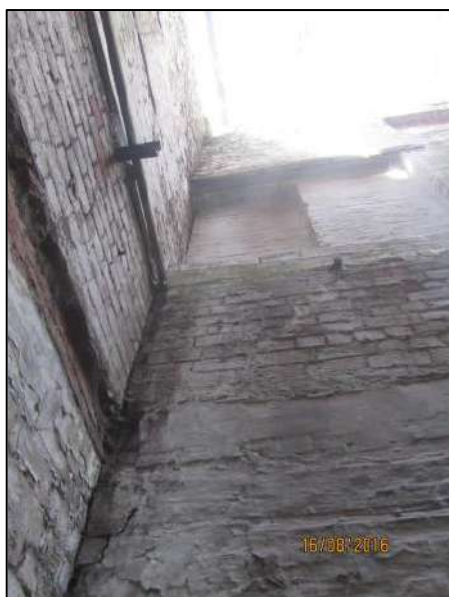
Fig.14 Interior of HOS silo

- 3.5. The internal space is basically a rectangular shell formed of painted masonry walls. As described above the roof and floors have been removed and replaced with a concrete ring beam at eaves level height supporting a steel framed roof structure.
- 3.6. The internal space is largely filled with steel silos and associated machinery; it is possible the modern steel silo is the barley dryer mentioned in Conway-Jones & Higgs (2008) as being part of the modernisation of the site in the 1960's. Images of air venting structures may support this theory. Figs.14 to 17 give a visual overview of the interior of the space.

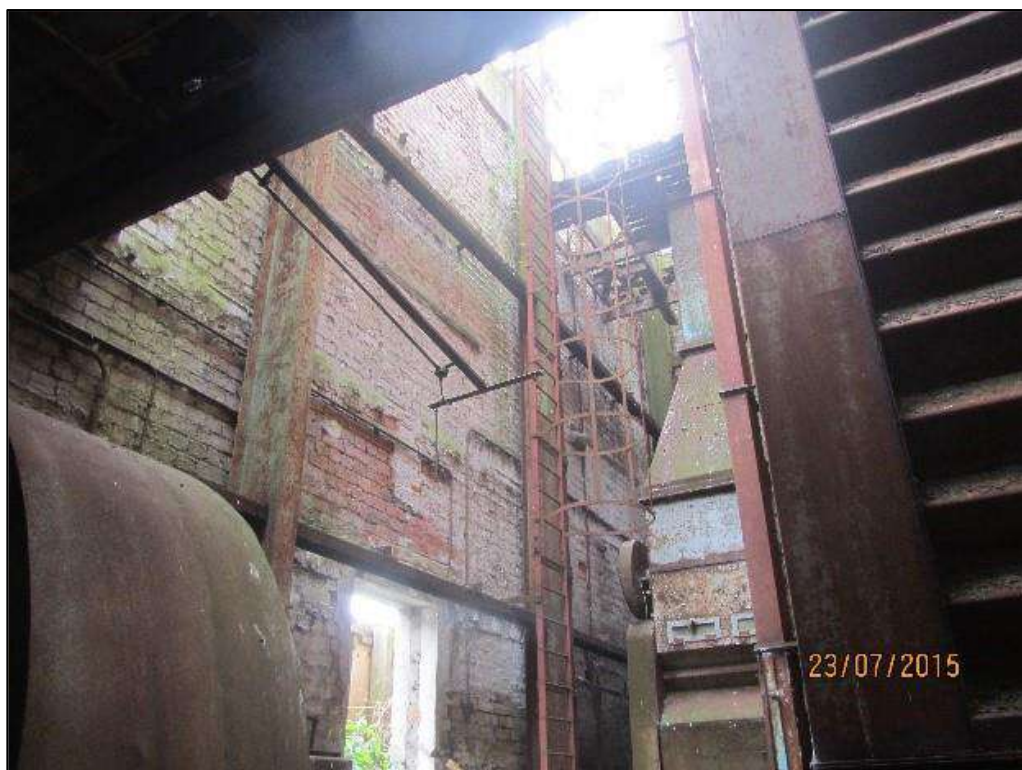
Fig.16 Interior of HOS Silo

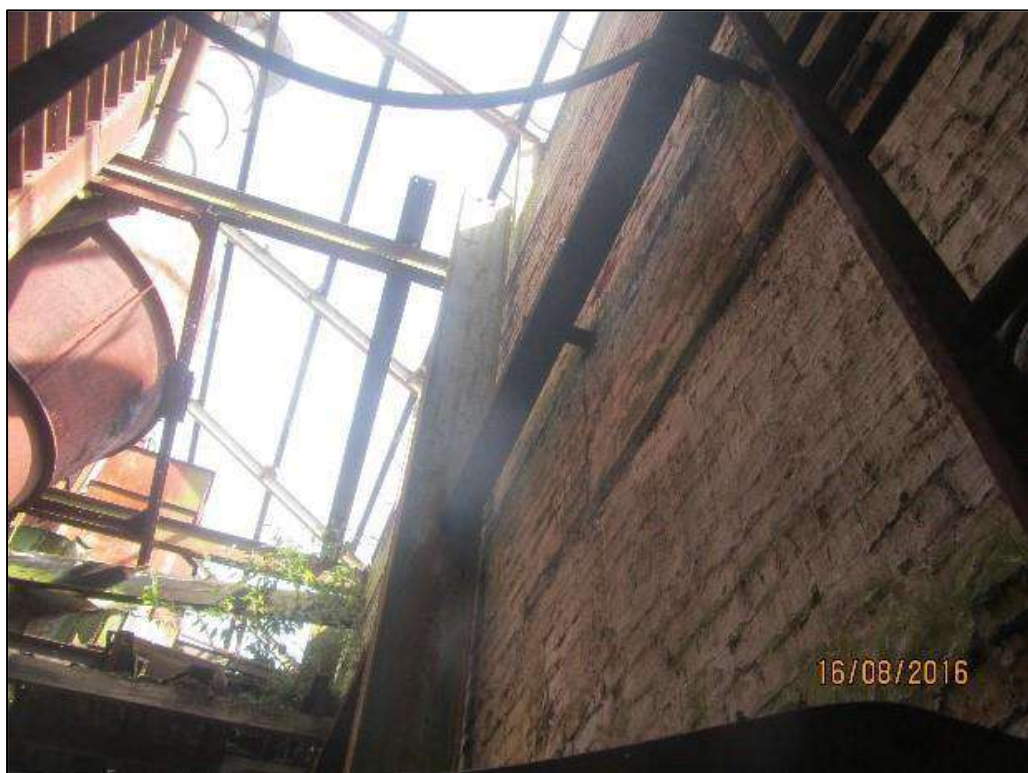
Fig. 17 Interior of HOS Silo looking up

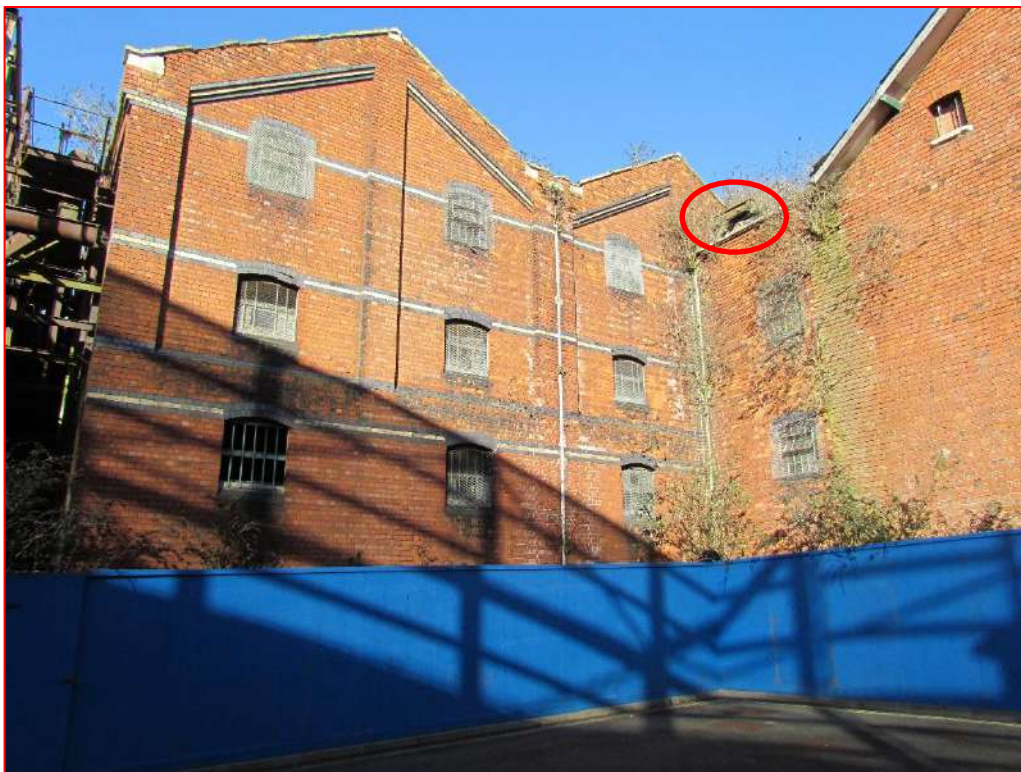
Fig.19 Downings Malthouse eastern elevation with displaced hoist circled

on this elevation the drop of the northern roof slope and the northern portion of this elevation is obscured by an infill staircase extension and gable roof extending from the High Orchard Warehouse. It is understood this was a link block built at a later date to provide a stairwell, which explains the awkward juncturing with the malthouse and the displacement of the hoist structure as seen above the stairwell in Fig.19.. It is known that the High Orchard Street warehouse is an earlier building, therefore this response looks to be a pragmatic approach to knitting the earlier warehouse and later malting together.

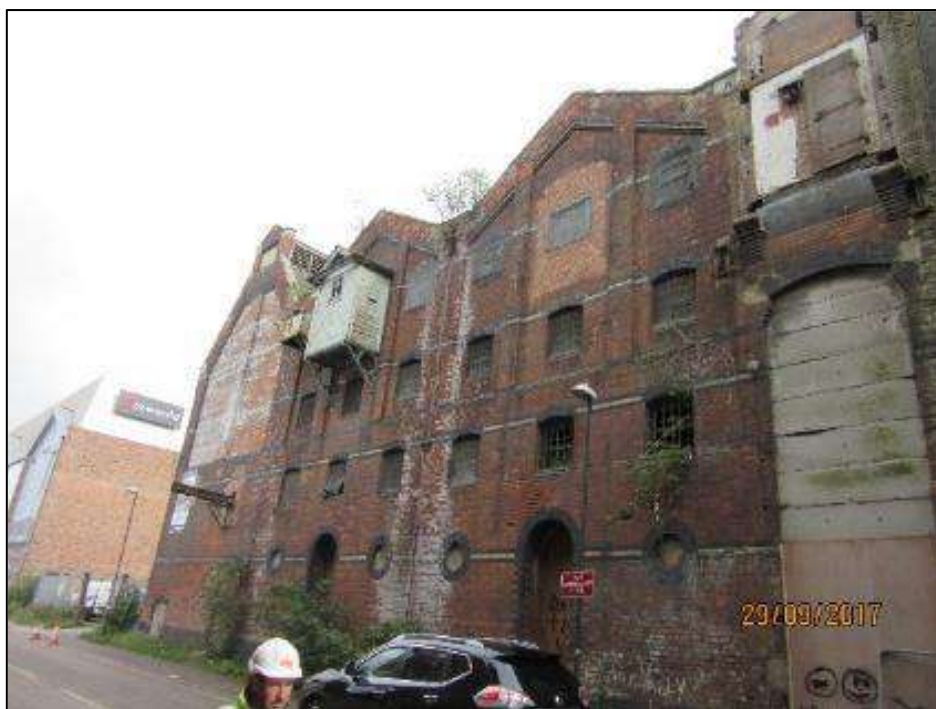
Fig.23 View of western elevation of Downings malthouse

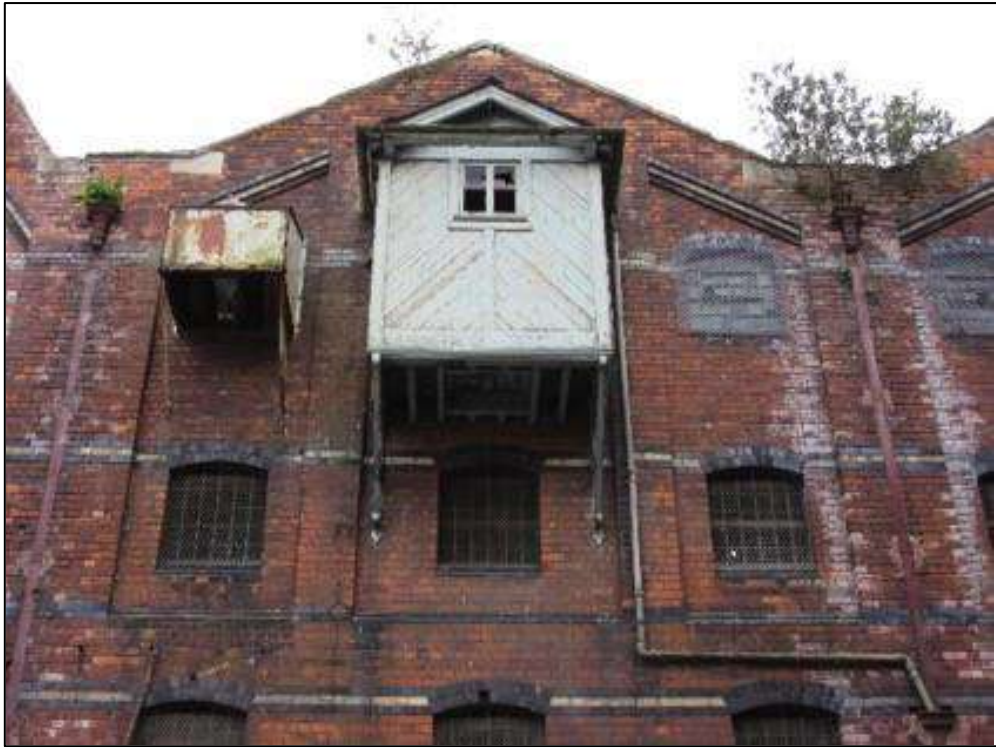
Fig.25 detail of timber hoist structure, western elevation

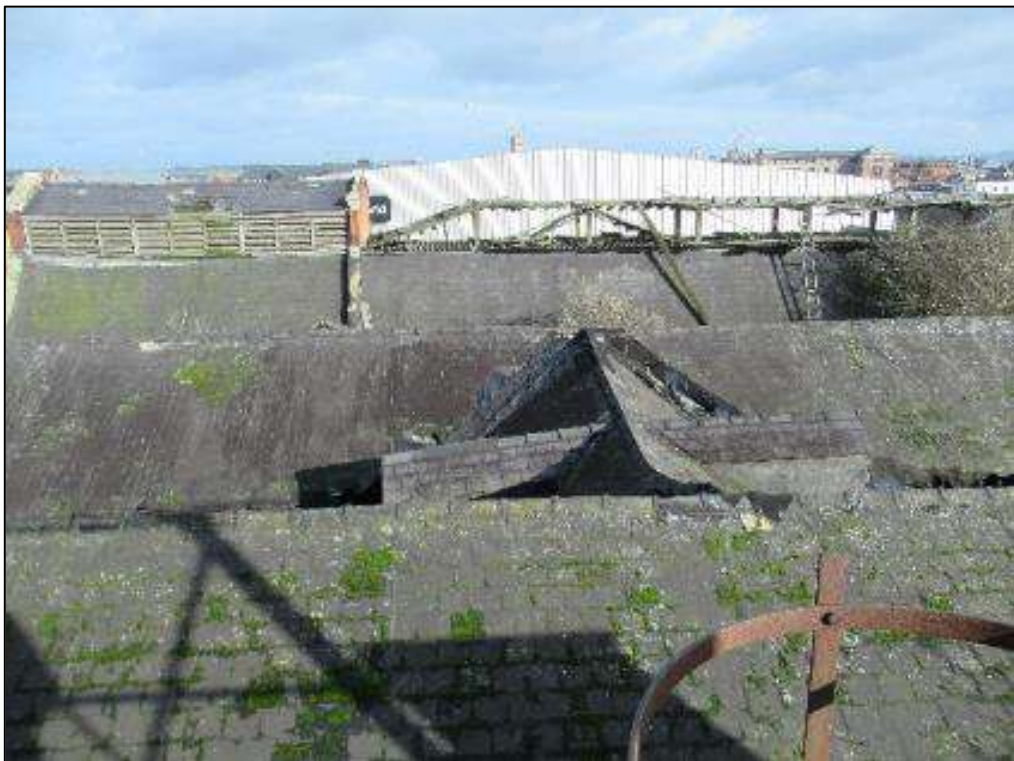
Fig.26 Detail of roofscape, Downings Malthouse

- 4.7. The gable ends feature brick parapets with stone copings. The roof profile is of a double pitch roof of slate with bitumen over. Two central gutter lines traverse between the roofs running east-west. A central connecting feature between the two trusses is also seen in aerial imagery.
