Downings Malthouse Baker's Quay, Gloucester

Heritage Assessment

CA Project: CR0989

Historic Building Recording Addendum

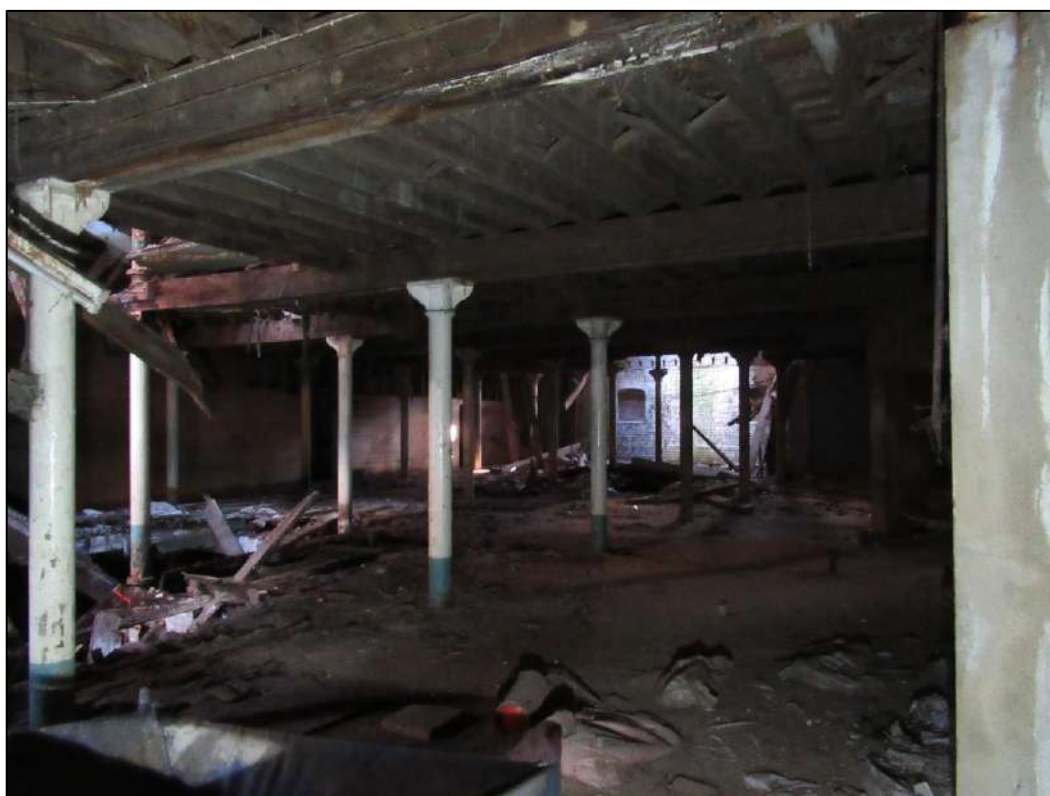
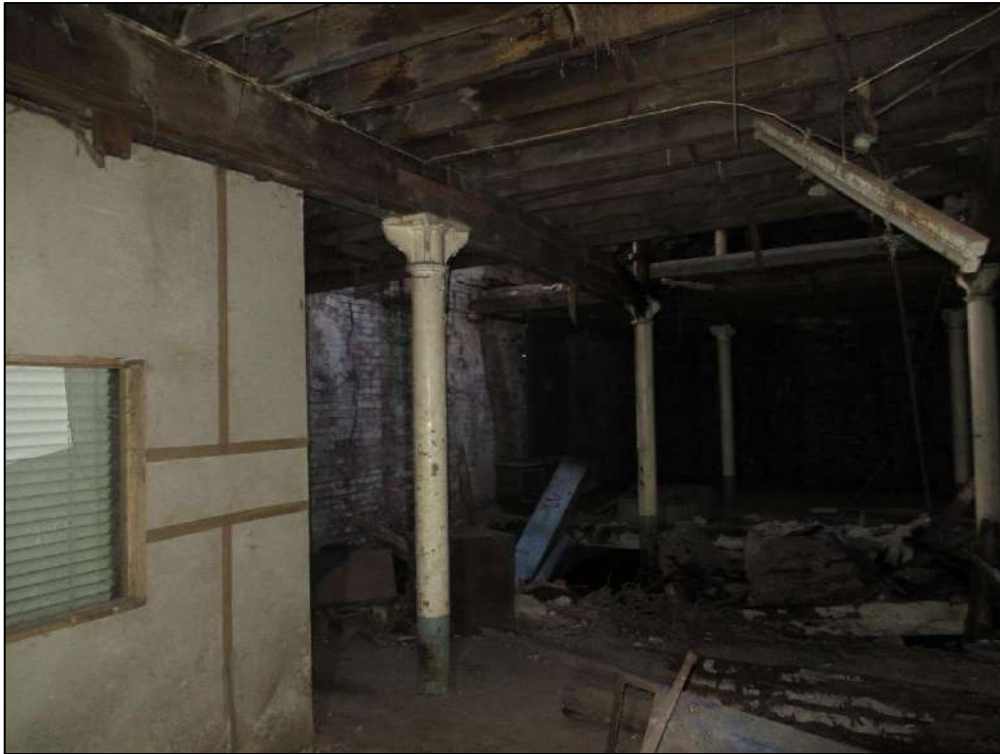
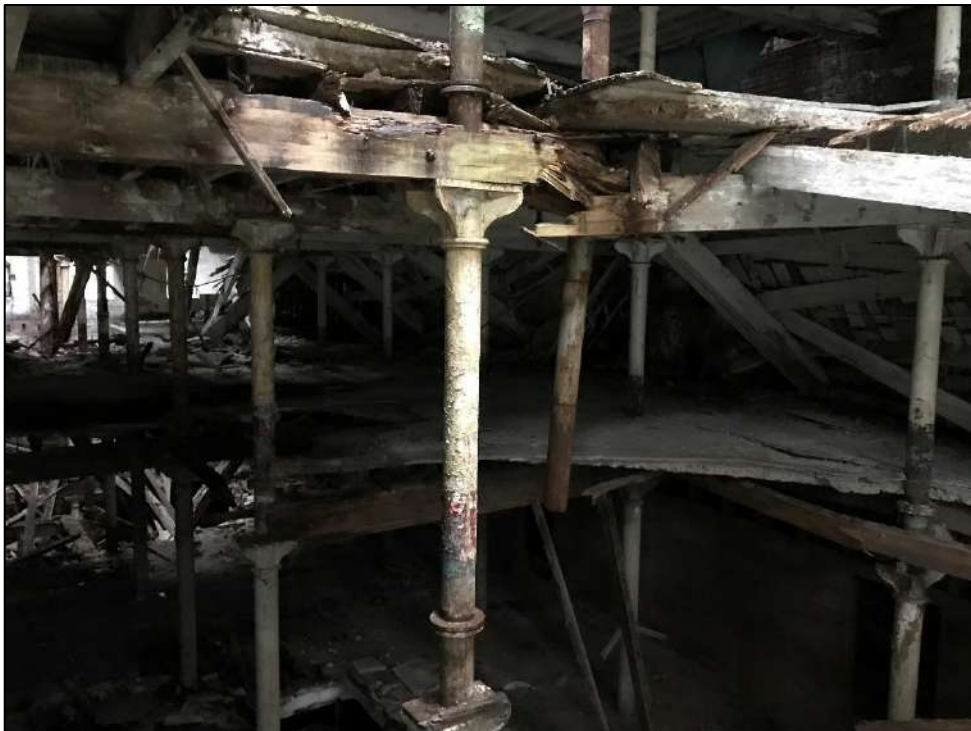
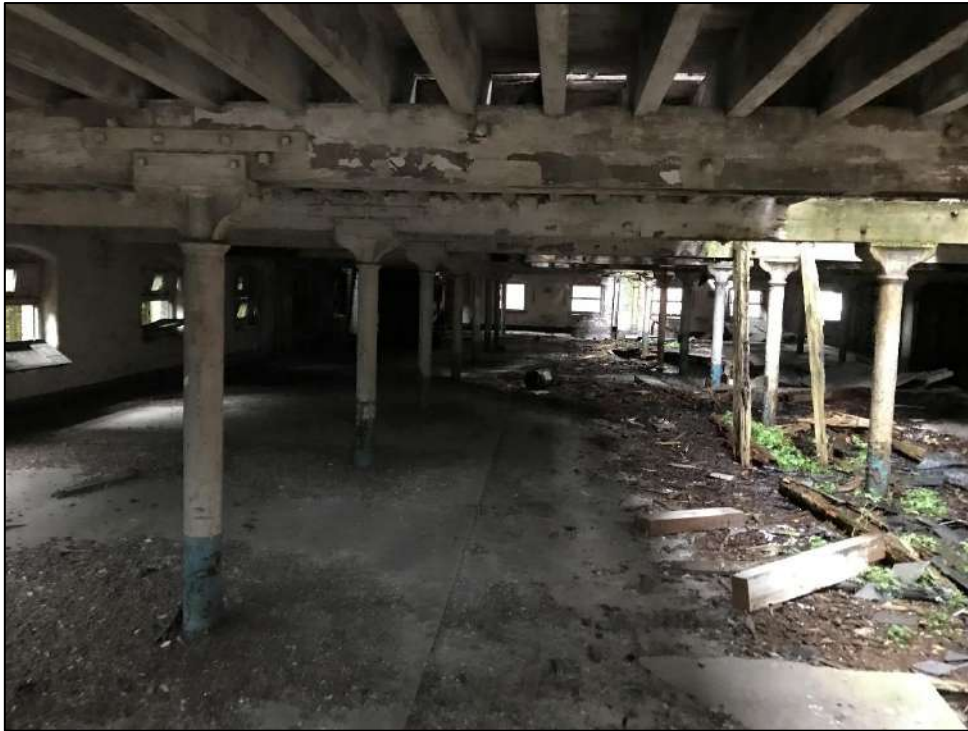
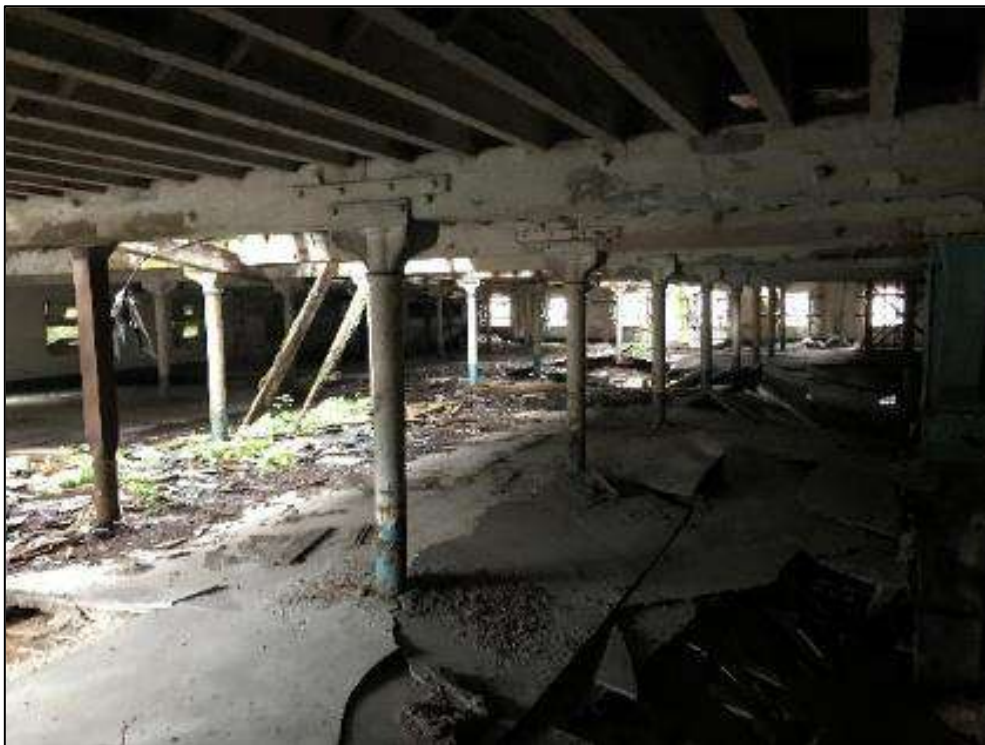
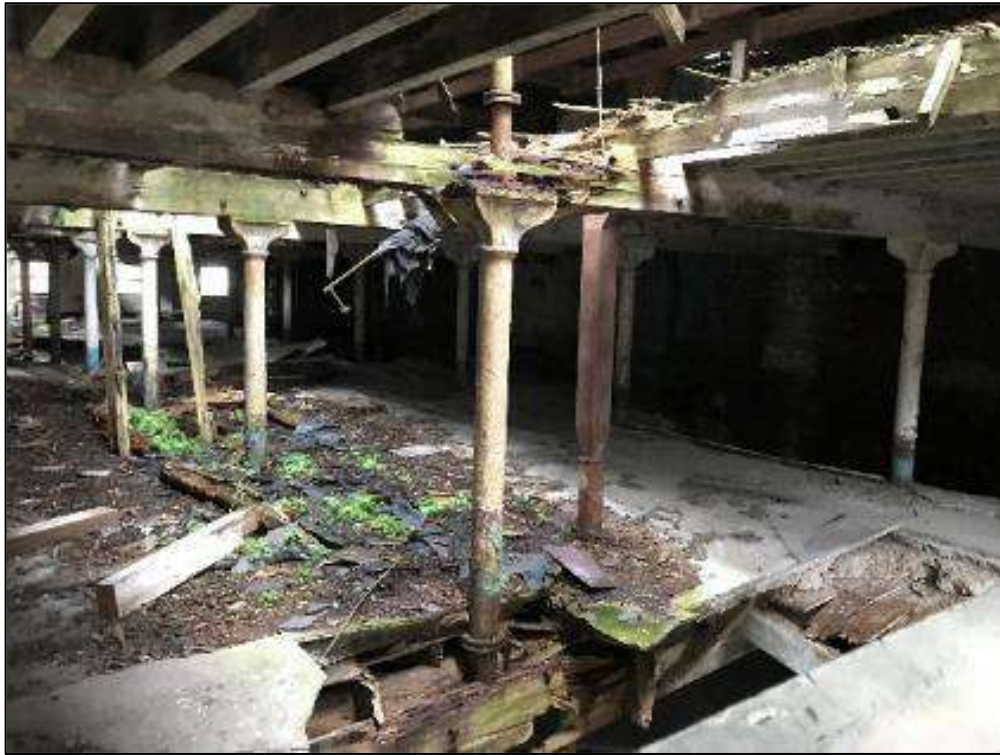
Fig.30 View of ground floor Malthouse 2

Fig.31 View of ground floor, Malthouse 2

Fig.32 View of first floor, Malthouse 2

Fig.33 View of second floor. Malthouse 2

Fig.34 View of second floor, Malthouse 2

Fig.35 View of second floor, Malthouse 2

- 4.13. No remains of machinery or historic features beyond the cast-iron columns were noted from the photographs. It is understood the ground floor was a malt room (for storing and bagging malt), and the first and second floors were working (germinating) floors, having easy access to the kiln to the north side. The building overall has a combination of multi-pane metal windows with hinged ventilation sections, and more simple 1/1 timber windows with top opening horizontal timber shutters (as seen in Fig.33).
- 4.14. Figs. 30 to 35 give an overview of the ground, first and second floors.

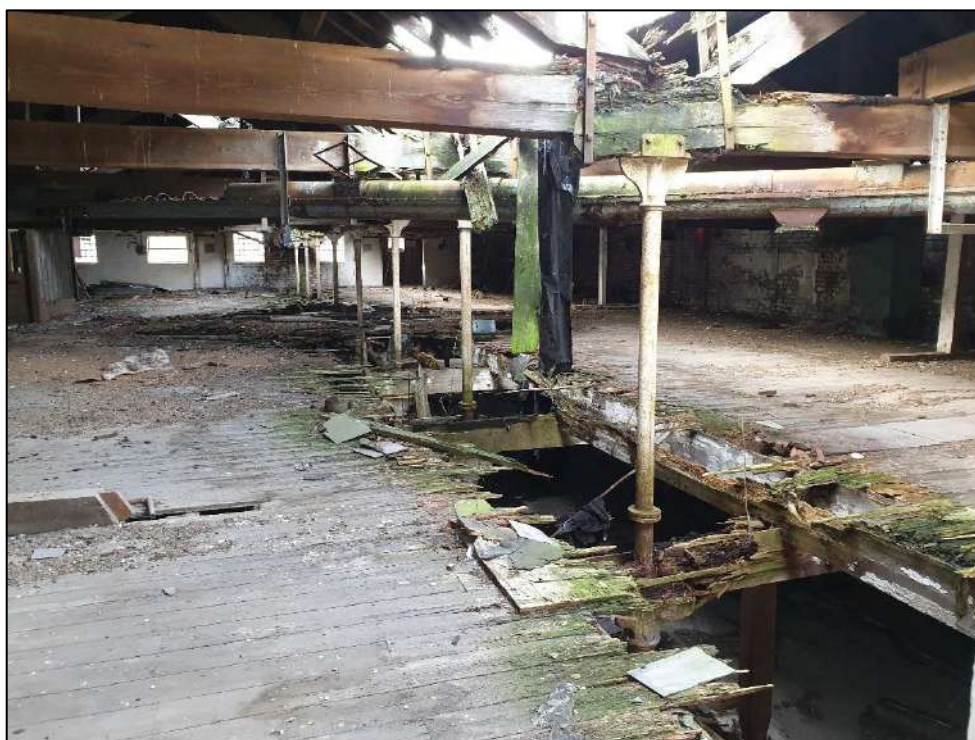
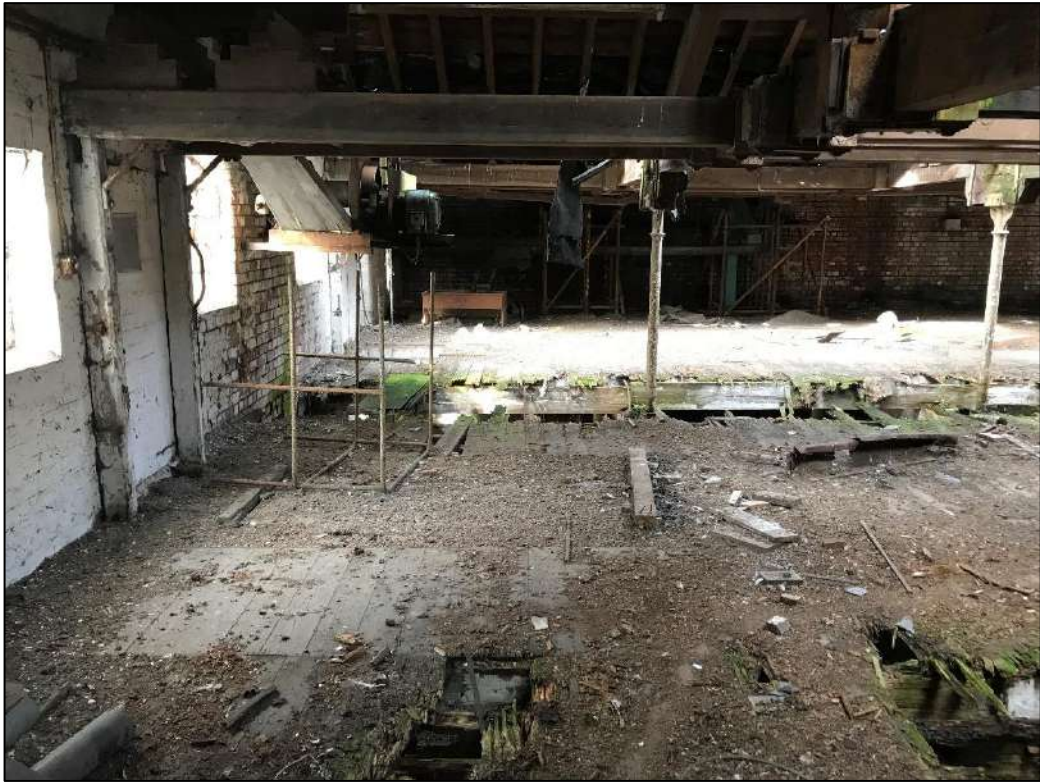
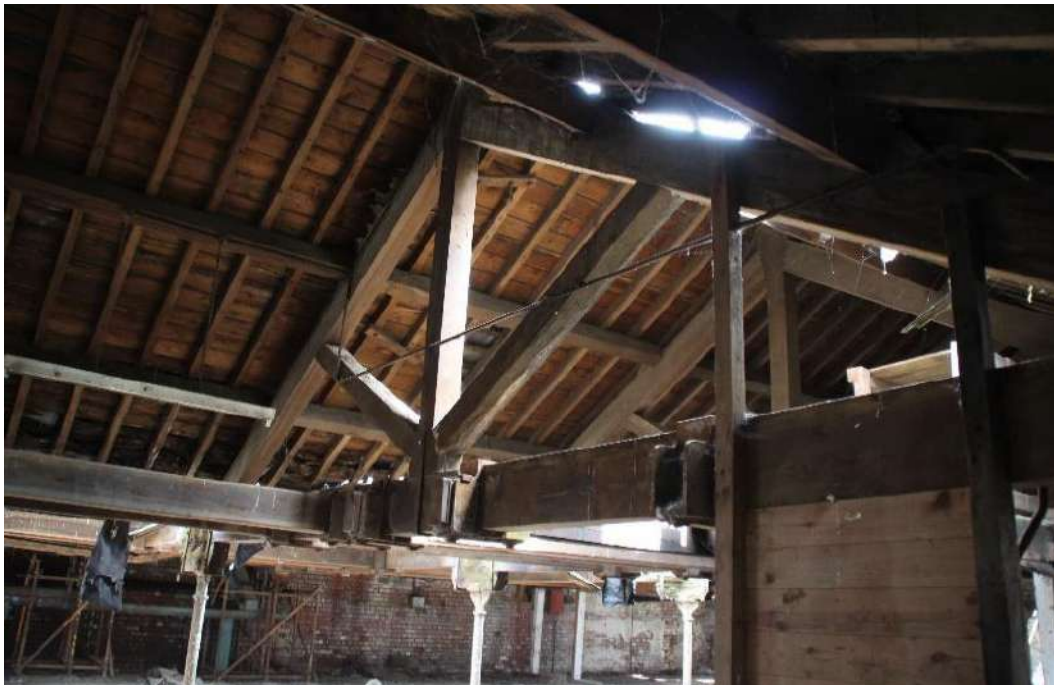
Fig.36 View of the third floor of Malthouse 2

Fig.37 View of third floor, Malthouse 2

Fig.38 View of roof truss, third floor Malthouse 2

- 4.18. Two of these joists at the west end supported a timber cradle for the power hoist for the wooden cantilevered loading loft and they were supported at the west end by timber posts set against the wall. An electric motor seemed to be the power source for the hoist.
- 4.19. This was used as a storage floor originally as there was no access to the kiln range on the north and in any case this floor was too high to access the drying floors over the kiln block on the north. However, a grain auger and an elevator was noted in the north side of the room leading into the kiln range, both probably of mid-20th-century date.
- 4.20. There was also much circular-section ducting in the east end of the room which was not approachable. This was associated with “modern” studwork and again was probably of mid-20th century date.
- 4.21. Figs.36-38 provide an overview of the third floor.

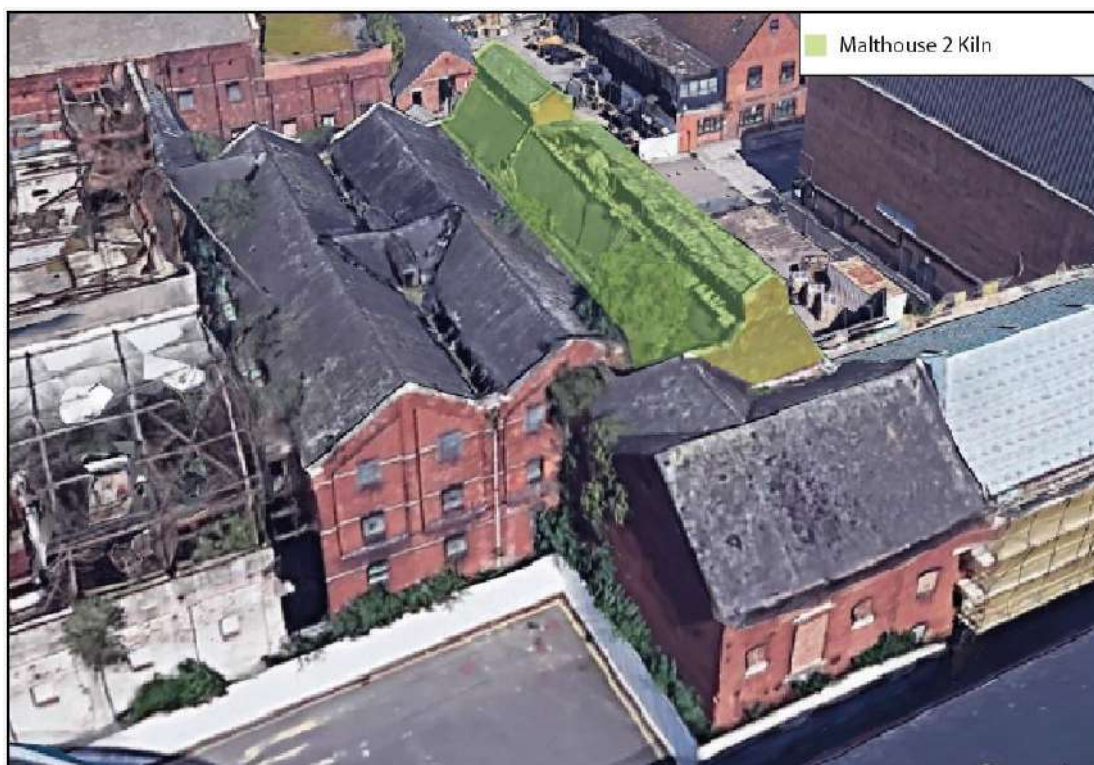
Fig.39 Malthouse 2 kiln (Image courtesy of Google Earth)

- 5.1. This structure, though separate in function and construction, forms part of the main Malthouse 2 building in external appearance, as seen in Fig. 39. It is formed of a smaller western kiln, which was a barley drying kiln, and a longer eastern malt kiln (Conway-Jones and Higgs 2008). Access to the kiln is only possible in the basement area, therefore inspection of the upper floors was only possible upward from the inside of the kiln at basement level.

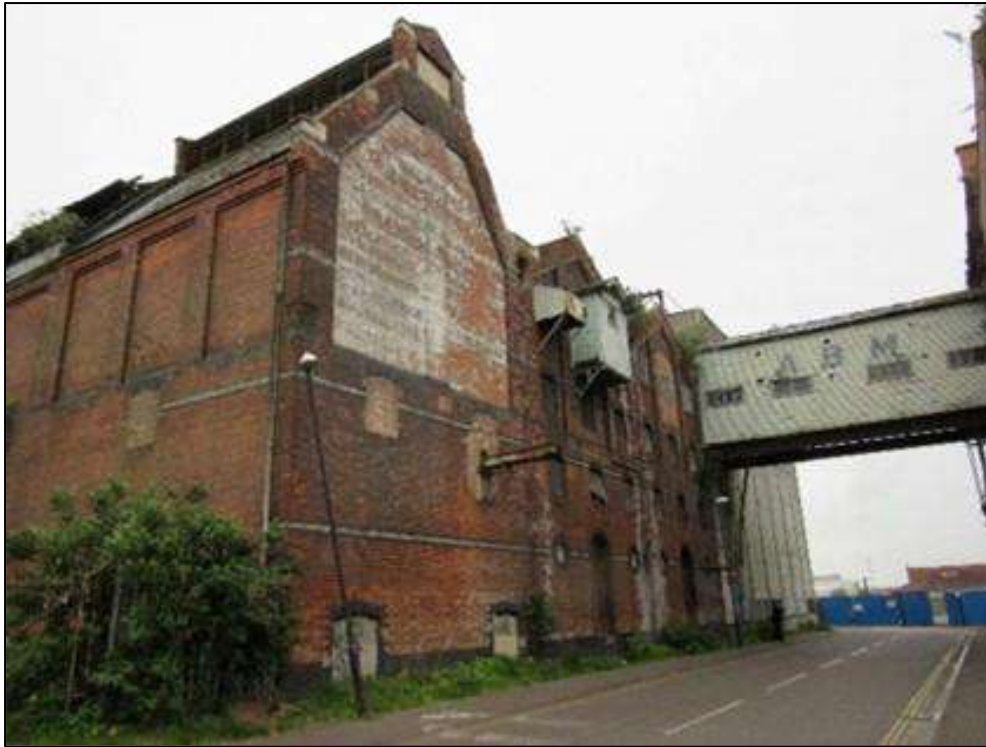
Fig.40 Malting 2 Kiln, western elevation

- 5.2. The west elevation of the kiln building is formed in essence of a blank brick gable end as seen in Fig.40. A recessed panel covers the upper parts of the elevation, bearing a ghost sign no doubt announcing Downings Maltings. The recessed panel is bordered at its top gable edges with blue brick dressings. Two blanked in windows are seen at first floor level, below one the remains of part of a grain auger protrudes. Two shallow doorways with segmental blue brick arches are seen at ground level, giving access to the passage ways surrounding the furnaces.
- 5.3. As the single pitch roof has a distinctive upstanding square louvred ridge which forms the chimney and ventilation for the kiln.

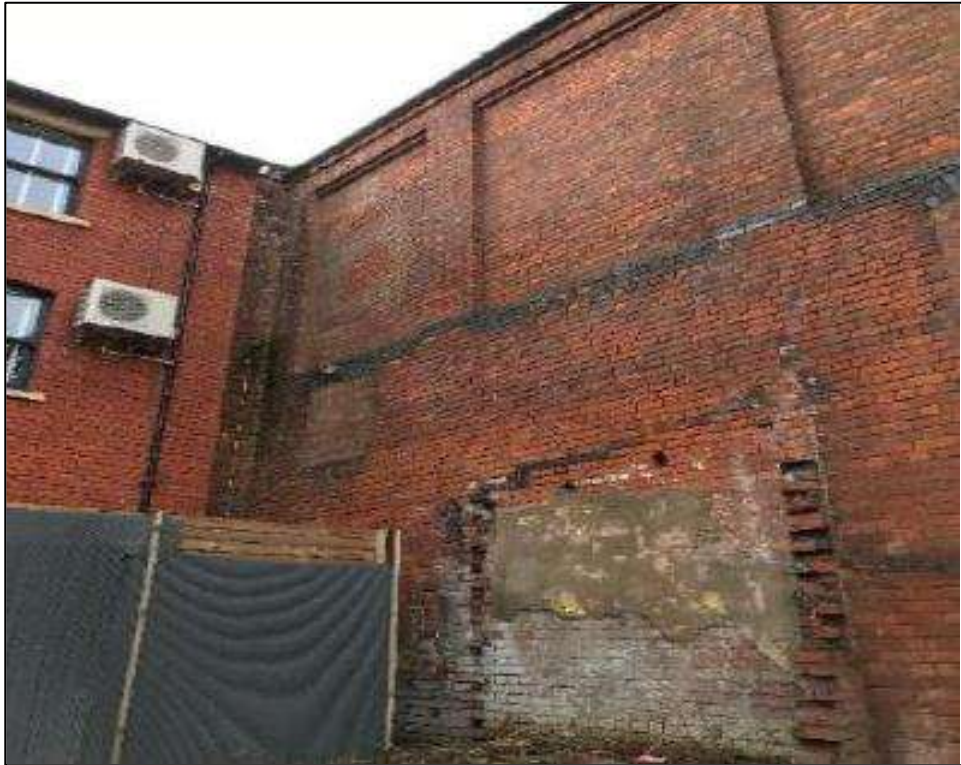
Fig. 42 **Detail of Maltings 2 kiln, northern elevation**

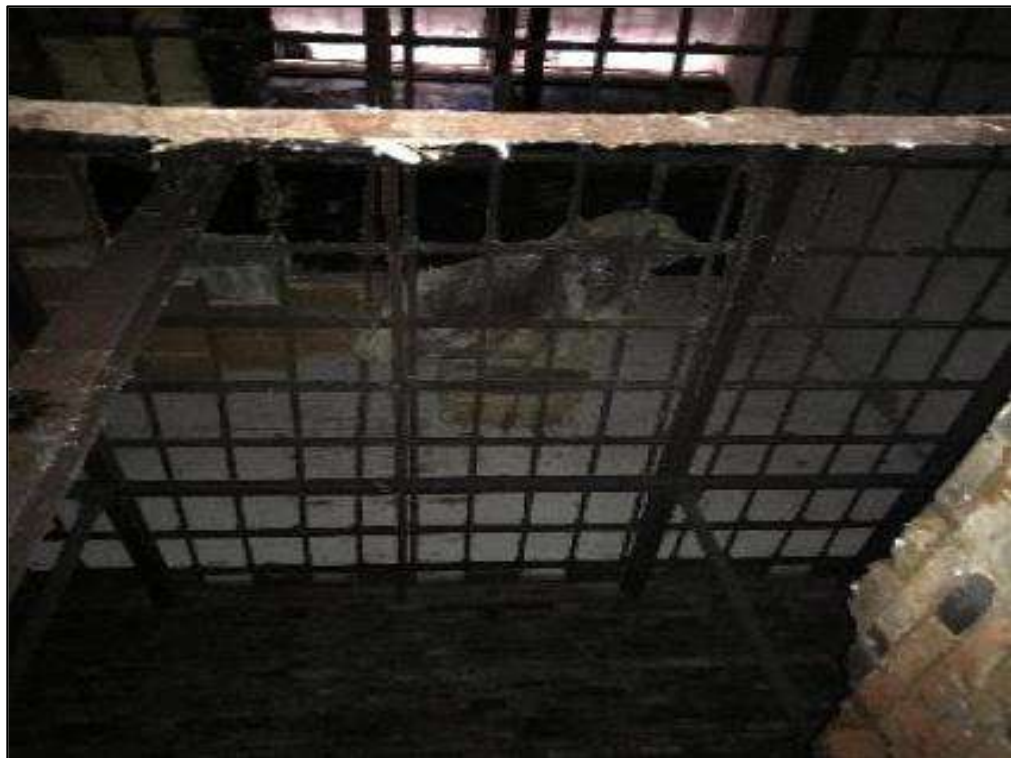
Fig.44 Detail of kiln drying floor, steel grid upon which perforated tiles were placed

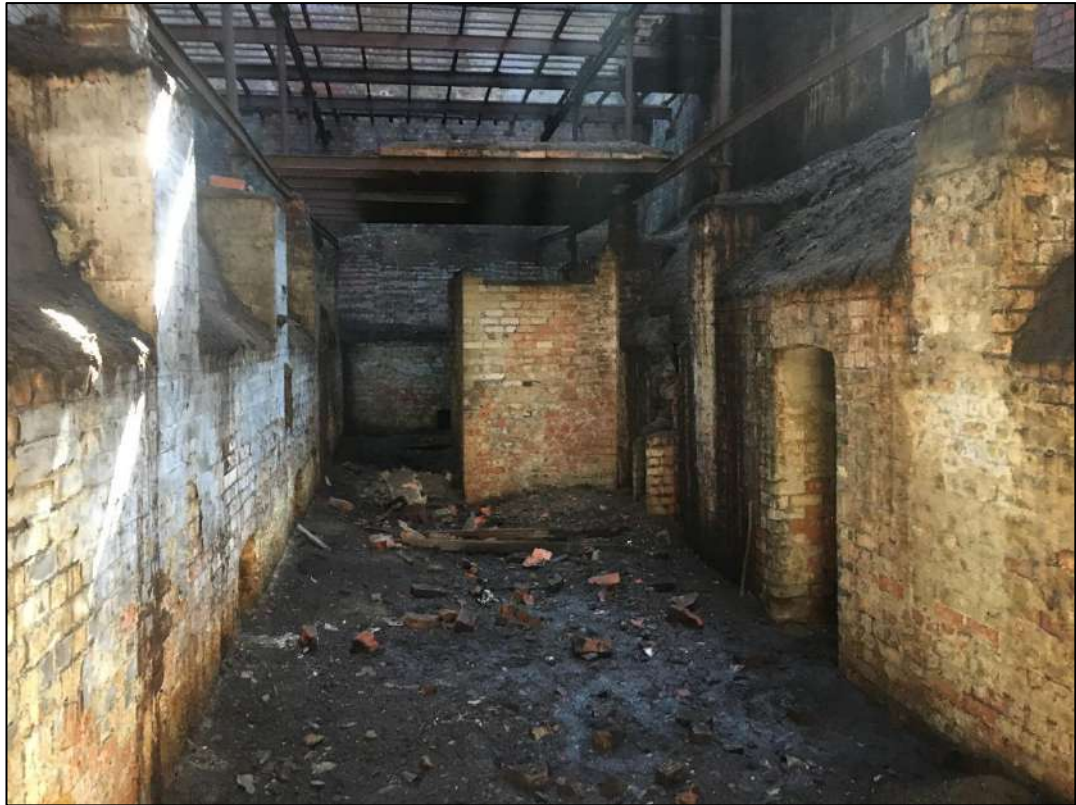
Fig.45 Detail of interior of east kiln showing profile of vaulted corridor running around the external walls, steel structure above and remains of furnace in the rectangular brick structure

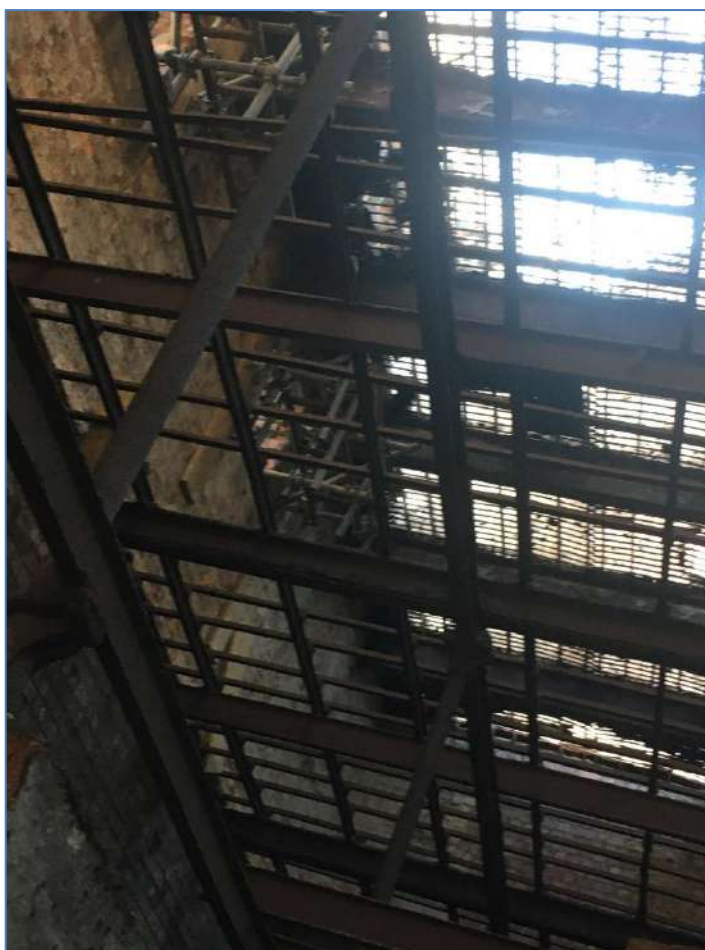
Fig.46 Grid floor detail in east kiln, image taken looking upwards

- 5.9. In the eastern kiln area, there is a second drying floor; this would be logical given this was the kiln for malting and would therefore require a larger capacity. The second floor was viewed through holes created in the original window openings therefore visibility was limited.
- 5.10. The floor was supported by steel beams at 2.4m centres running north-south spanning the full width of the building. The steel beams support a grill of steel bars which support a light weight steel open mesh floor. The roof structure is of trusses, purlins and rafters supported on the external walls, and featuring the long ridge cowl chimney.

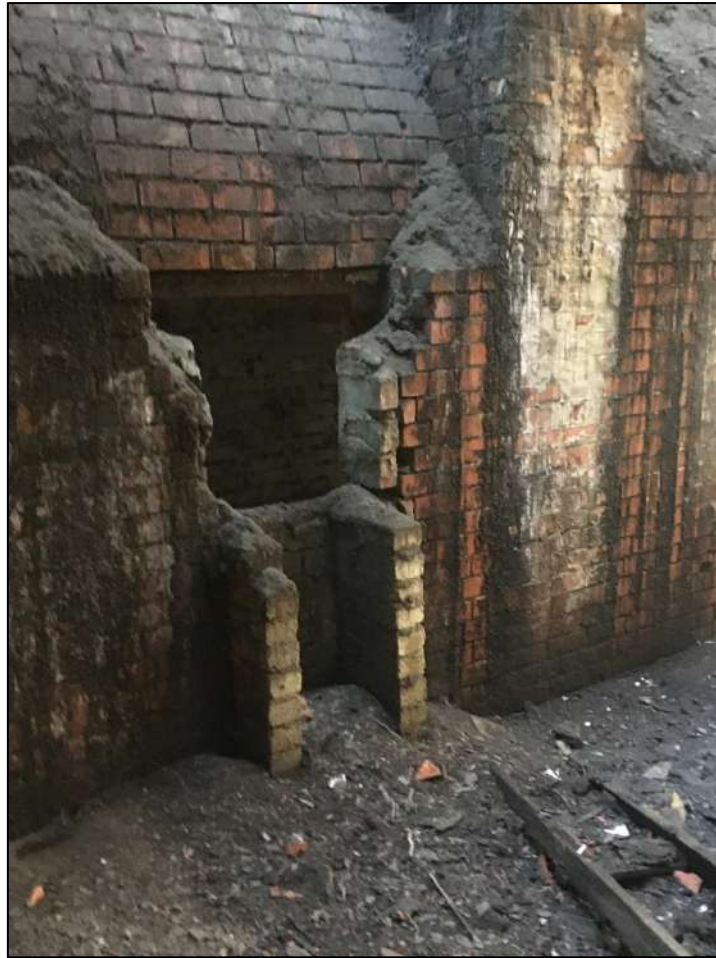
Fig.47 Detail of furnace opening viewed from the inside of the now lost furnace structure. The furnace would have been stoked from the exterior corridor

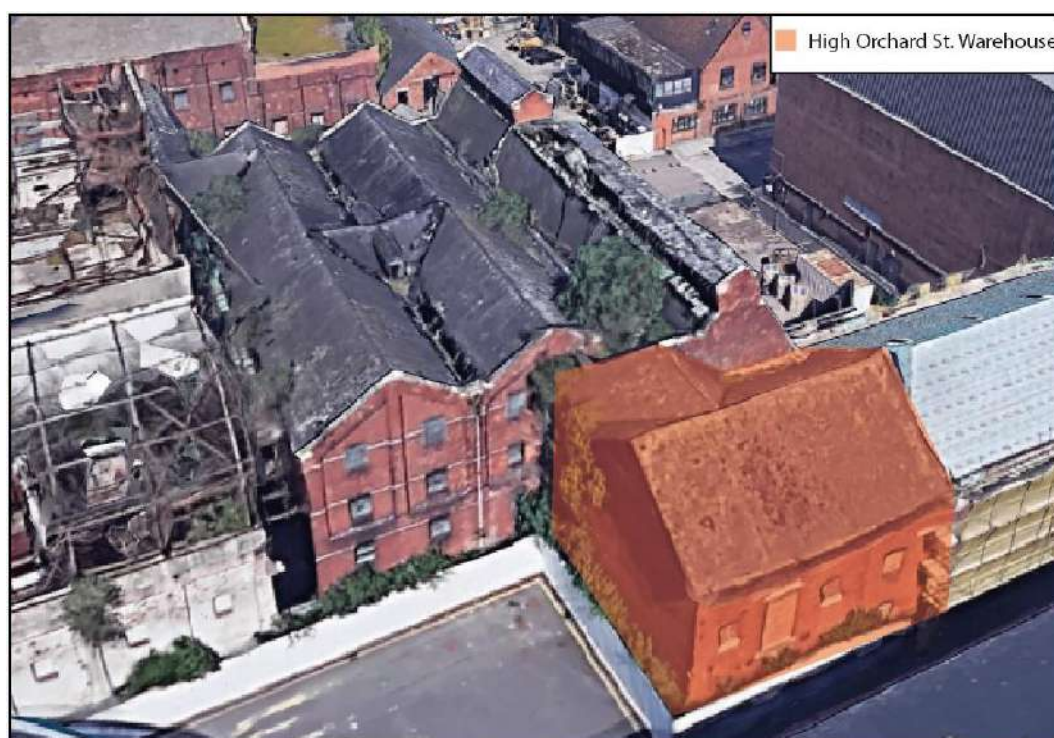
Fig.48 High Orchard Street Warehouse

- 6.1. The warehouse on High Orchard Street was built between 1843-1852 and is the original building on the site. Malthouse 2 and its associated kiln were both built up against this building. Conway-Jones & Higgs detail that it was a warehouse for cleaning and repairing sacks, though it is very likely that at some point it stored grain, being located adjacent to the Malthouse. It is a three-storey structure constructed in two phases, with a northern section being a possible newer element formed to square off when the malthouse was built.

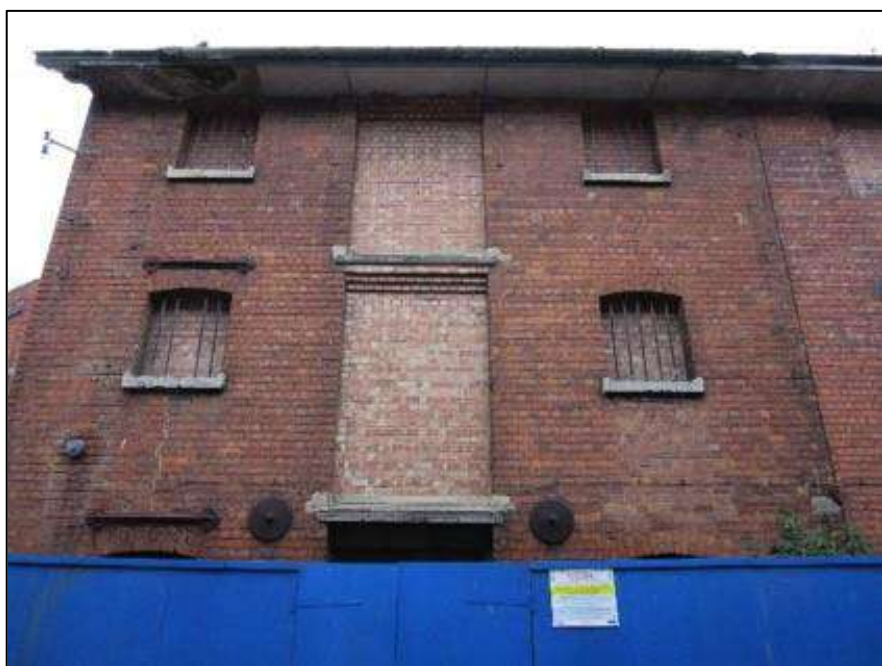
Fig.49 Eastern elevation of HOS warehouse

- 6.4. The roof is single pitched in slate with wide eaves to both gable ends and frontage. Considerable tying-in has been observed with plates visible either side of the door, and strapping over the window lintels, straddling a large vertical crack.
- 6.5. The southern elevation is essentially the large blank gable wall of the building, knitted into the stairwell of Malthouse 2 at the western extent, the staircase roof projecting as a gable from the rear slope of the warehouse. It features two high level windows, currently blocked, and is other devoid of feature or decoration.

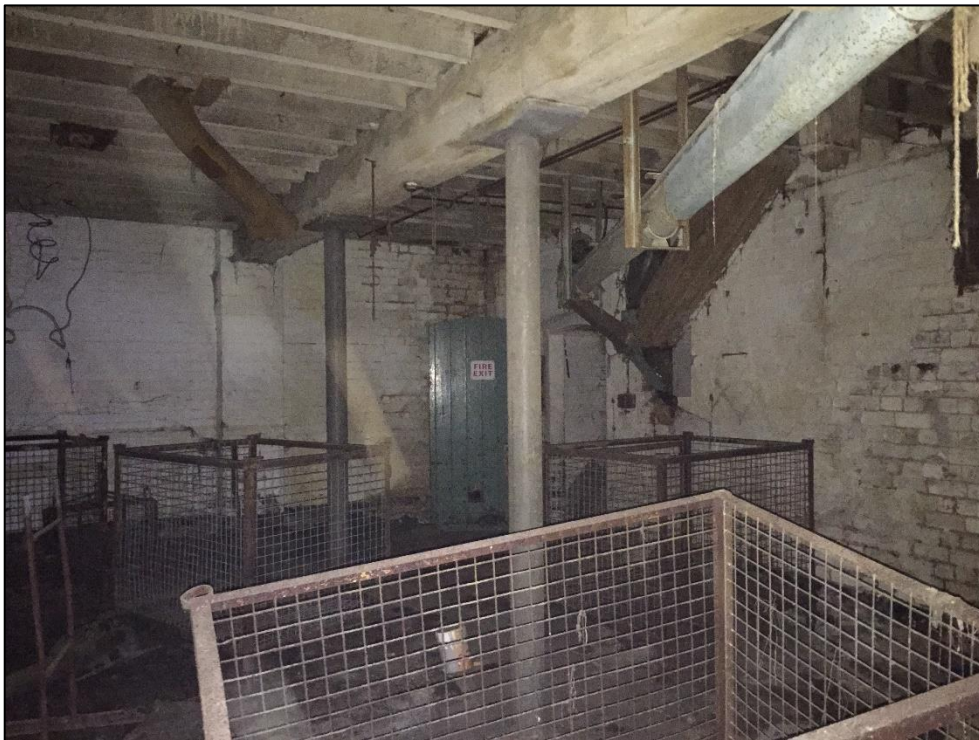
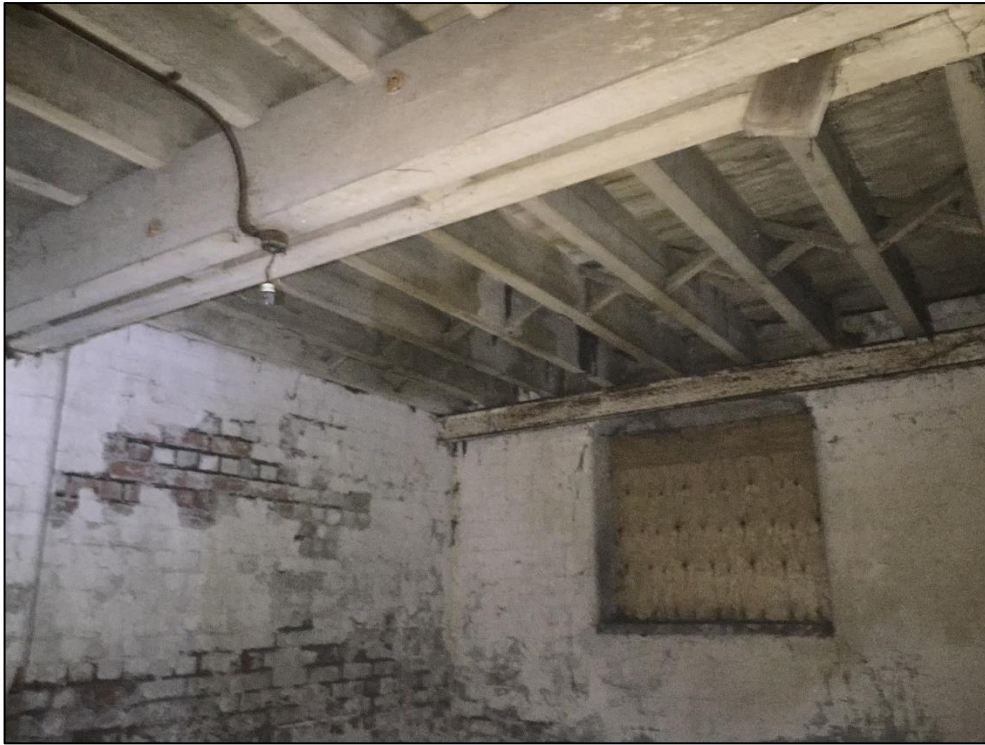
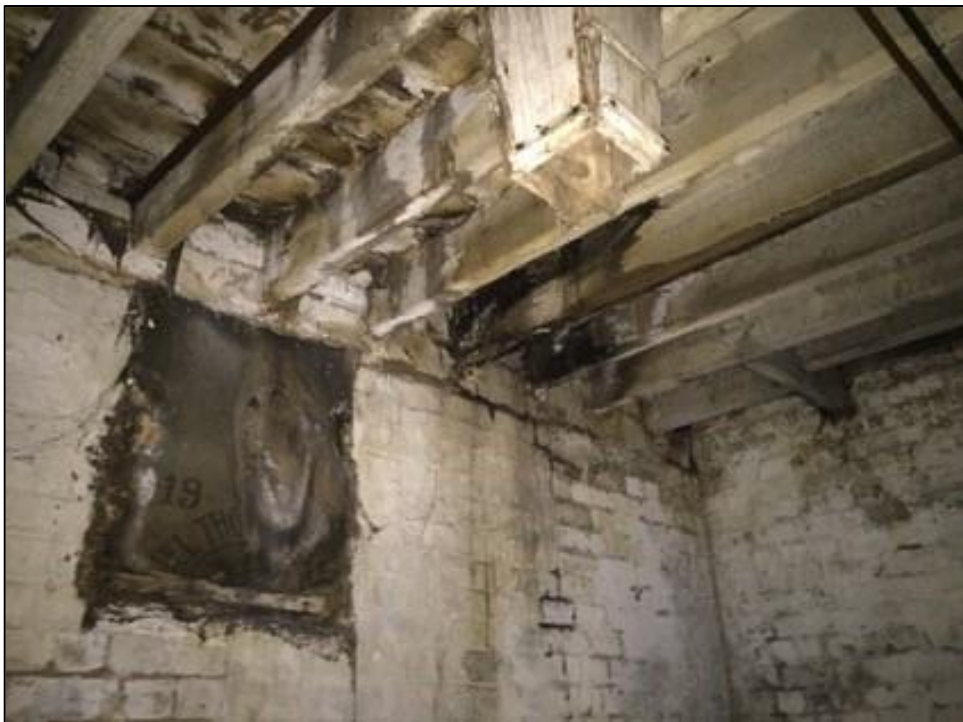
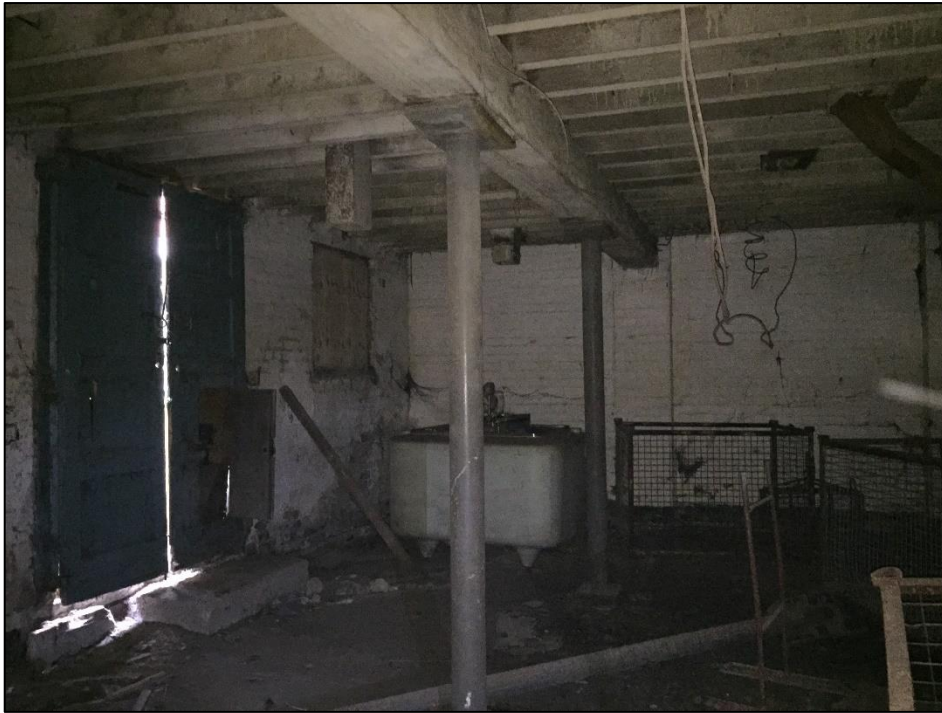
Fig.52 Ground floor HOS Warehouse

Fig.53 Ground floor HOS Warehouse

Fig. 54 Detail of ground floor ceiling, HOS warehouse

Fig. 55 Ground floor, HOS Warehouse

- 6.7. The room contains remnants of modern auger and grain handling machinery, one acting as a chute between ground and first floor, and some wire trolleys were dotted about, presumably for sacks. An arched doorway to the Malthouse stairwell is seen in the south-western corner of the main room. Some form of chute from one floor to the other is also seen in the western section of the main room.

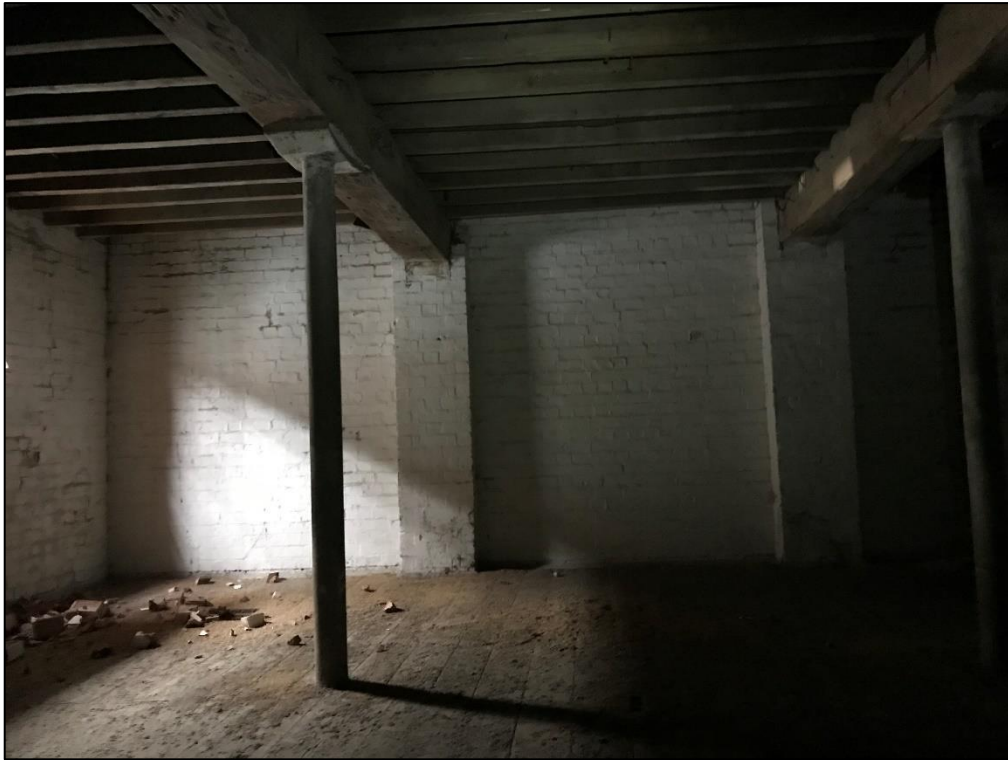
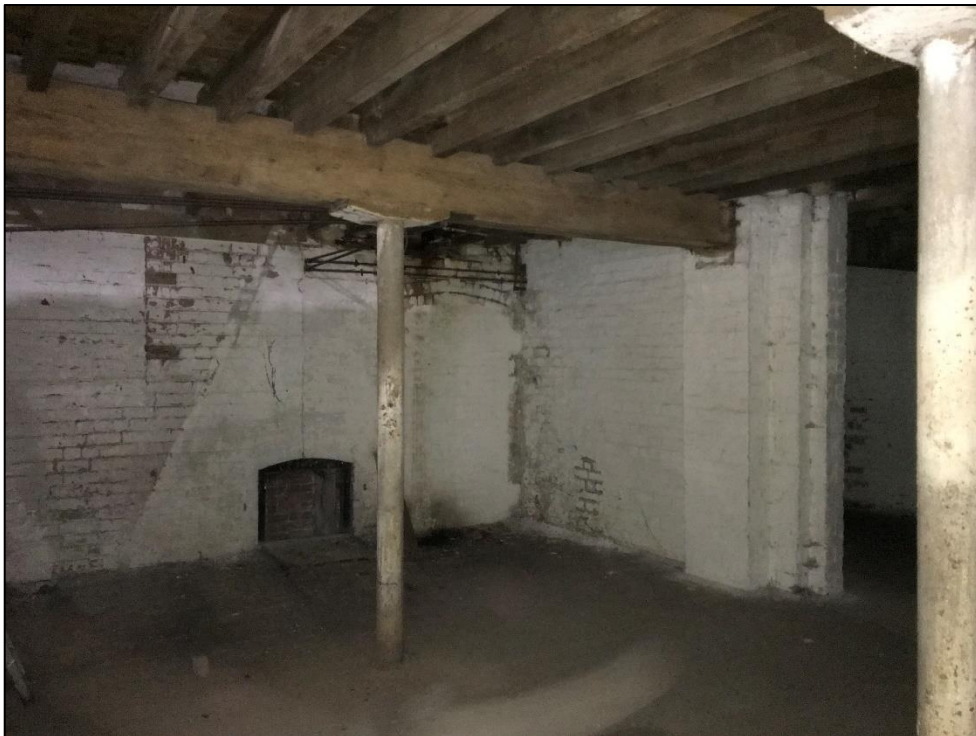
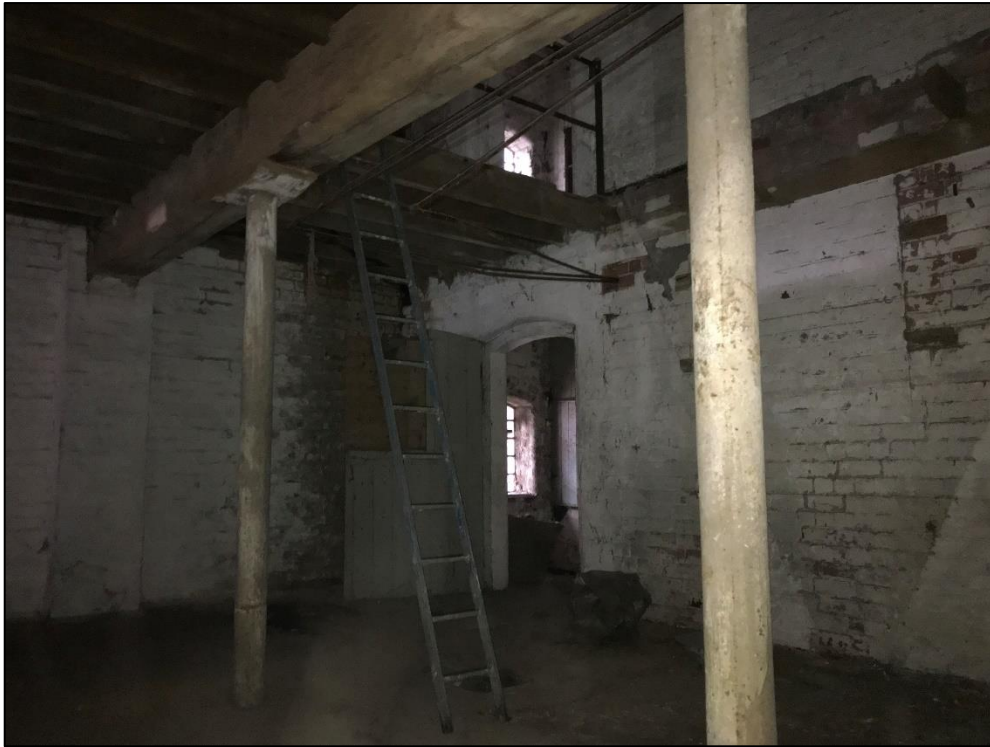
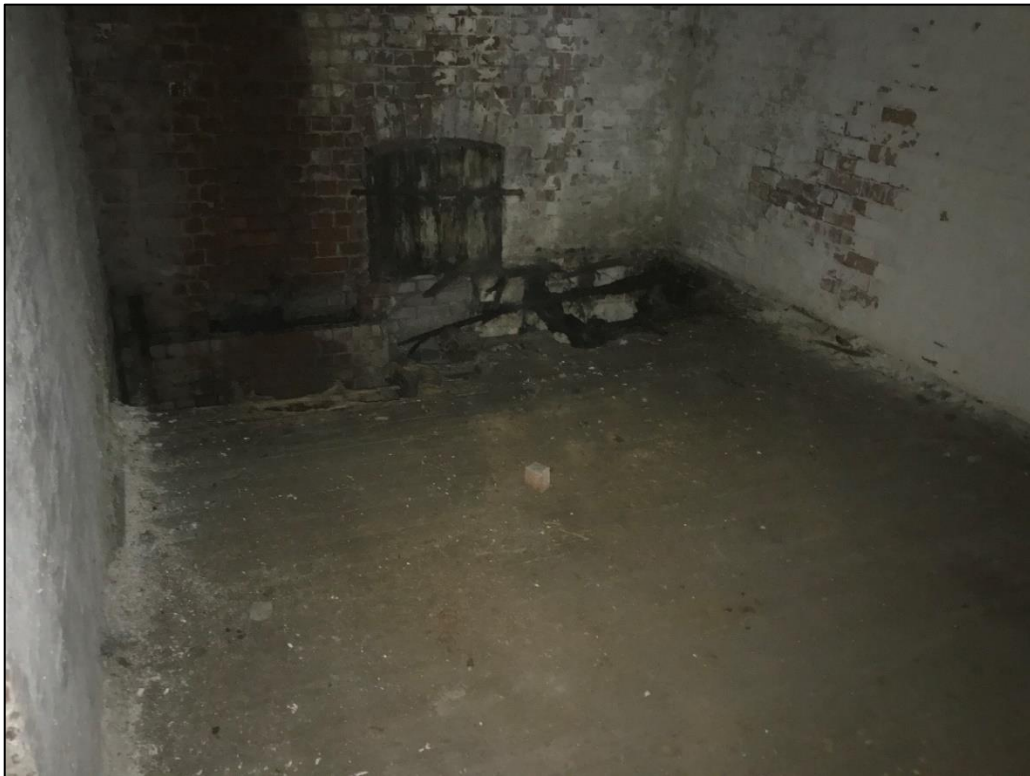
Fig. 56 First floor, HOS Warehouse

Fig.57 First floor, HOS Warehouse

Fig.58 First floor HOS Warehouse

Fig.59 Detail of hatch, HOS Warehouse

- 6.8. The first floor consists of two rooms as per the ground floor, with timber floors, and exposed timber beams and joists above. The larger room is propped on steel columns which do not appear to be original but may well relate to the building of the malthouse. Both rooms appear to have some sort of low level hatch through to the malthouse at their western wall end, and the bricked in window is seen in the eastern wall in the northern room. A large opening to the floor above is located in the middle of the west wall, presumably for hoisting goods up to the upper levels. No staircases are provided in the building, only in the now collapsed stairwell in the Malthouse, which is accessed through a doorway in the south-western corner.

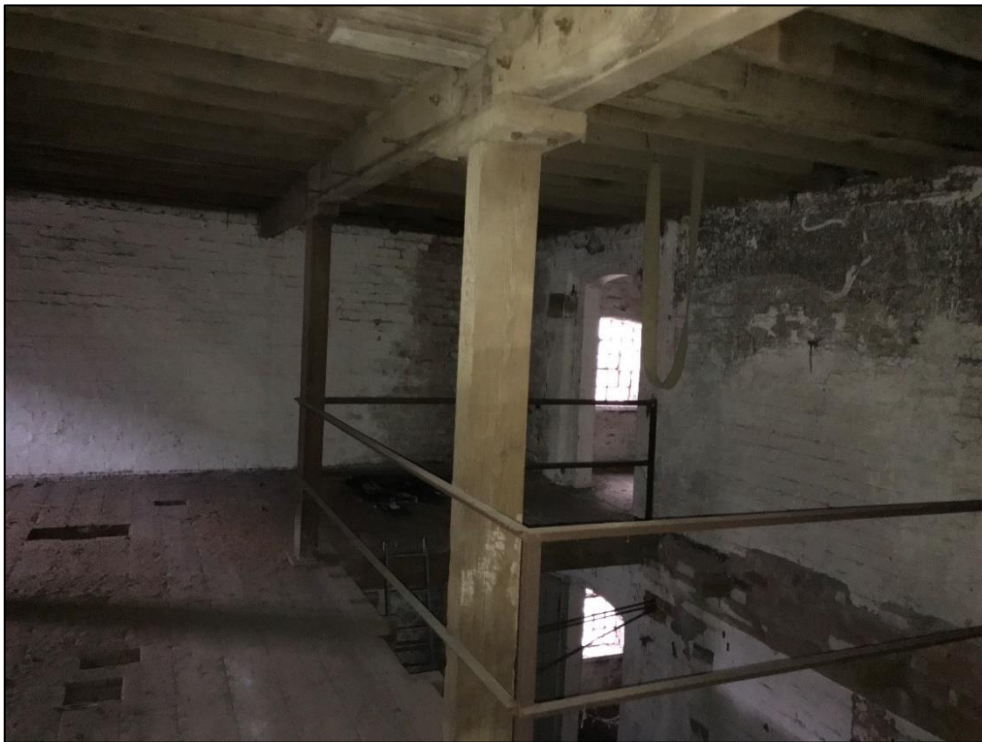
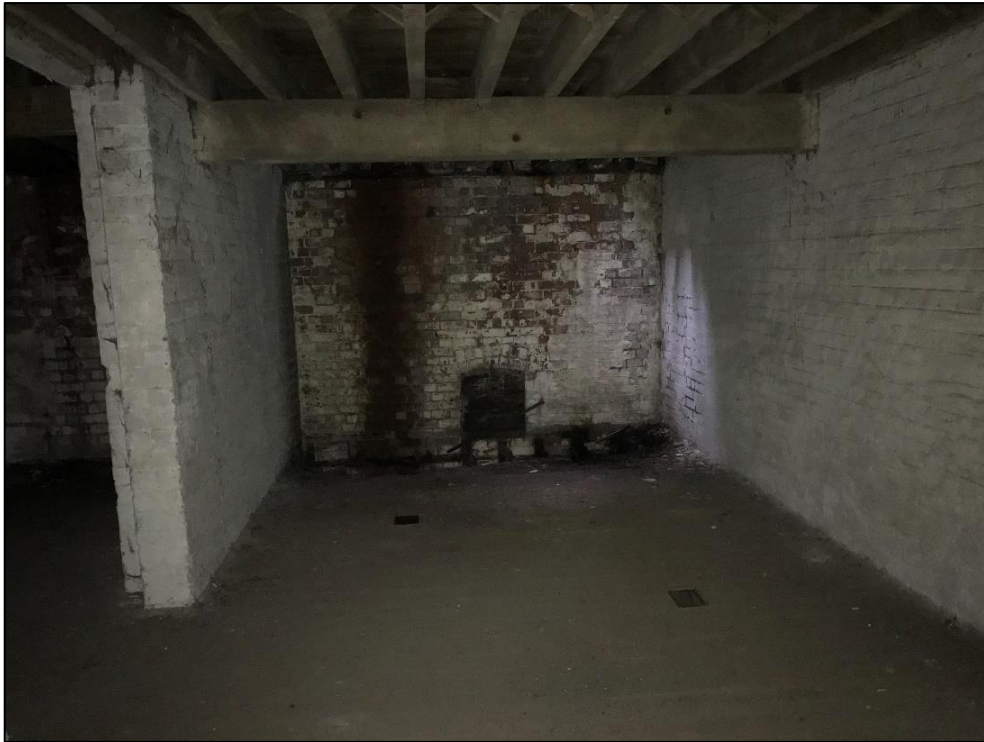
Fig.60 Second floor, HOS Warehouse

Fig. 61 Northern room, looking west, HOS Warehouse

-
- 6.9. The second floor is very similar in layout to the first floor. The timber beams in the southern room are smaller than the floor below and may have been added at a later date as there is evidence of scarfing and jointing to the areas above the timber posts. There is a large opening to the floor below in the middle of the west wall. The low-level hatches on the western wall are evident, these appear to access the malthouse.
