Downings Malthouse Baker's Quay, Gloucester

Heritage Assessment

CA Project: CR0989

Historic Building Recording Addendum

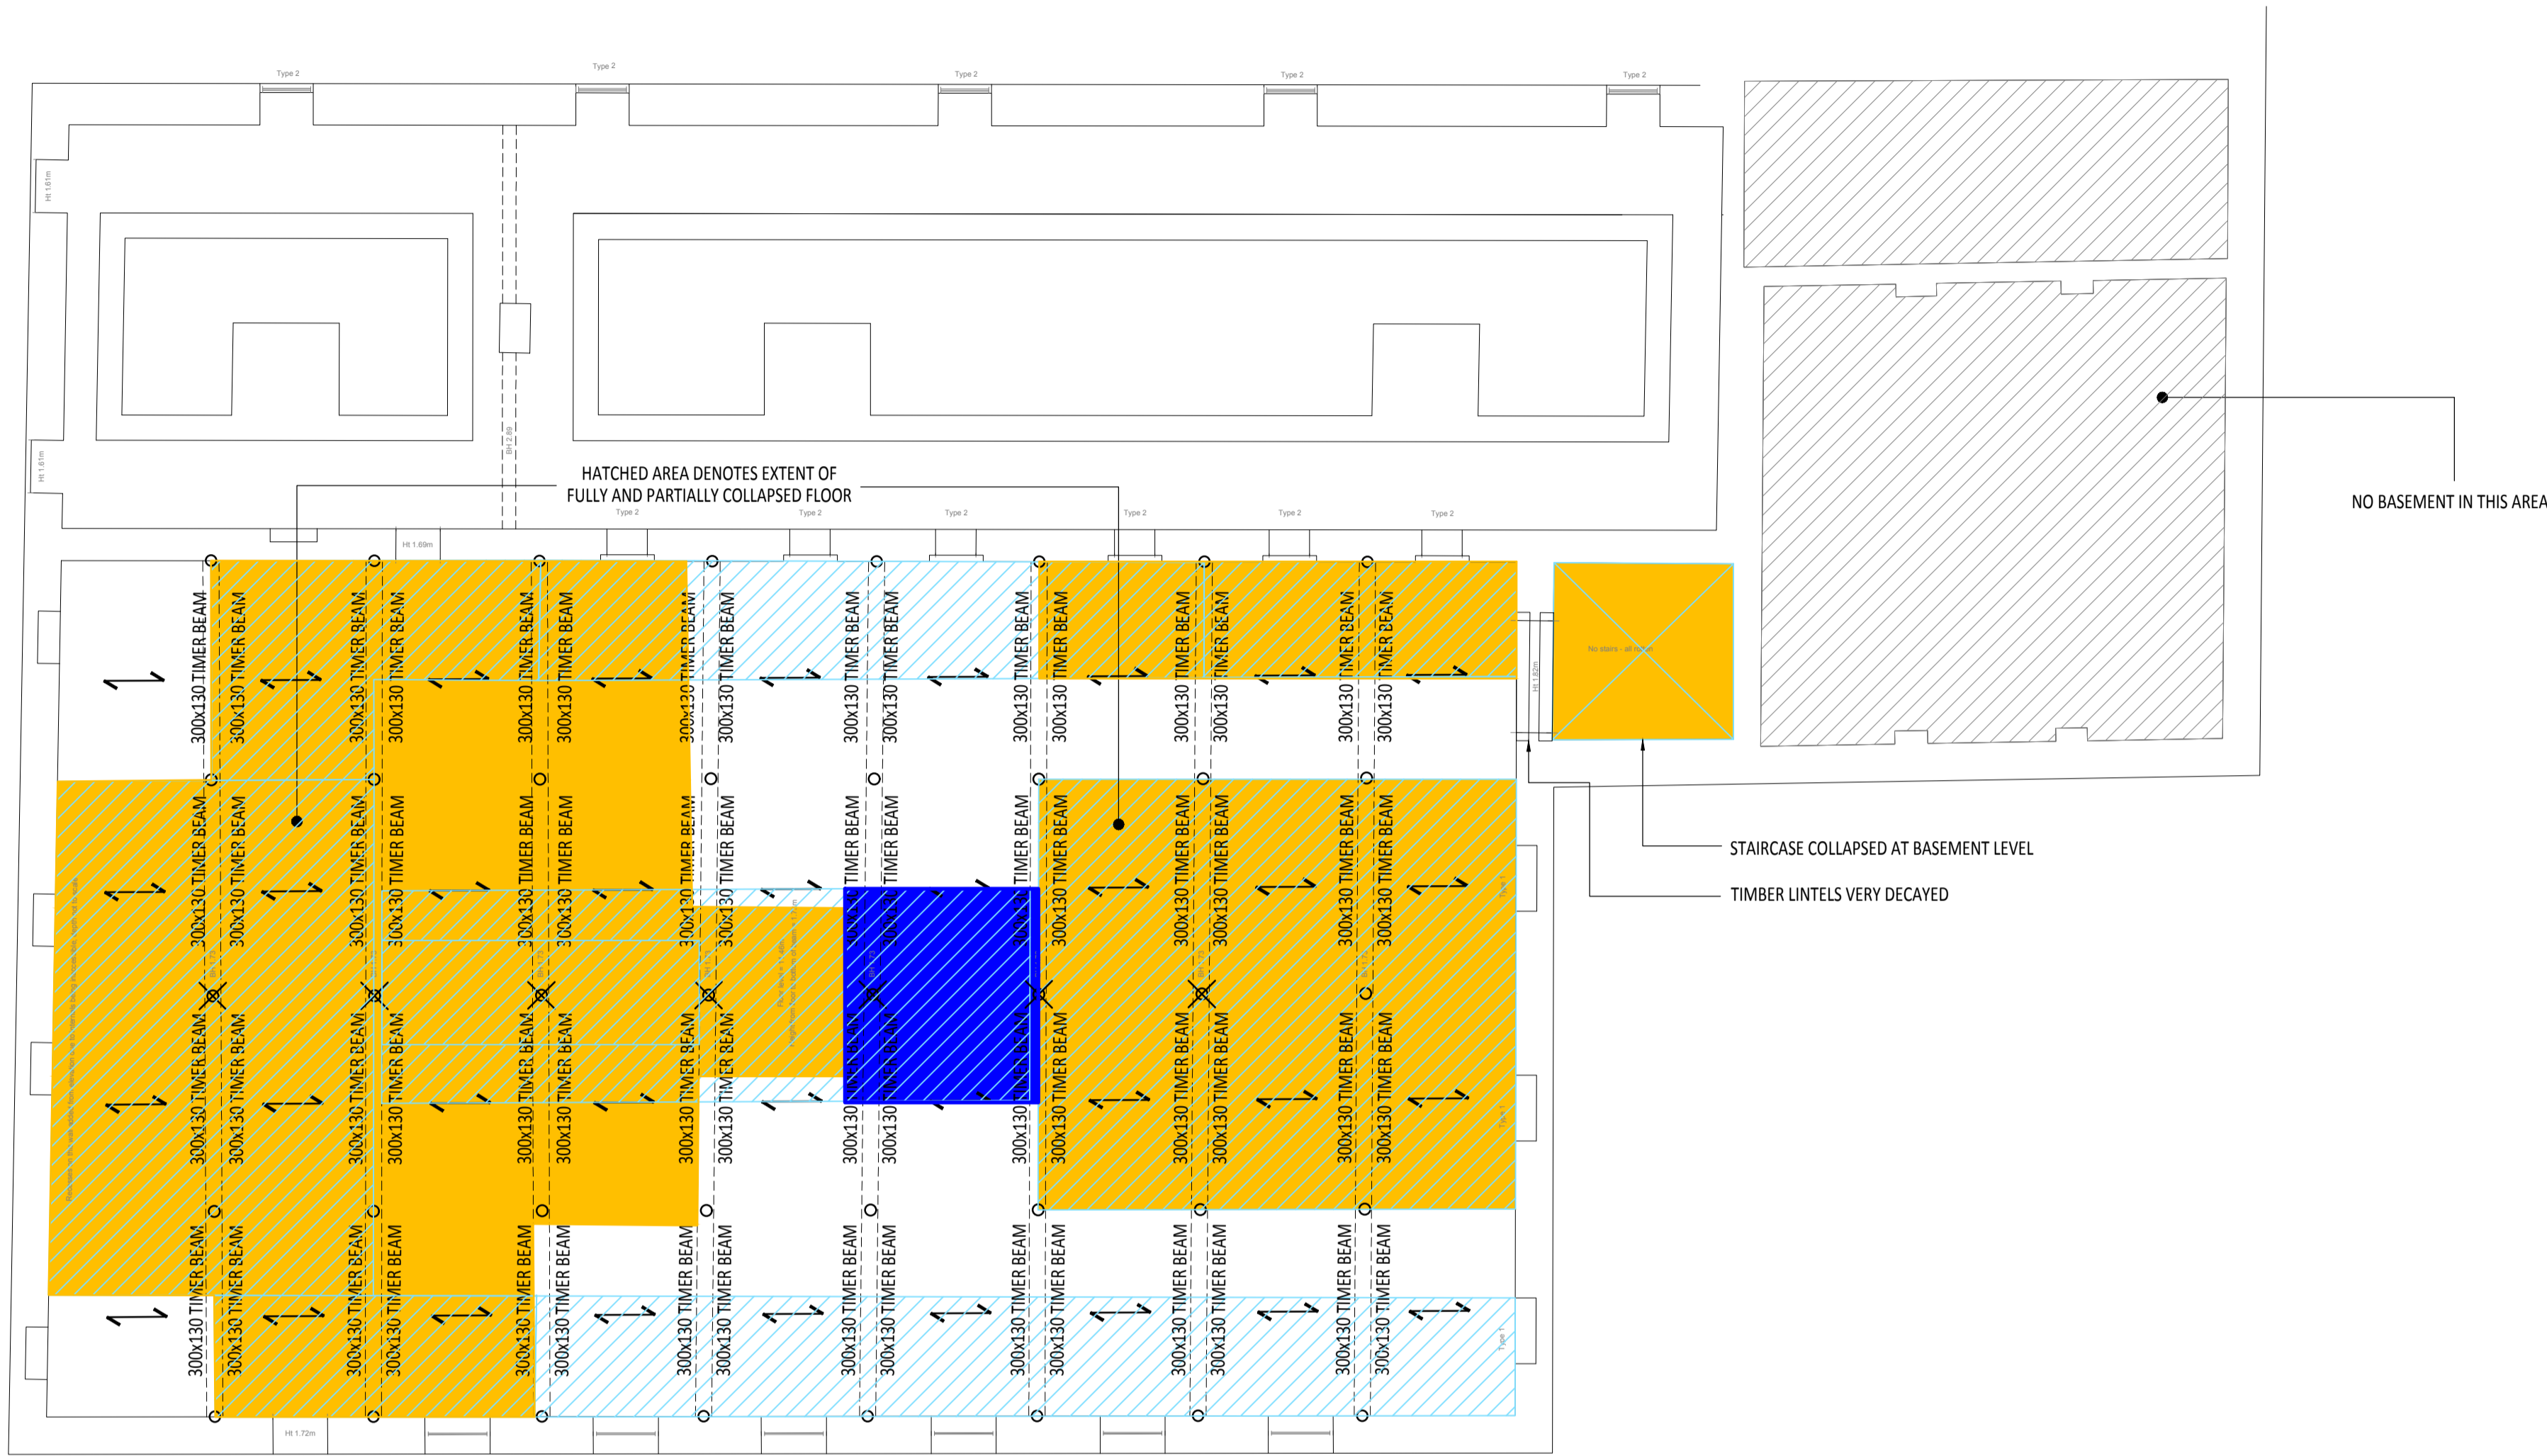
BASEMENT LAYOUT SHOWING EXISTING GROUND FLOOR STRUCTURE OVER

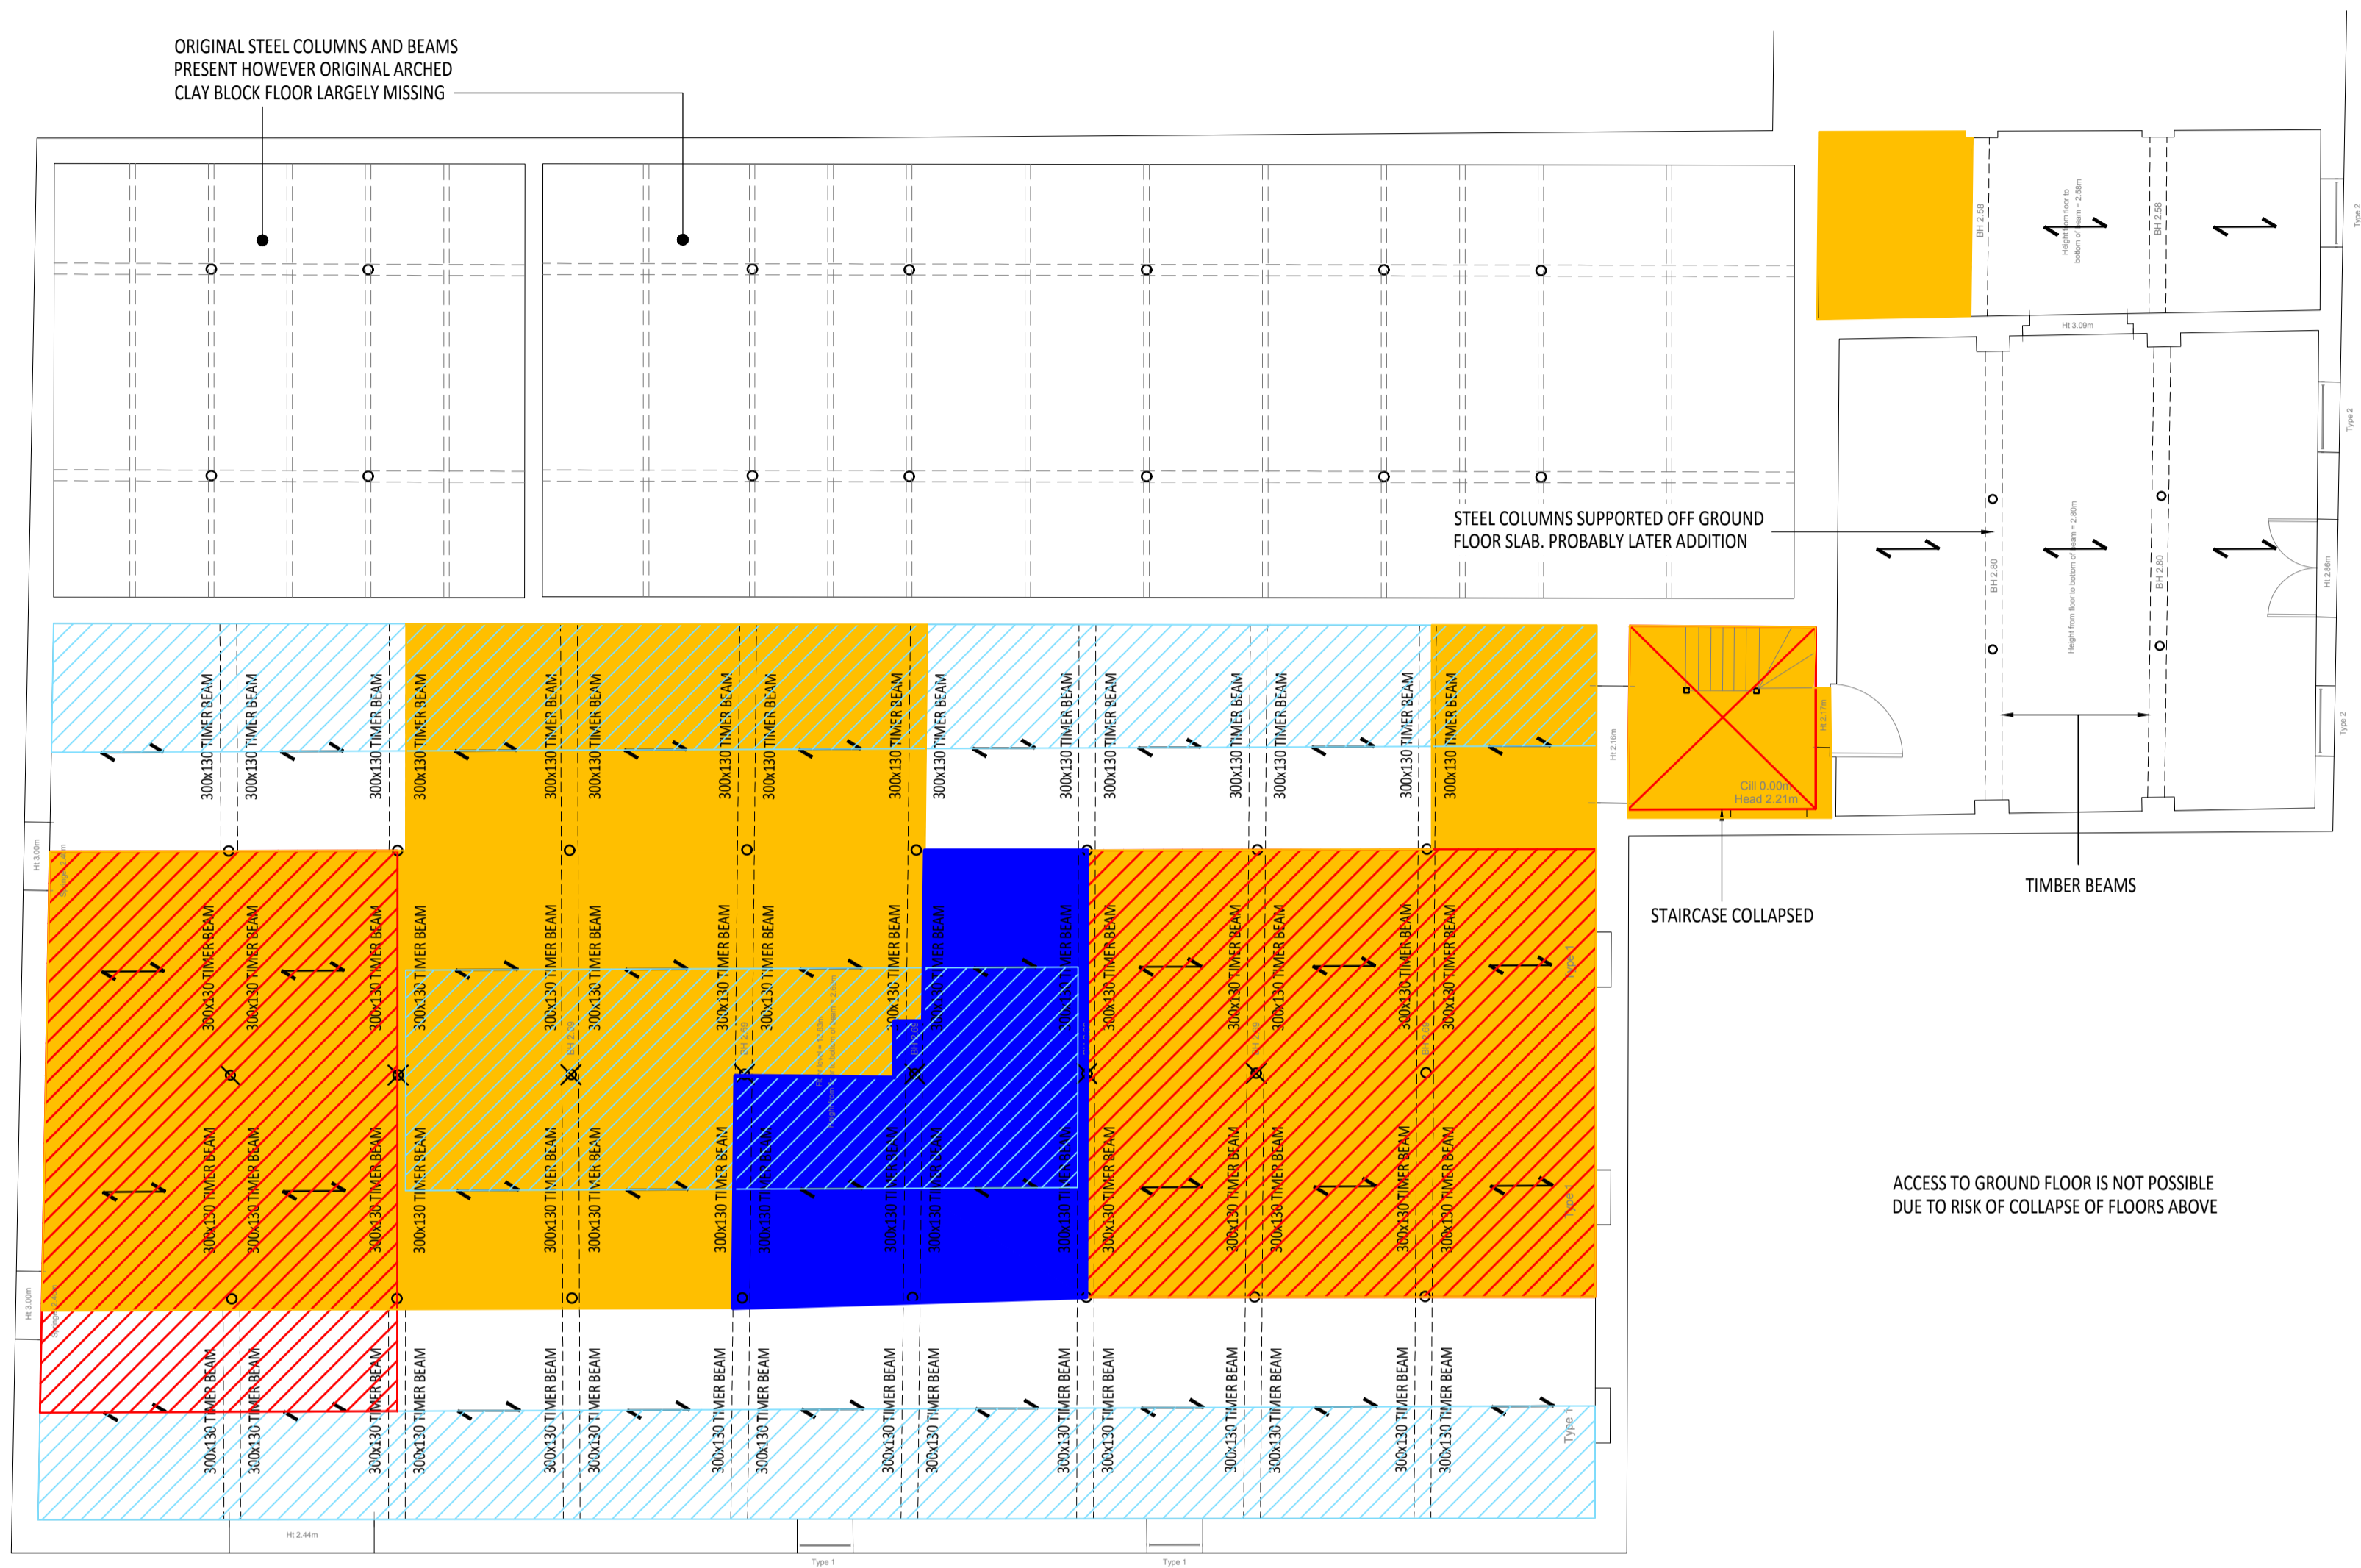
GROUND FLOOR LAYOUT SHOWING EXISTING FIRST FLOOR STRUCTURE OVER

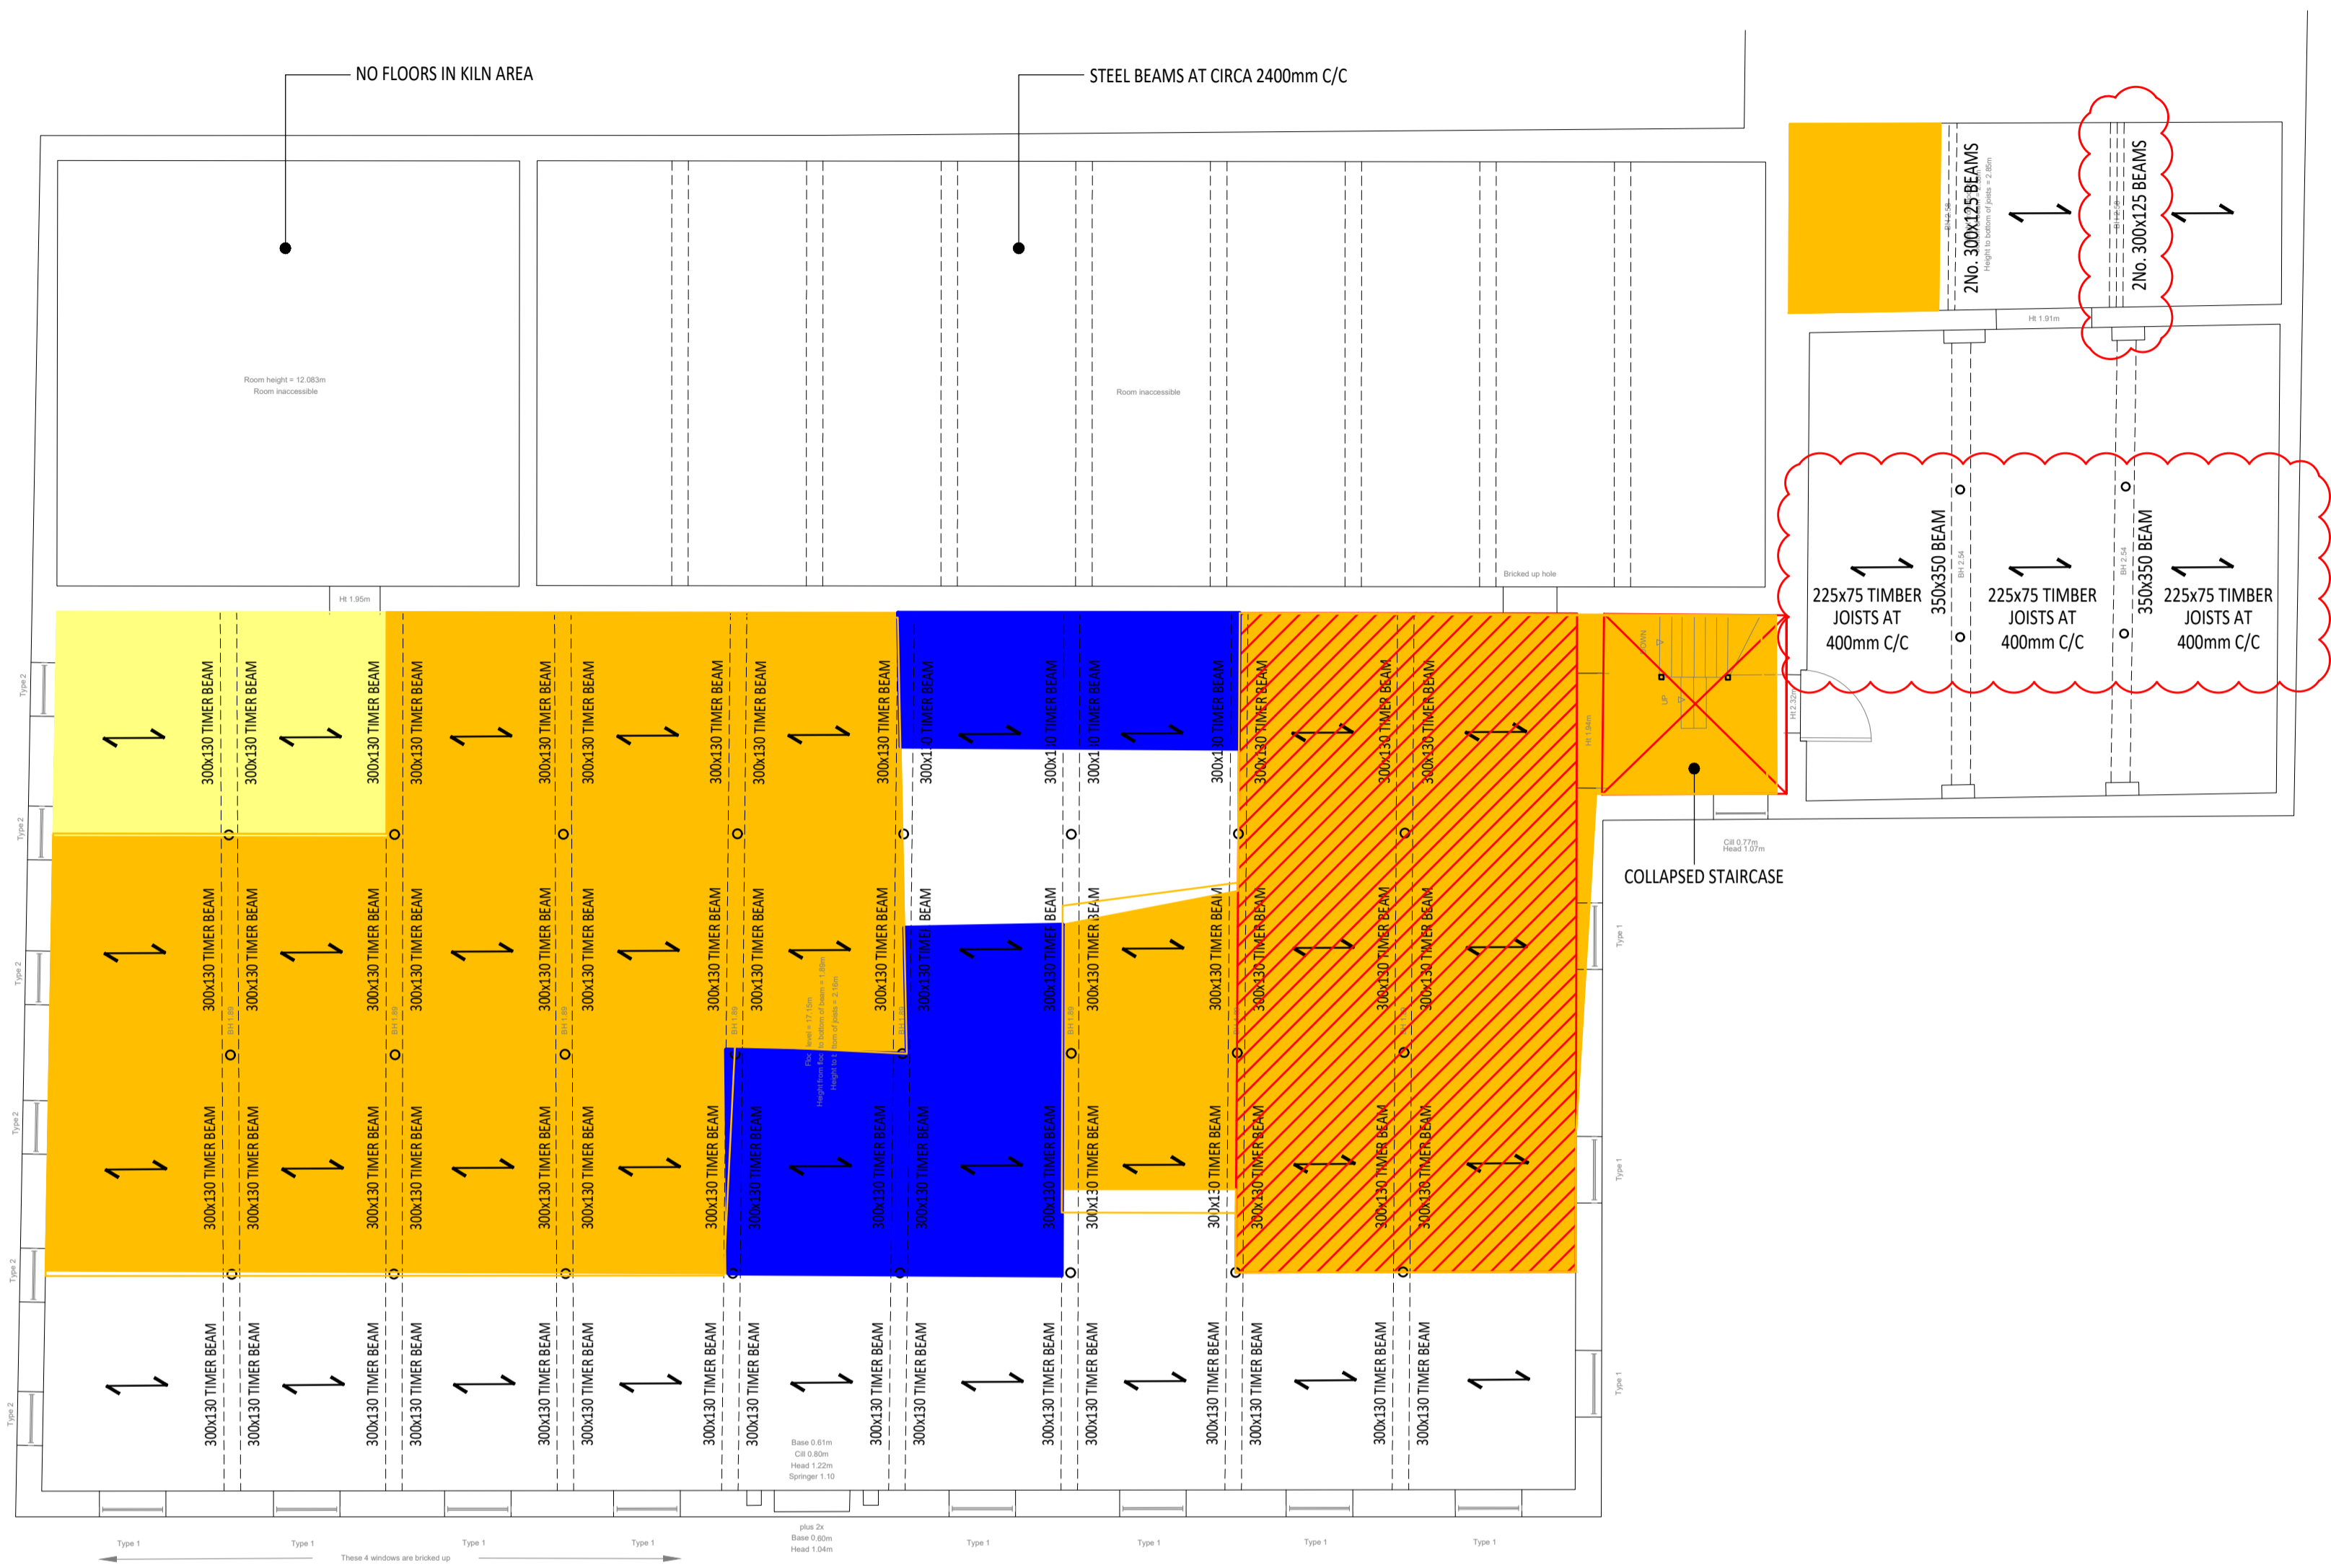
FIRST FLOOR LAYOUT SHOWING EXISTING SECOND FLOOR STRUCTURE OVER

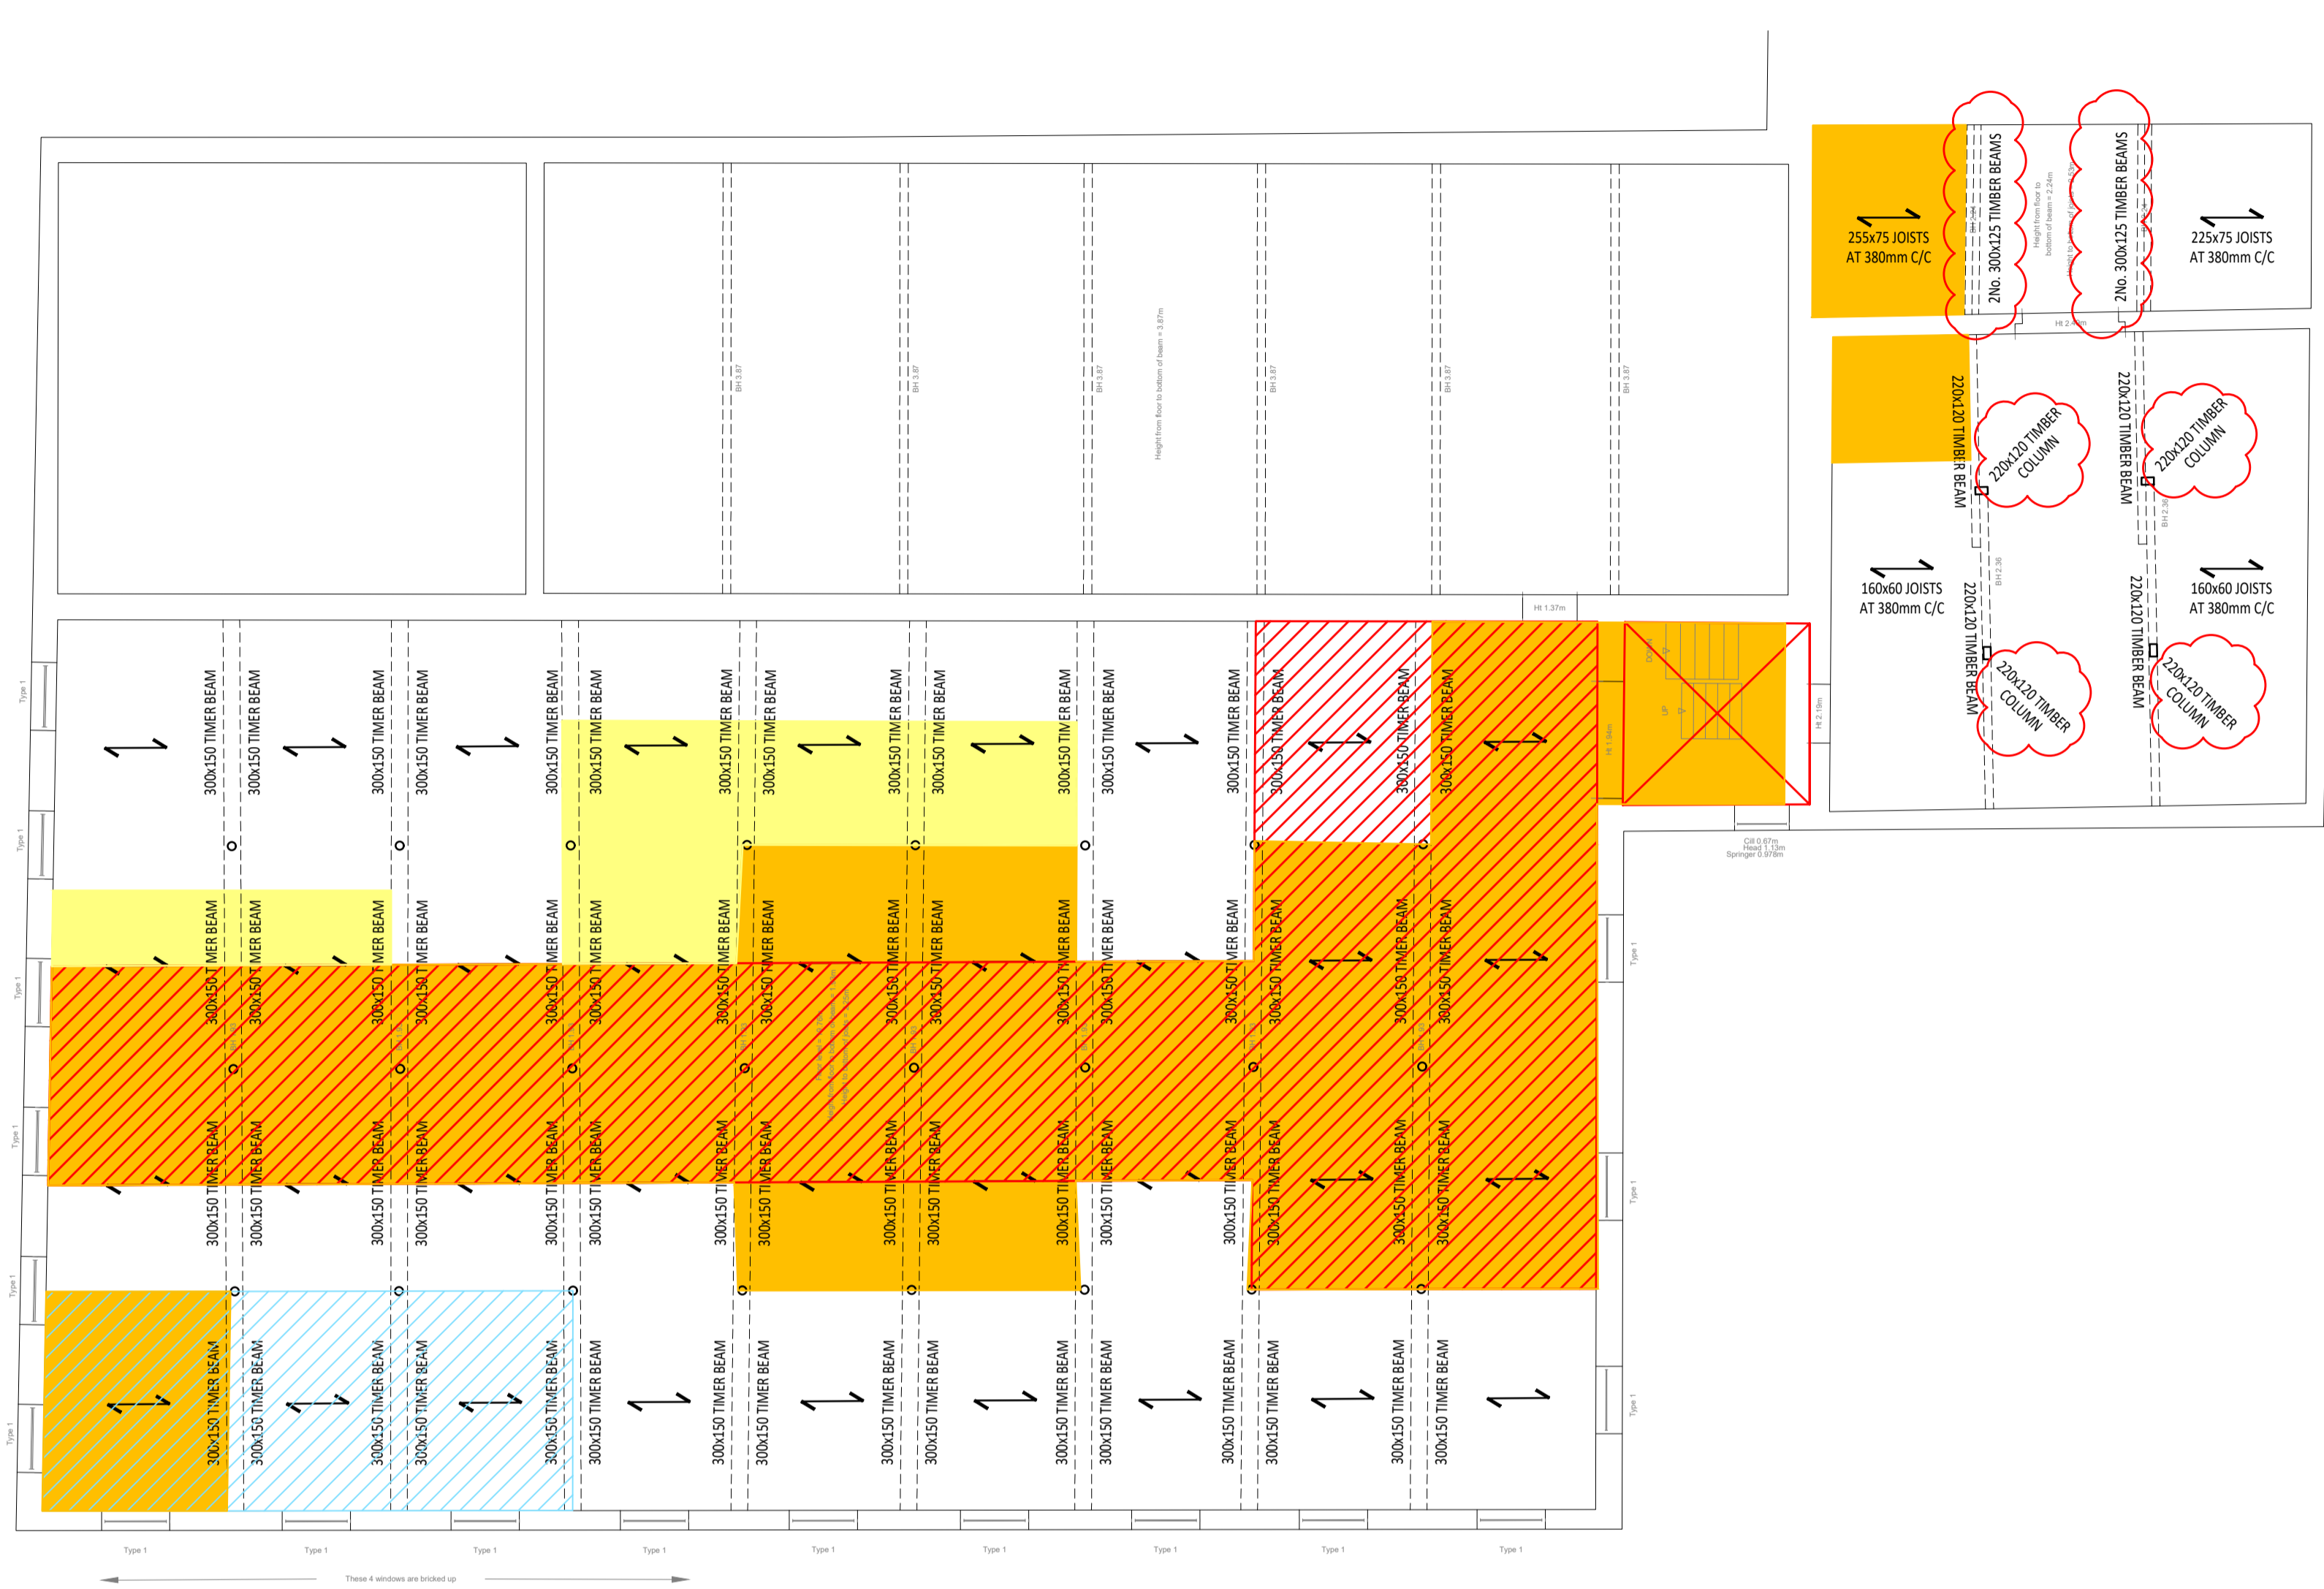
SECOND FLOOR LAYOUT SHOWING EXISTING THIRD FLOOR STRUCTURE OVER
