University of Gloucestershire  
**City Centre Campus: Debenhams  
re-development**  
Ecological Impact Assessment  
(EcIA)

GCC-ARUP-ZZ-XX-RP-Z-0004

For issue | 9 December 2021

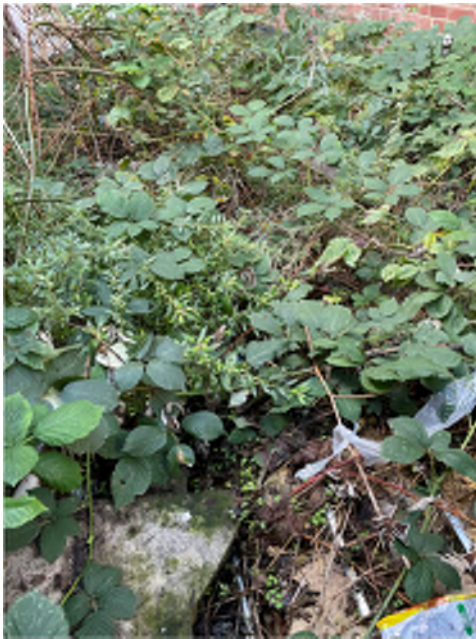
A small parcel (approximately 20m<sup>2</sup>) of dense scrub was present within a courtyard area in the north-west of the site (Photograph 1). Bramble (*Rubus fruticosus* agg.) dominated with further species including occasional butterfly bush (*Buddleia davidii*) and pellitory of the wall (*Parietaria judaica*). Aerial imagery reviewed as part of the desk study identified that this habitat was previously present across a larger area of the site earlier in 2021 (TN1), and this has been estimated as an additional area of 30m<sup>2</sup> for inclusion into the Metric in-line with its associated guidance. For the purpose of this assessment it has been assumed that the composition and condition of the habitat was the same as the remaining parcel of scrub onsite.

Photograph 1 - Scrub habitat present within small courtyard off St Aldate Street

In line with the Metric this habitat has been assessed as being in poor condition due to a lack of diversity in age, structure and species, over 5% cover of undesirable species (butterfly bush) and lack of connective surrounding habitats of biodiversity value. The habitat is generally one which is common and widespread; therefore, the site habitat is considered to be of **site value (less than local)**.

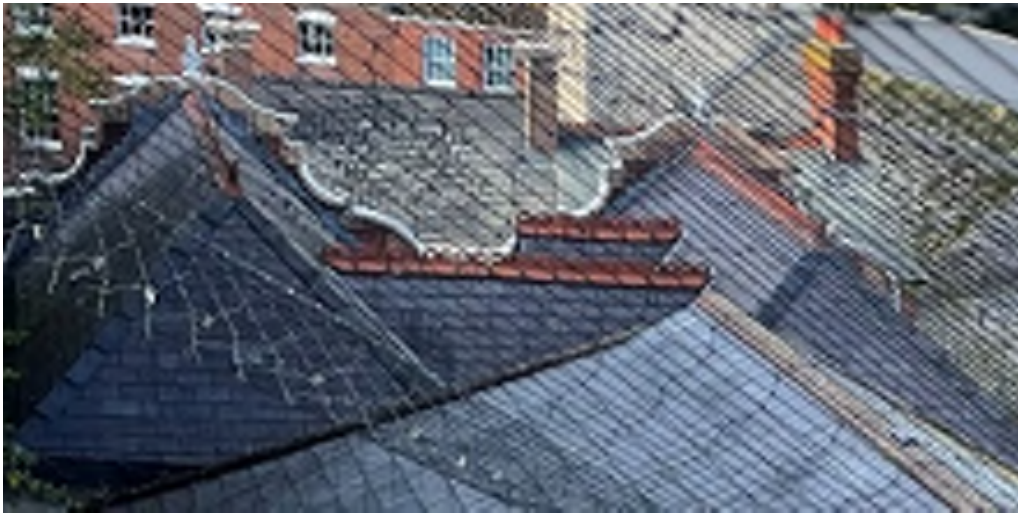
External visibility of the roof to the 1909/14 was limited by access, however, lifted tiles were noted along the southern-facing elevation of the northern-most gable to hip roof (F01; Photograph 2), along with lifted flashing along the valley gutter (F02) and lifted flashing along the southern-facing elevation of the southern-most roof (F03). An internal inspection of these roof voids revealed wooden boarding throughout, with no access points into the roof voids identified. The PRFs within the 1909/14 building are therefore considered likely to be limited to access under roof tiles and lifted flashing.

Photograph 2 - View looking towards Northgate Street showing the roof of the 1909/14 building as visible at the time of survey

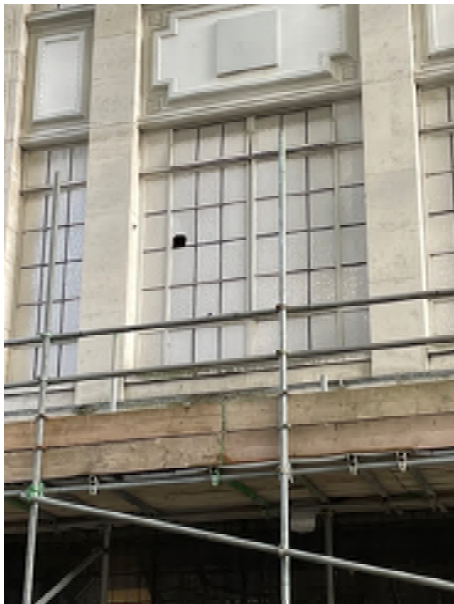
PRFs associated with the main building, comprising the largest section of the former department store, were largely identified on structures atop the flat roof. Two features of significance were noted upon the main building itself comprising a large wooden board affixed to the northern-facing elevation overlooking the courtyard (F04; Photograph 3) and broken window forming a gap of approximately 100mm in diameter on the south-western facing elevation, fronting Northgate street (F05; Photograph 4). Upon further inspection the former (F04) was observed to be covered in netting, creating a cluttered entrance to potential roosting features formed in gaps between the wooden boarding and brickwork, and the latter (F05) was found to lead into a brightly-lit area that was previously subject to frequently disturbance. As such, both of these features were assessed as having negligible suitability to support roosting bats.

Photograph 3 - View of the main building from The Oxode

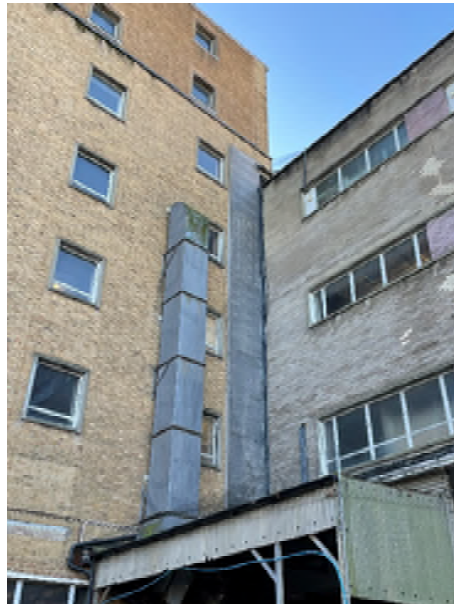
Photograph 4 - Boarding on the main building facing the courtyard

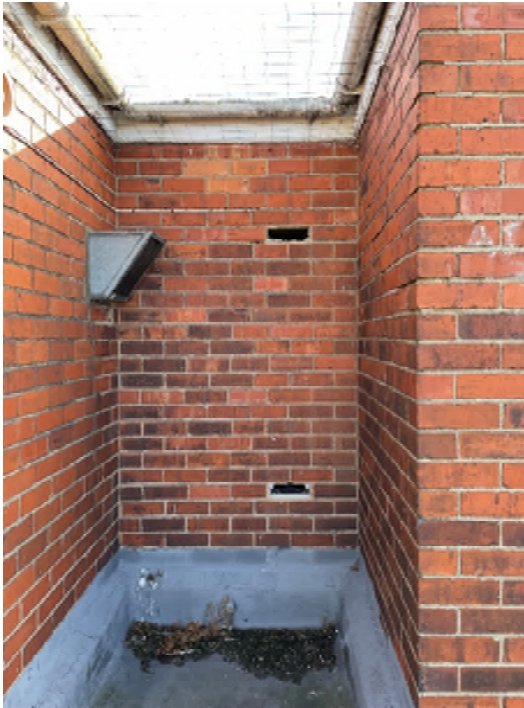
Structures atop the roof of the main building found to contain PRFs included plant room 1, plant room 2, the water tower, the wooden-louvred structure and plantrooms 4 and 5. Plant room 1 contained PRFs including limited areas of lifted metal flashing (F06) and missing bricks, mortar, and broken vents (F07; Photograph 5) which allowed access into the structure. A wooden soffit box with significant damage was noted upon the southern-western and south-eastern facing elevations of plant room 2 (F08; Photograph 6), this was further inspected using an endoscope (under licence<sup>13</sup>) which revealed gaps forming cavities of approximately 200mm in width and height and 400mm in depth.

Photograph 5 – Missing bricks on Plantroom 1

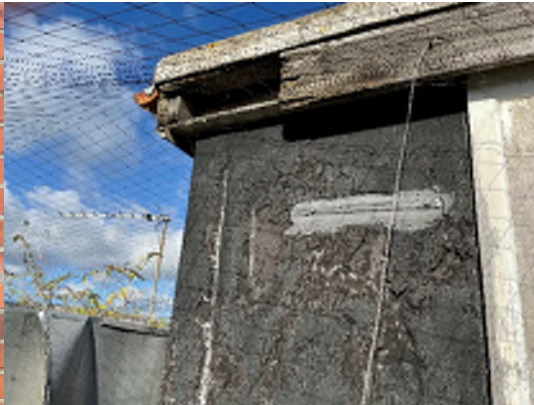
Photograph 6 – Damaged soffit box present on Plantroom 2

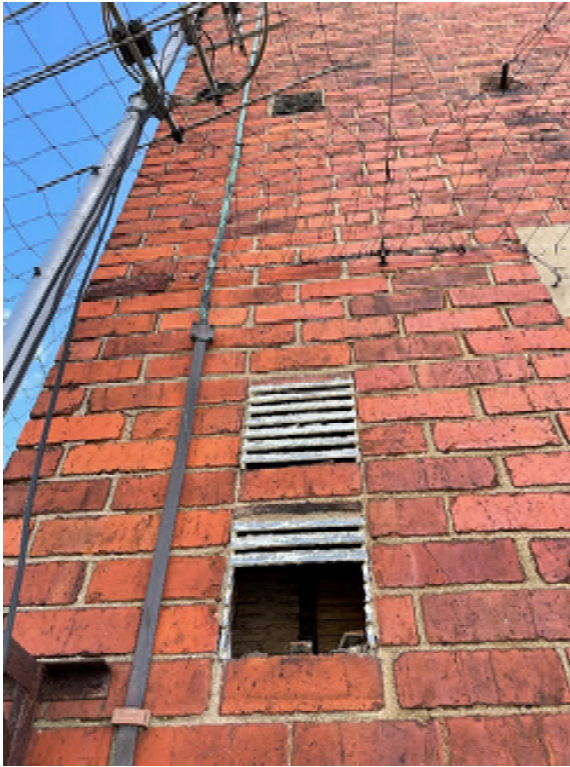
The water tower was inspected externally only from the roof-level of the main building. The water tower is a three-storey building upon which several PRFs (F09; Photograph 7) were noted including broken wooden vents leading into large gaps formed in cavity walls on all elevations, broken windows allowing access into the internal structure of the building, and cracks in brickwork and areas of missing mortar .

Photograph 7 – Example of broken vent on the Water Tower

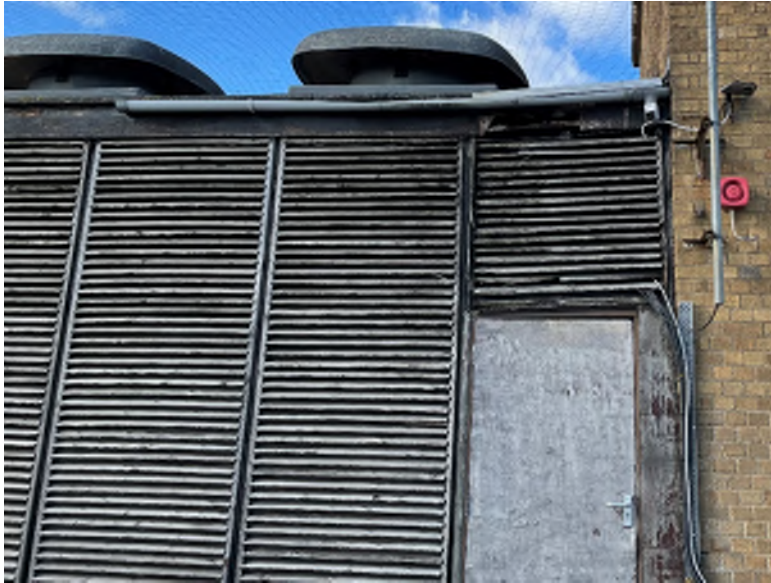
The wooden-louvred building is a single storey building, with wooden panels forming the walls of the structure on the north-west and south-east facing elevations (F10; Photograph 8). Broken wooden fascias, gaps around wooden doors and missing and broken louvres on these elevations provide potential access points into the structure which contains wooden-beam shelving throughout. The suitability of the building is somewhat reduced due to the presence of netting around the majority of the structure, however the netting is broken in places, and it is therefore considered that bats could find egress into the building to roost.

Photograph 8 – Wooden-Louvred Building

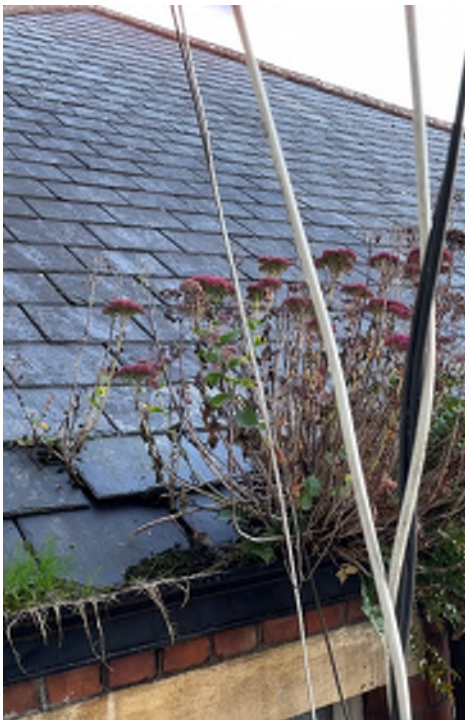
The Mezzanine building was inspected from the courtyard adjacent to St Aldate Street and roof-level of the main building, however, due to safety constraints limiting access, the roof was not able to be fully visualised at the time of survey. PRFs were noted on the courtyard elevation of the building comprising raised roof tiles and lifted flashing (F13; Photograph 9), several areas of lifted wooden fascia boards creating gaps of approximately 30mm by 100mm (F14), and a broken window-pane with a gap of approximately 100mm in diameter (F15; Photograph 10). The room containing the broken pane was not able to be accessed at the time of survey due to the presence of asbestos. The access into the roof voids created by the hipped roof is located in the same room and the voids were therefore also inaccessible at the time of survey.

Photograph 9 – Lifted tiles on the Mezzanine building

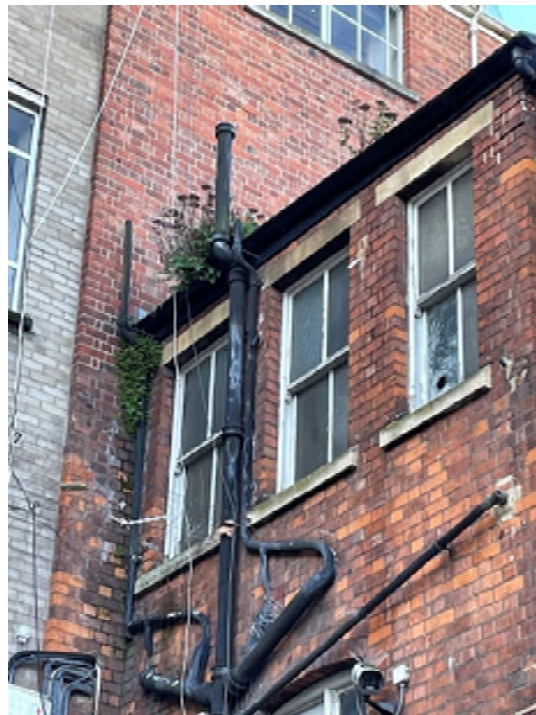
Photograph 10 – Broken windowpane leading into the Mezzanine building

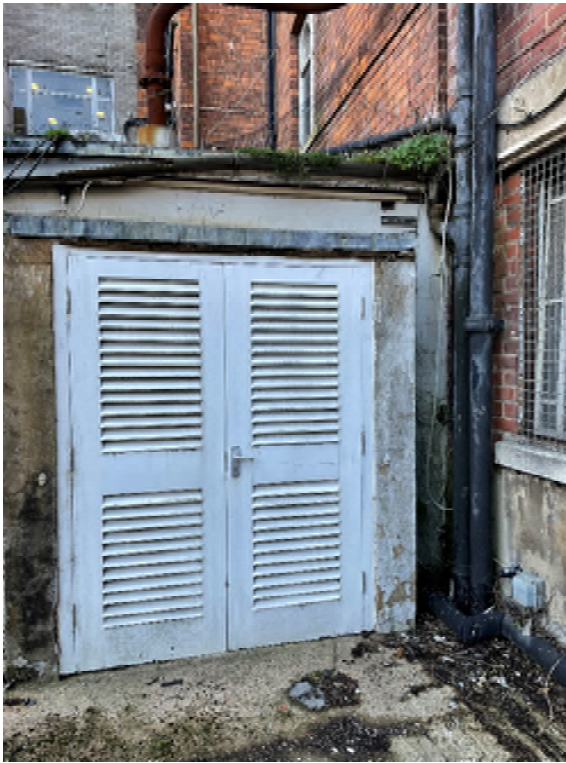
The structures in the courtyard were also subject to a PRA, with PRFs identified on the generator building forming a lean-to on the Mezzanine building. These comprised lifted ply capping, a hole in wall under the wooden soffit box and gaps in door panelling on the north-eastern facing elevation (F16; Photograph 11) on the north-eastern and south-eastern facing aspects.

Photograph 11 – Gap in wall and lifted capping on the Generator building in the courtyard

Further surveys are recommended in the form of emergence and/or re-entry surveys to assist in the identification of any features onsite used by roosting bats and general activity levels across the site. In line with the current assessment of features as having low suitability to support roosting bats, one emergence/re-entry survey should be undertaken between May and August.

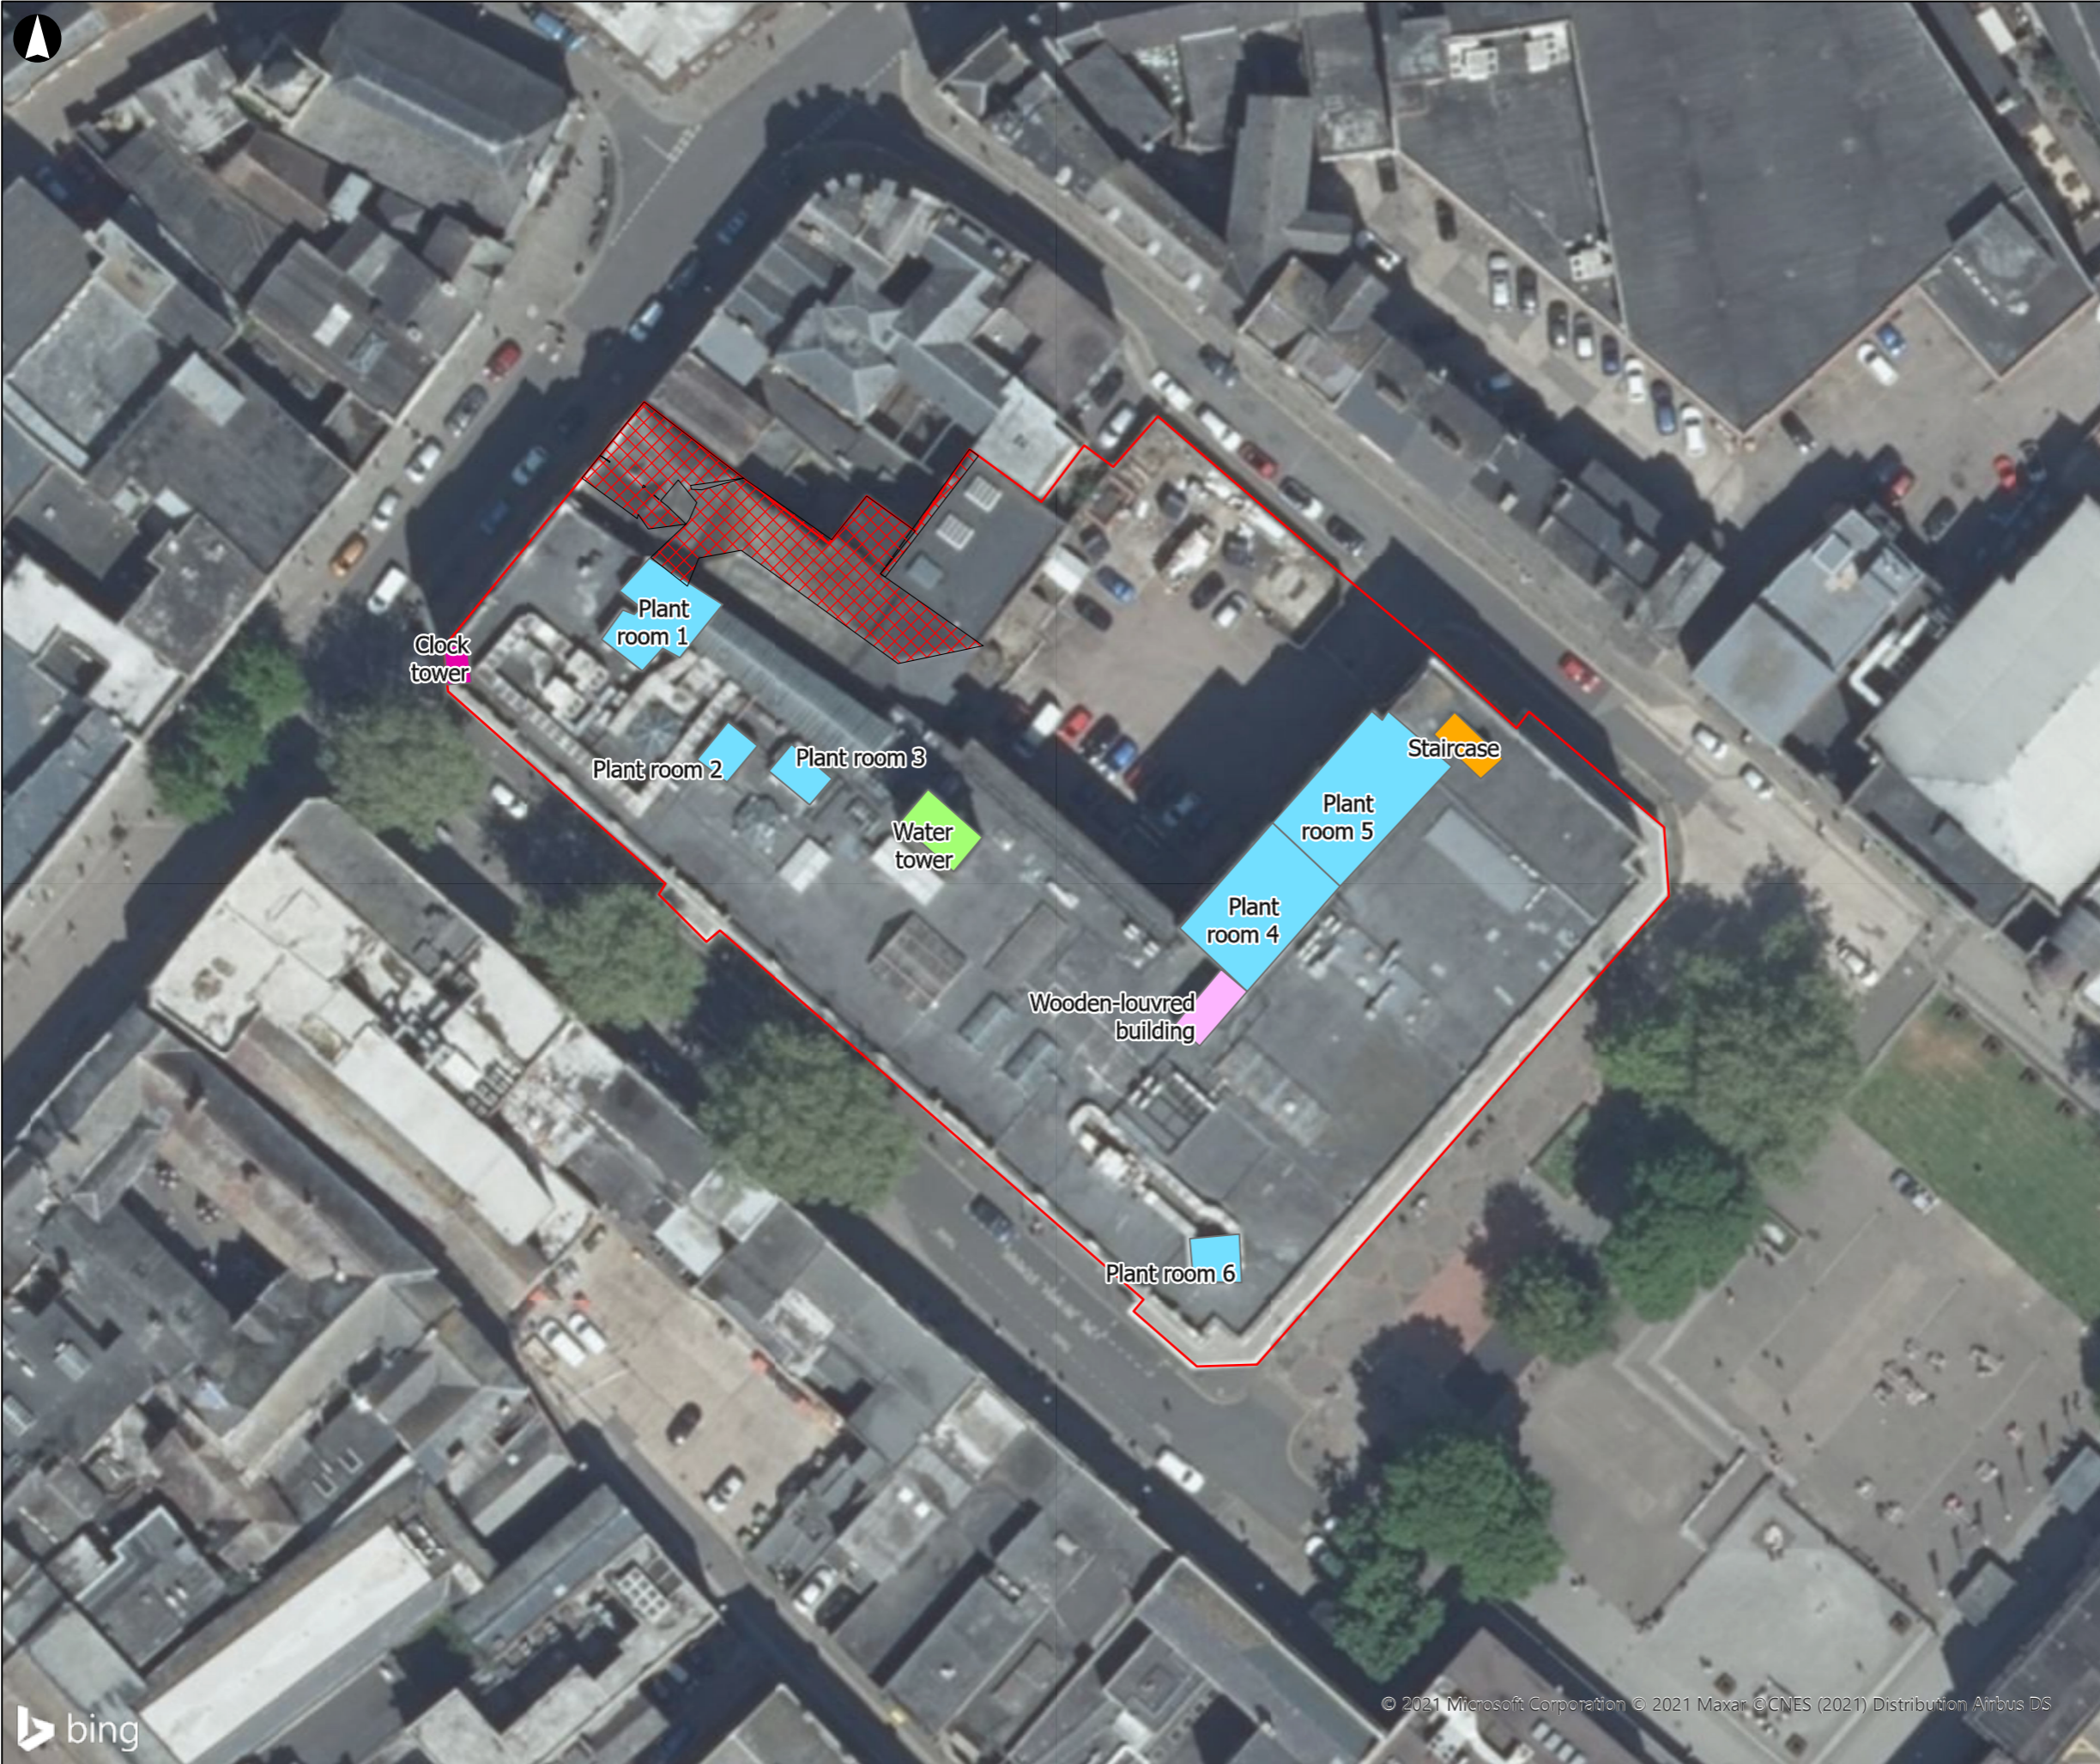
### **Figure 3 Building Plans**

There were several PRFs identified during the inspections which were assessed as having **low suitability** to support roosting bats in line with BCT's Good Practice Guidelines<sup>12</sup> and as such, further surveys are recommended as detailed in the section below. The findings of the PRA summarised in Table 4 overleaf and further detailed under the relevant headings, where identified PRFs are referenced as F01, F02 etc. The below should be read in-conjunction with figures 3 and 4.

PRF reference (see Figure 4)	Structure (refer to Figure 3)	Description	Suitability for roosting bats
F01	1909/14 building	Lifted tiles	Low
F02	1909/14 building	Lifted flashing	Low
F03	1909/14 building	Lifted flashing	Low
F04	Main building	Gaps behind large board affixed to wall (behind netting)	Negligible
F05	Main building	Broken windowpane leading into former store area	Negligible
F06	Plantroom 1	Lifted flashing	Low
F07	Plantroom 1	Missing bricks, missing mortar and broken vents	Low
F08	Plantroom 2	Damaged soffit box	Low
F09	Water tower	Broken window vents leading to cavity walls, broken windowpane, cracks in brickwork	Low
F10	Wooden-louvred building	Broken louvres and fascias leading into the building, gaps around doors	Low
F11	Plantroom 4/5	Lifted flashing	Low
F12	Plantroom 4	Lifted capping	Low
F13	Mezzanine building	Lifted roof tiles and lifted flashing	Low
F14	Mezzanine building	Lifted fascia boards	Low

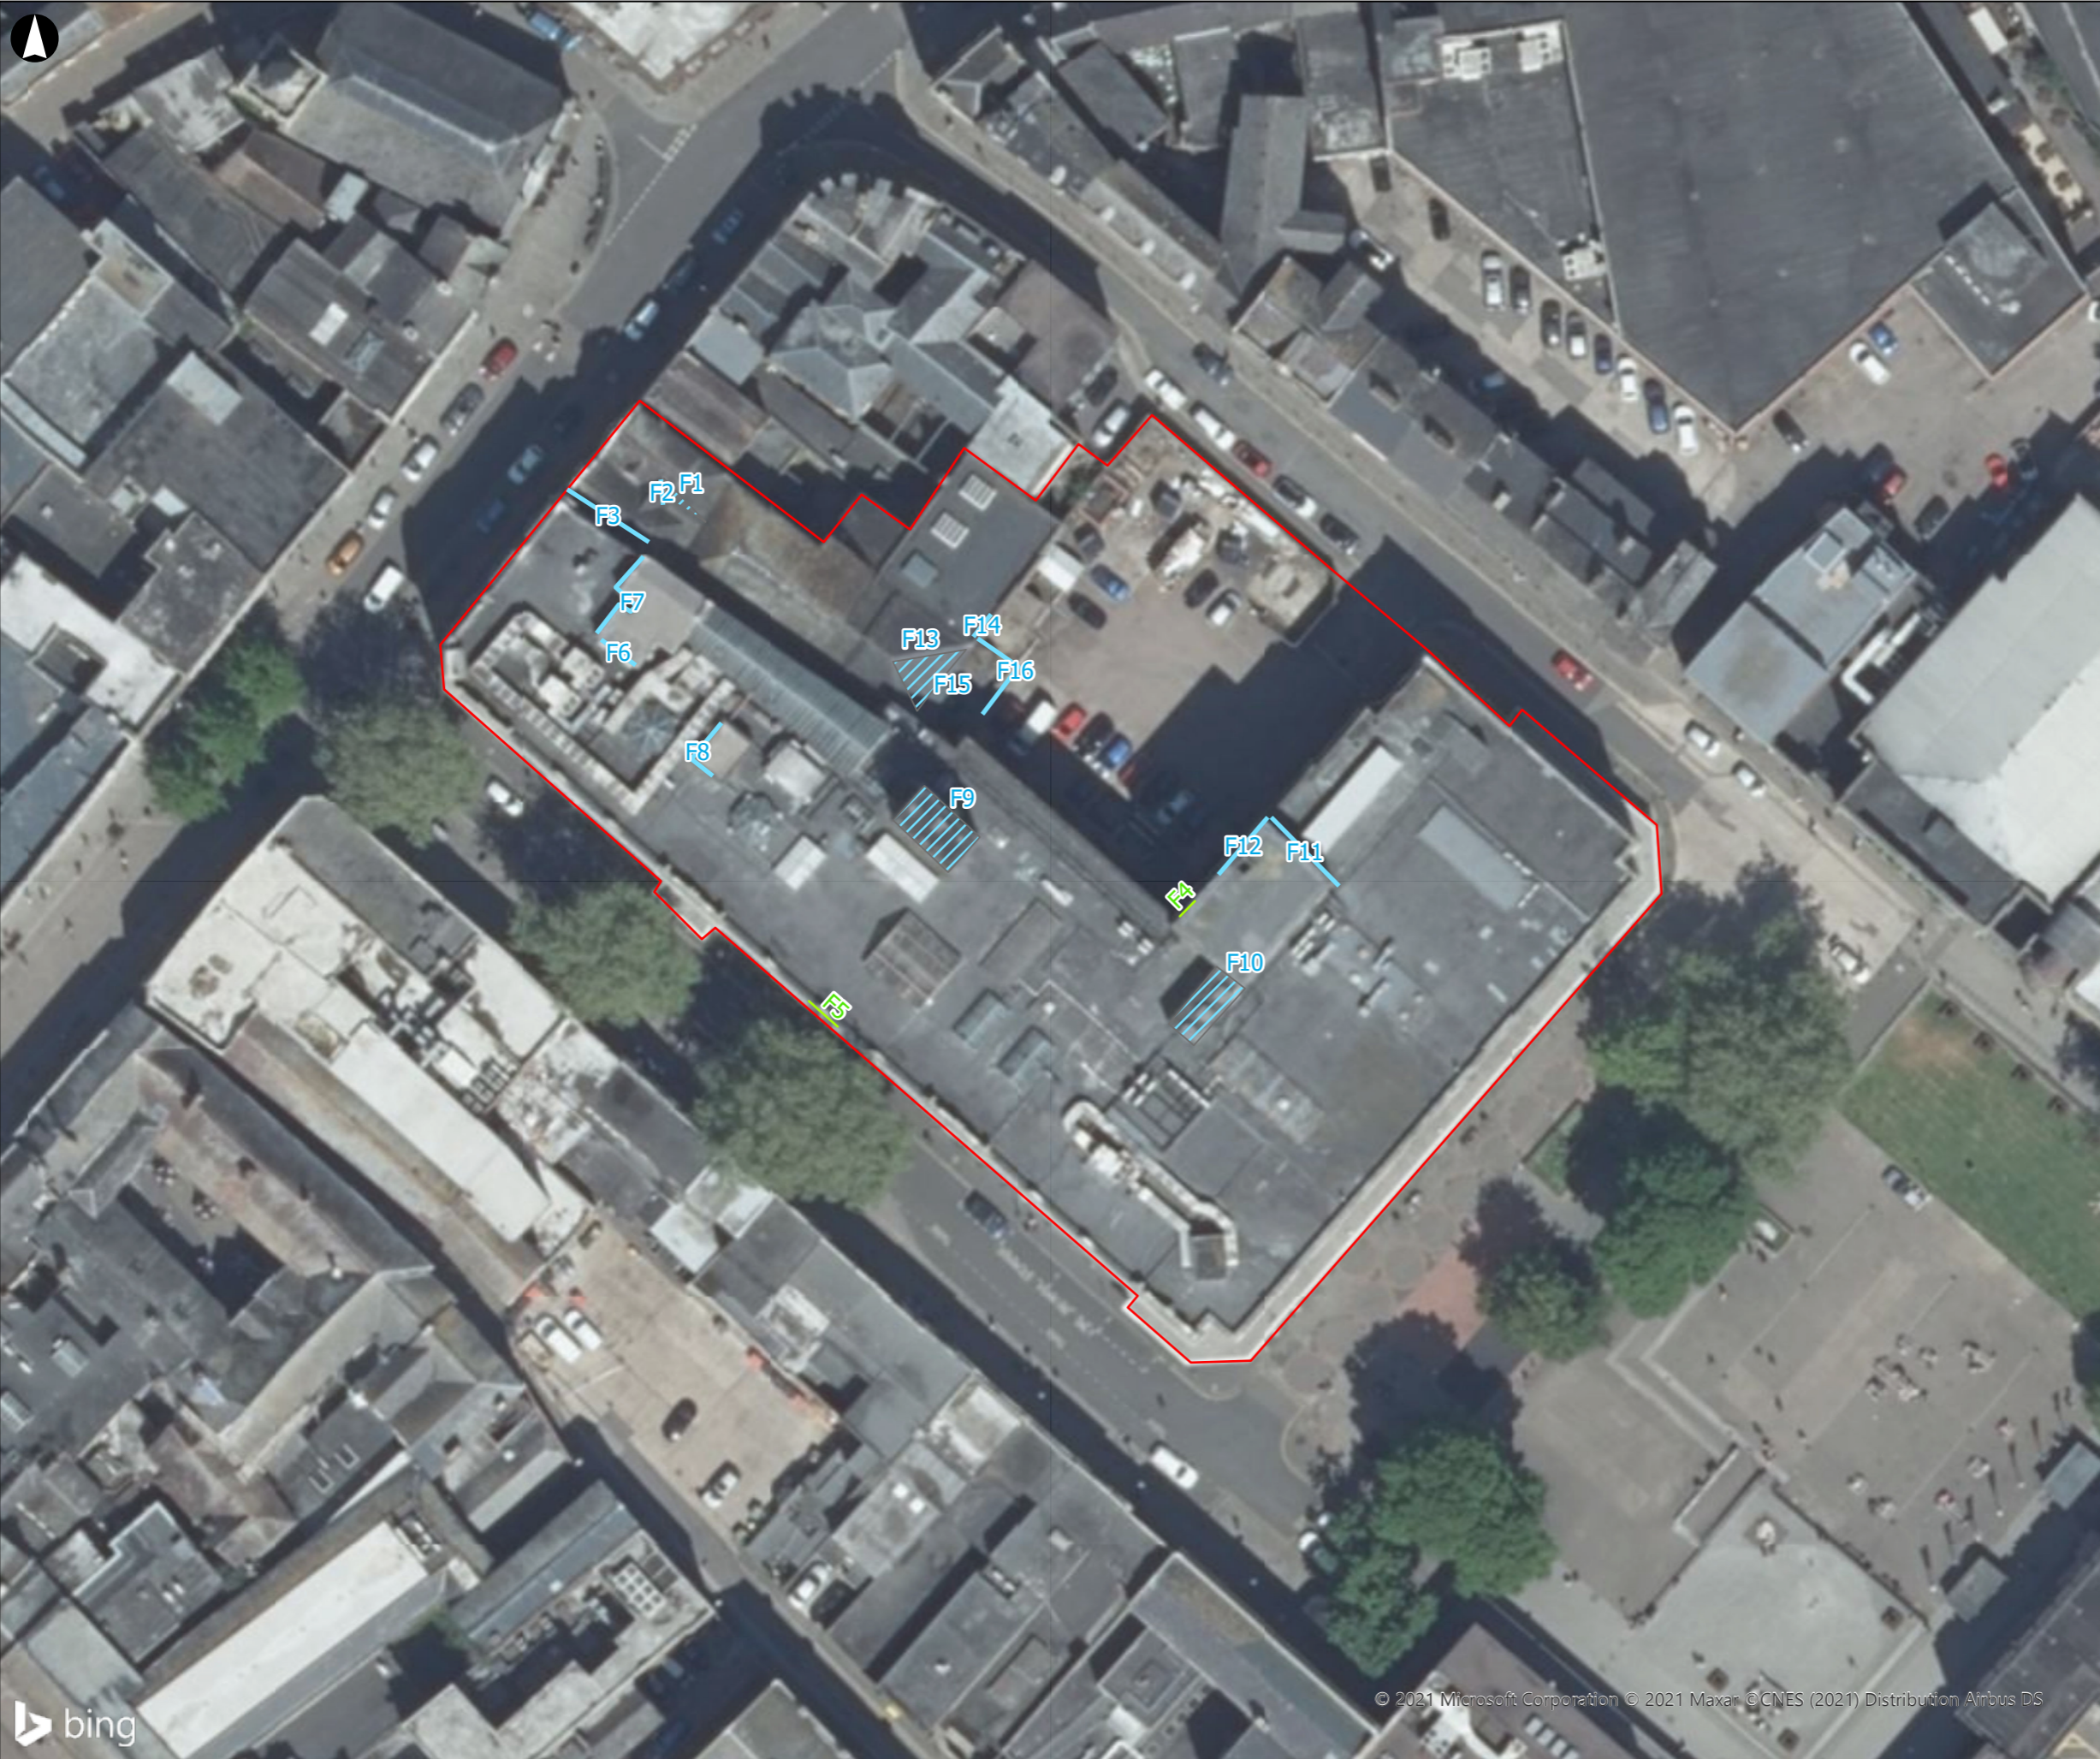
## Figure 4 Bat Potential Roost Features

F15	Mezzanine building	Broken windowpane	Low
F16	Generator building	Gap in wall, lifted capping and gaps in door panelling	Low
