GLOUCESTER CITY COUNCIL
2ND BAR RESURVEY

Revised Buildings At Risk Register
Part II

Project No. 6705

January 2014

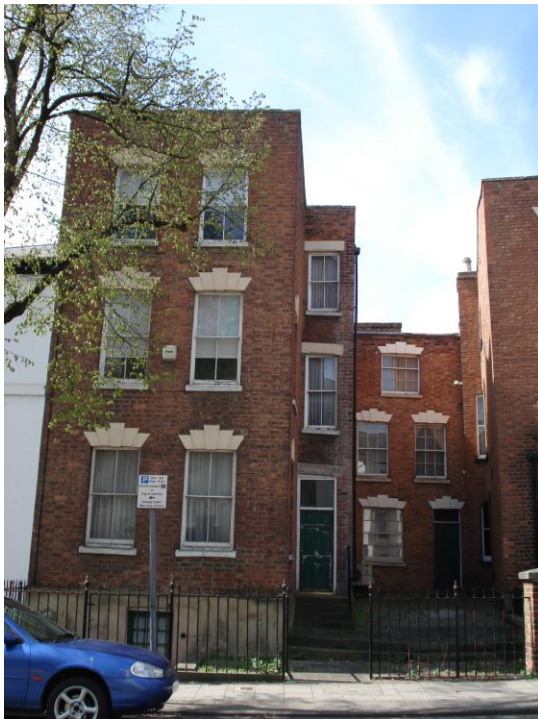
30 Brunswick Rd.

Red brick house with slate roof, c1820.

The building, along with nos. 26 & 28 was used as offices for a local building firm until 5 years ago. External evidence (dropped lintels & cills) of some movement in the past in the thin projecting block on the right hand side. More recently a problem with water ingress from a leak in the roof has resulted in damp penetration to first and second floor rooms in the projecting block. The leak has now been repaired. Some brickwork needs re-pointing.

In view of the above and the fact that the property continues to be empty, the building falls into the 'Vulnerable' category. The City Council will encourage the owners to implement one of the outstanding permissions to get the building off the register.

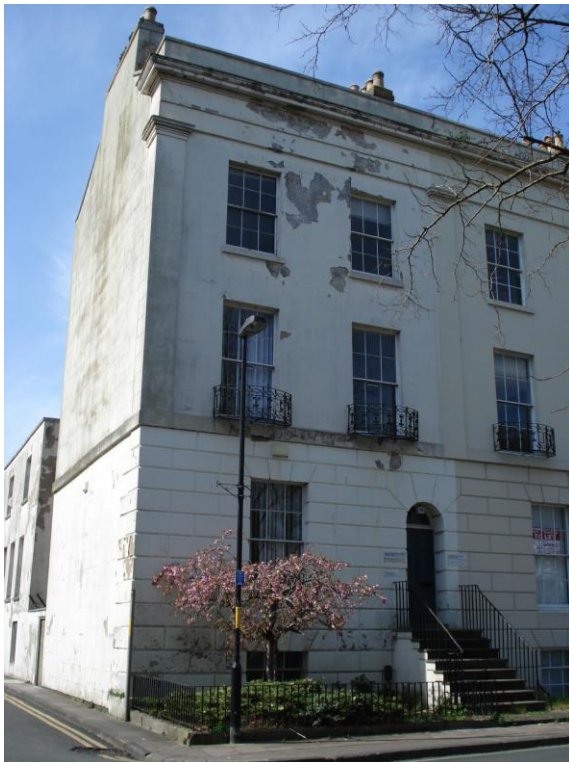
18 Brunswick Square

The end of a terrace of seven houses on the western side of the square. C1825. A double depth block with rear wing.

Last used as offices. Empty for 3/4 years. Showing signs of neglect from peeling paint and cracking to render, repairs needed to stonework and broken windows to rear. Theft of metal pipes in early 2011 gave rise to flooding in the basement. Out-building to the rear is in a very poor state of repair.

Property has been on the Council's BAR Register as 'One to Watch' since Aug. 2011. Remains 'Vulnerable'. Currently on the market, meanwhile the City Council will press the owners for any urgent repairs to be carried out.

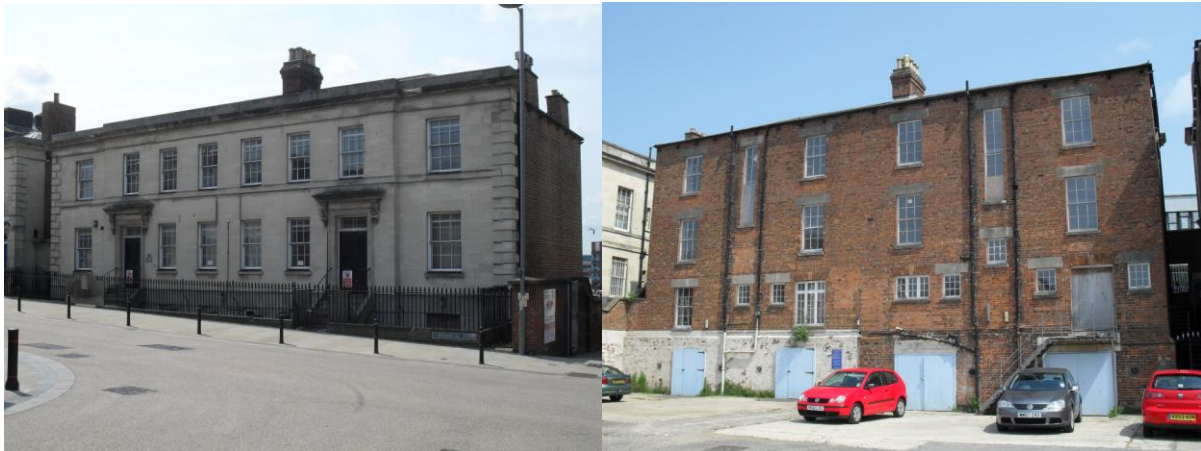
27 & 29 Commercial Rd.

Offices, built in 1848 for merchants operating in the Gloucester Docks. Brick, front faced in ashlar, hipped slate roof and central brick stack. A mirror image pair of buildings. Original wrought iron railings & gates to front.

The property has been vacant for several years. It is showing signs of neglect in the form of damaged/broken windows & vegetation on walls, particularly on the rear elevation facing The Docks. Internally there are a number of indicators of past water ingress and on-going damp problems, from fallen plaster, mould and rotten timber. The property is classed as 'Vulnerable'.

Gloucester City Council had ownership of the building transferred to it in 2010 following the winding up of the SWRDA (previous owners). Prior to this SWRDA did carry out some repairs to the roof. GCC is likely to be looking to market the property in 2014.

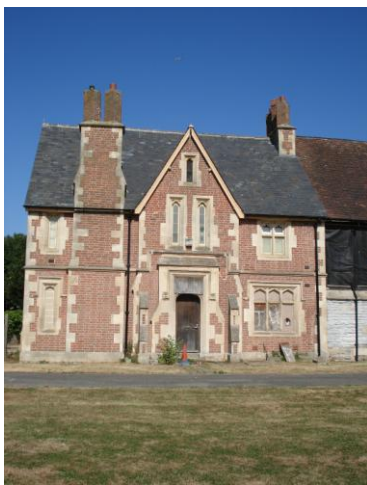
Llanthony Priory Farmhouse, Llanthony Rd.

A red brick farmhouse c1870-80 built in the Tudor Gothic style and incorporating some remains of the south end of the former 14th century range of monastic buildings of the Augustinian Priory of Llanthony Secunda.

In 2007 a management trust took over responsibility for the priory from the City Council. Since then the trust has carried out extensive works to stabilise the farmhouse & the adjacent medieval lodgings. In order to eradicate dry rot, the whole of the upper floor of the farmhouse was removed, new floors were inserted and rooms recreated. In addition the roof was repaired and rainwater goods renewed. A survey in May 2013 revealed a problem with a blocked downpipe but no evidence of any further outbreak of dry rot. Some graffiti has appeared in recent months but of greater concern is a recent (July 2013) break in and attempted theft of copper pipes, which caused the ground floor to be flooded.

The property has been on the City Council's BAR Register since 2005 (Risk Category 4 – One to be watched) and should remain on as 'Vulnerable'. The Trust was recently successful in getting Stage I Approval, with development funding, from the HLF to progress with a programme of repair and conservation of all the buildings at the priory, including a new interpretation centre. It is hoped work will start on site in Autumn 2015.

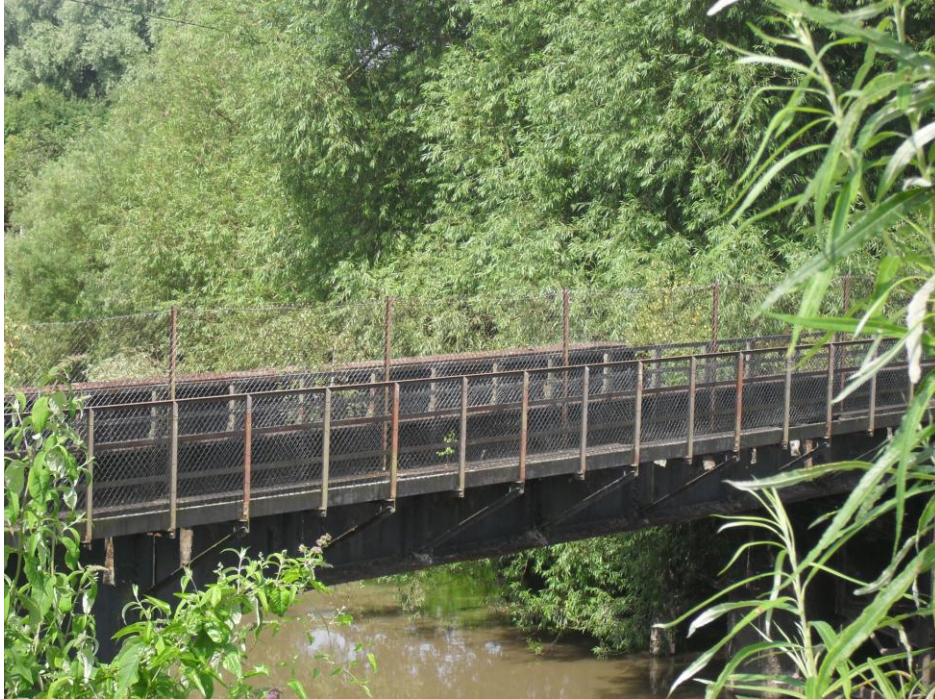
Llanthony Swing Bridge, Llanthony Rd.

This railway bridge was constructed in 1910 from 1890 GWR designs. It is a plate girder steel swing bridge that pivoted on a drum on the SE bank of the River Severn and rested on 2x cylindrical iron-clad piers on the NW side of the river. The abutments are of stone and brick. A later footbridge was attached to the NE side. The bridge has been fixed and no longer works as a swing bridge.

It is showing signs of neglect through vegetation growing on the bridge and peeling paintwork.

The structure is classed as 'Vulnerable'.

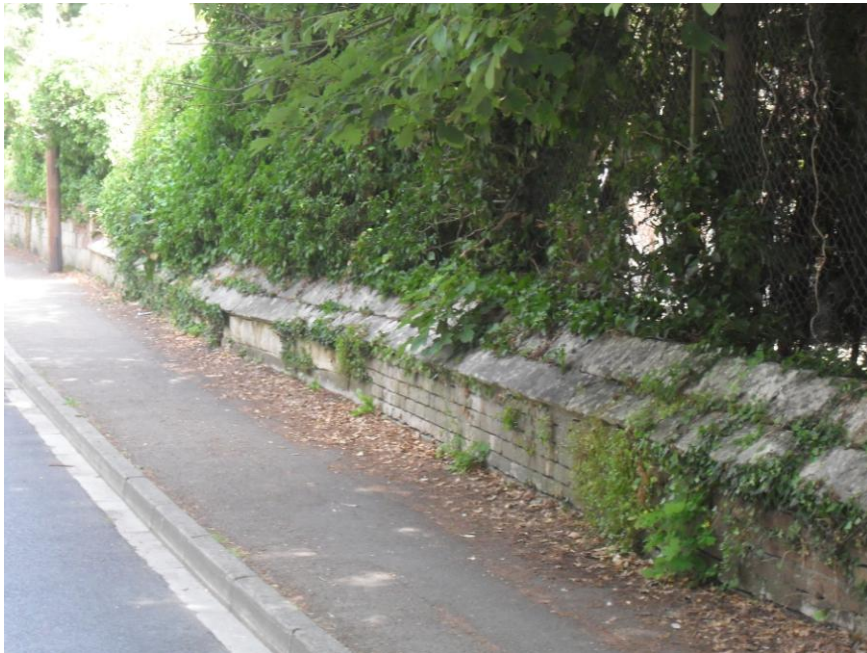
**Boundary Wall to Street Frontage to South West & South of Selwyn School,
Matson Lane**

The wall was probably constructed in the late 18C as the front garden wall to Matson House. Approx 200m in length, the northern half is about 1.3m in height and the southern half about 0.75m high. Dressed stone in courses (some stretches patched in brick), probably reused, with stone coping in two courses.

A significant amount of spalling has taken place to the stonework and there is a problem with unmaintained vegetation, in particular ivy. The wall is classed as 'Vulnerable'. The City Council will work with the owners to get the wall repaired.

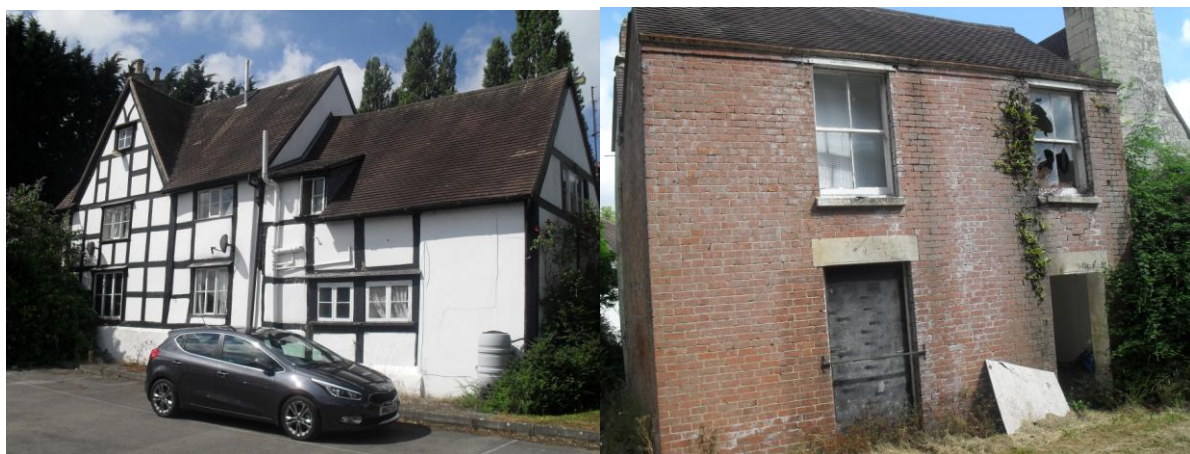
Gloucester Country Club (former Larkham Farmhouse), Matson Lane

Former farmhouse c1600, with substantial brick extension dated 1866. Original building consists of a timber framed range with a stone wing, tiled roof and stone stacks. Converted into bedroom accommodation for a country club in 1974 and more recently used for staff.

The property has been empty for two years and is showing signs of neglect, particularly around the Victorian extension, in the form of unmaintained vegetation, broken and boarded up windows and a leaking downpipe. There have been a few break-ins but not much internal damage to date.

The building is classed as 'Vulnerable'. There is an outstanding planning and listed building consent to convert the property and the associated former barns into residential use. The City Council will work with the owners to get the property more secure & weathertight and ultimately to get the building back into use.

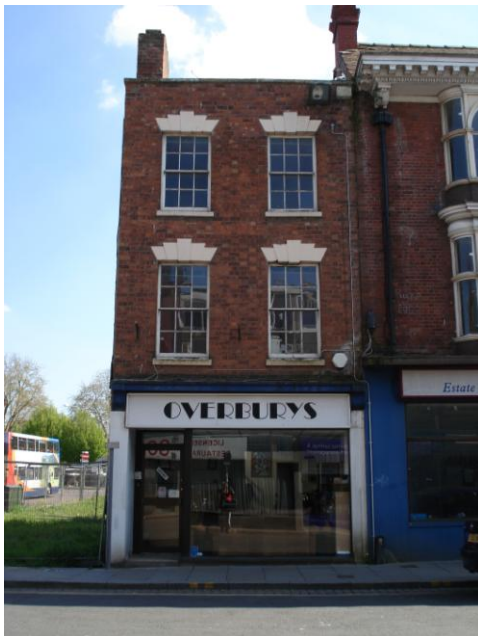
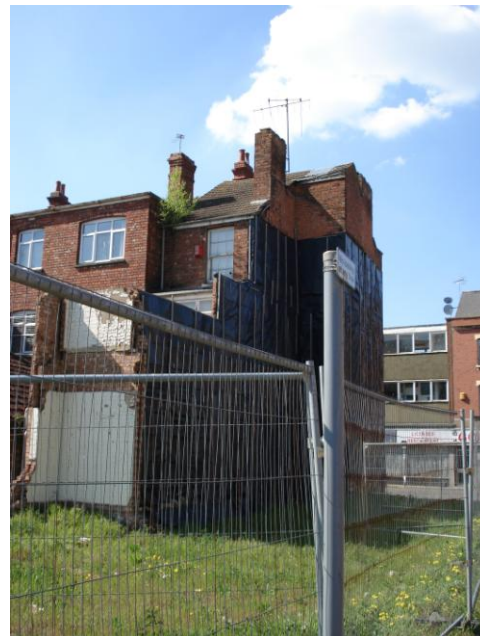
102 Northgate St.

Shop and former dwelling. Early 19C with 20C alterations. Brick with stone details, slate roof & brick stack.

Adjoining property (No 104) was demolished in 2007. Plastic sheeting held down with battens was fixed to the east facing gable wall to No 102 as a temporary protection measure. There is planning consent to re-develop 104 but due to complications this has not been implemented.

Inevitably, due to the length of time the temporary cover has been in place on this 9” wall, there have been problems with damp ingress into the property. There are also some structural problems at the rear. Property therefore falls within the ‘Vulnerable’ Category.

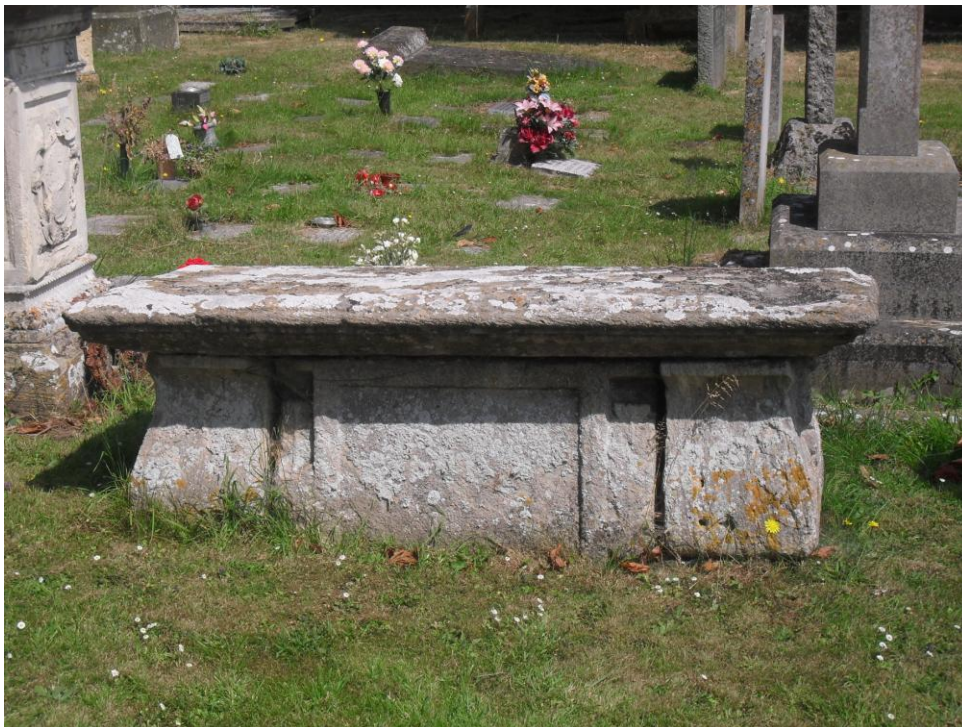
Chest tomb approx. 1.5m south east of Church of St Swithun, St Swithun's Rd.

A mid C17 tomb located to the south-east of the church. It is the eastern most tomb in a group of three.

The base of the tomb has subsided. The vertical joints between the stones of the chest have opened up and the slab has tilted. The tomb has been on the City Councils BAR Register as 'One to Watch' since 2005 and remains 'Vulnerable'.

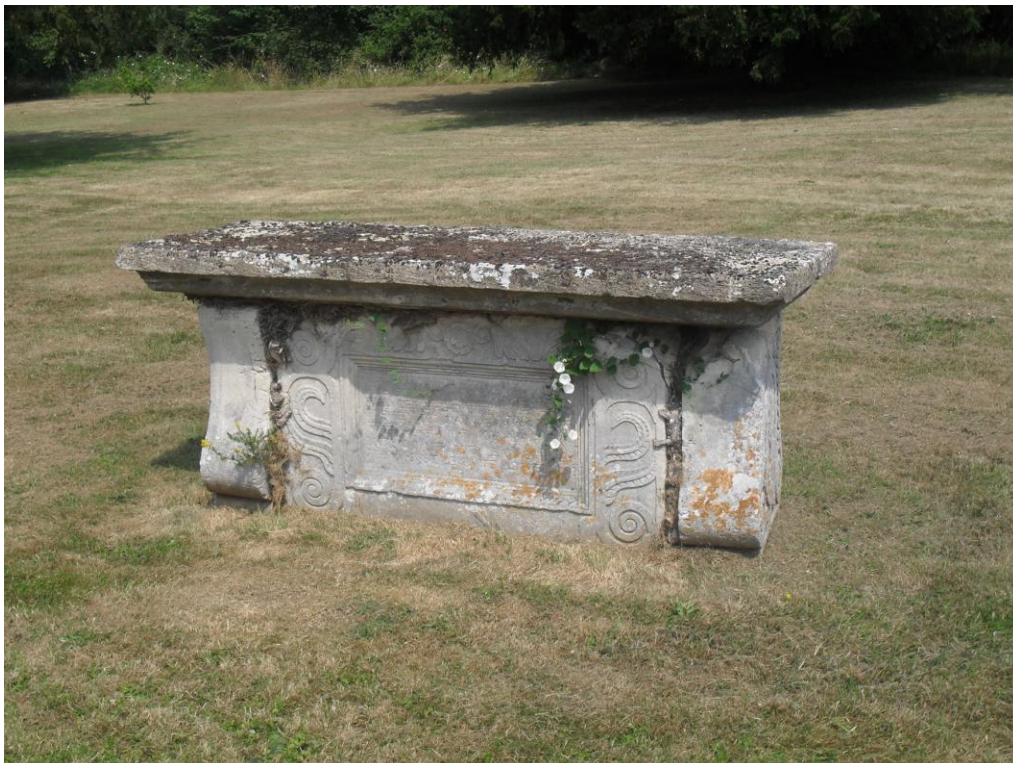
Gennings Monument in the Churchyard approx. 4 metres North of Vestry to Church of St James, School Lane

Late 17C limestone chest tomb.

There is a problem with ivy getting established in the gaps between the stone slabs. There are some splits in the stone and one end is breaking away.

The structure has therefore been classed as ‘Vulnerable’.

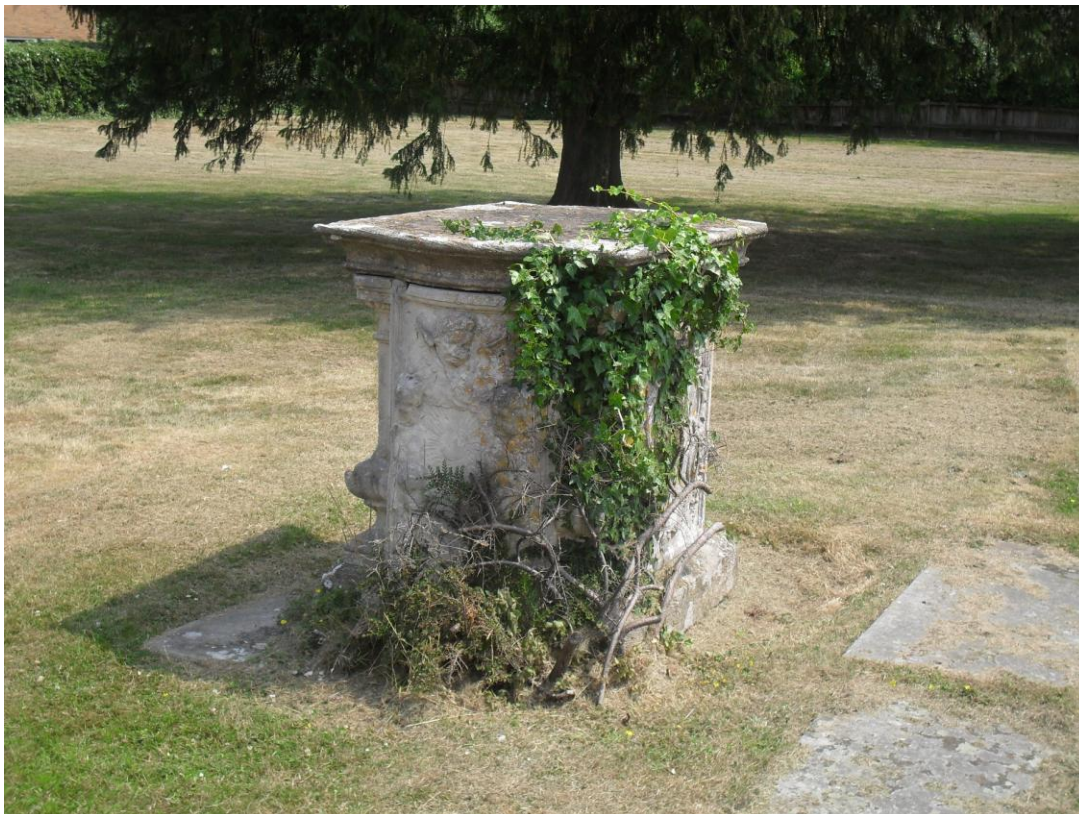
Minchin Monument in the Churchyard approx. 5 metres North of Wells Monument to East of Church of St James, School Lane

A limestone pedestal tomb dating from 1756. Tall and rectangular, with bow ends and gadrooned corner balusters.

There is a considerable amount of vegetation, including ivy, growing up the side of the tomb, which needs to be carefully removed. The structure is classed as 'Vulnerable'.

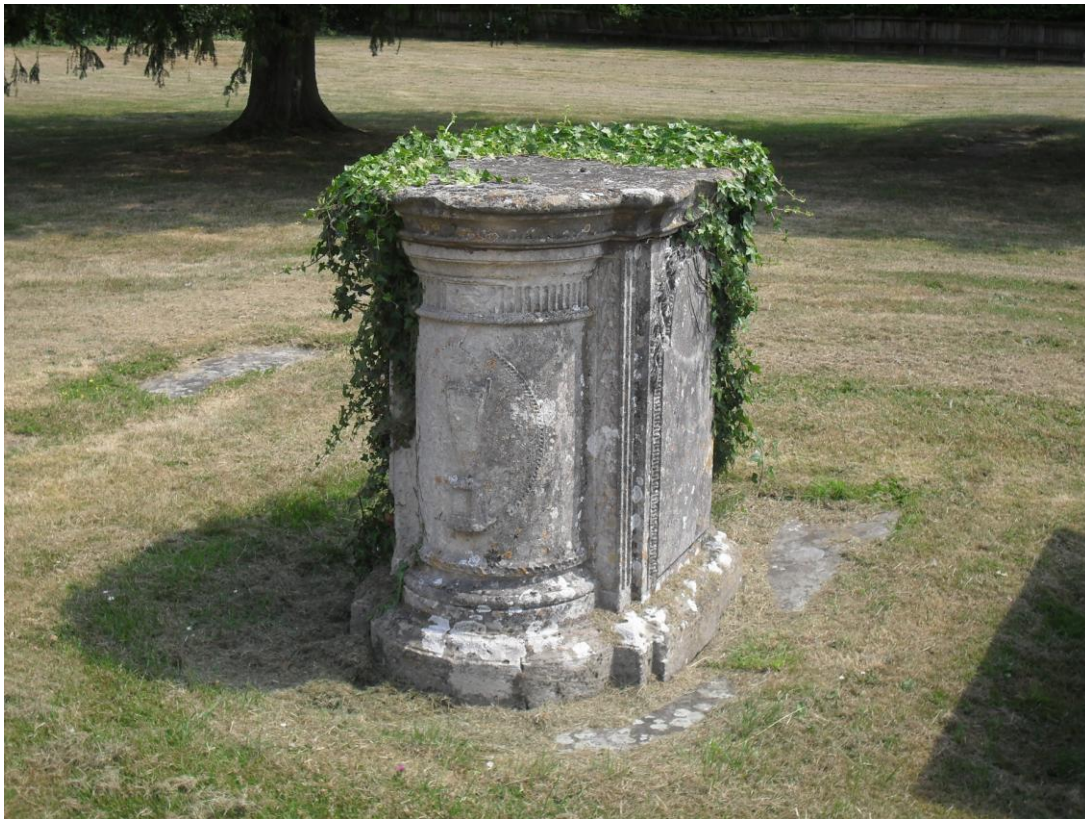
Unidentified Monument in the Churchyard approx. 3 metres North Of Wells Monument to East of Church of St James

A late C18 limestone pedestal tomb.

There is a considerable amount of vegetation (mainly ivy) growing over the tomb, which needs to be carefully removed before it causes further damage.

The structure is classed as 'Vulnerable'.

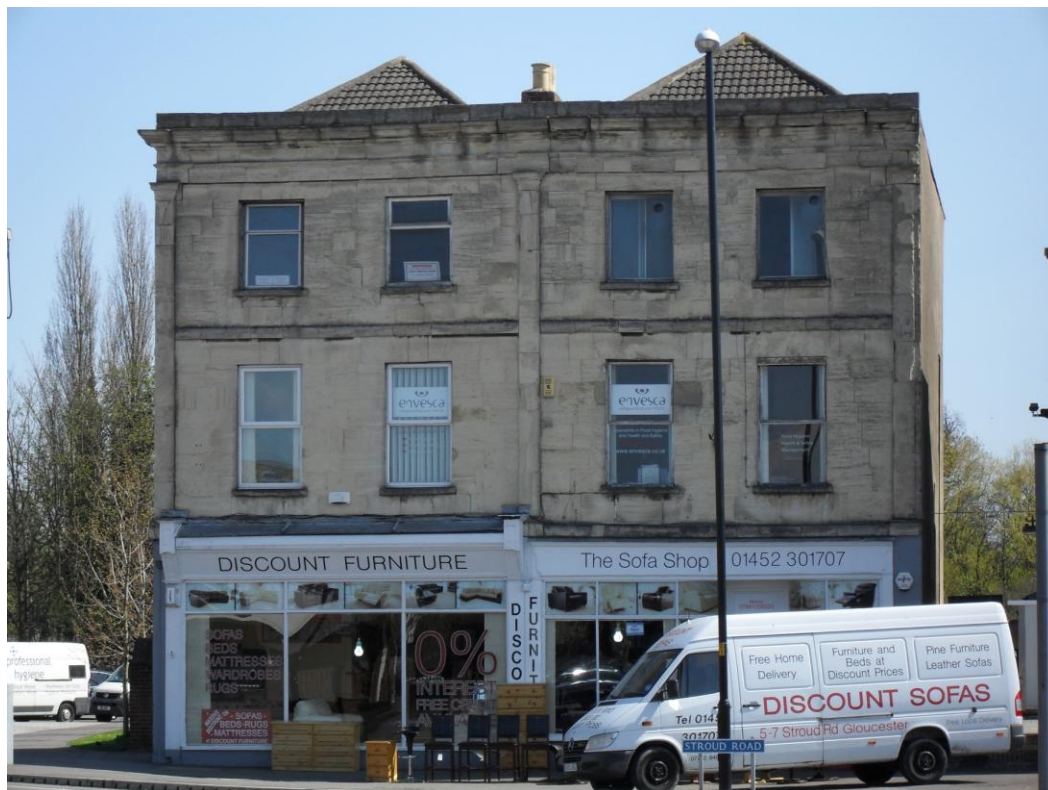
5 & 7 Stroud Rd.

Pair of semi-detached houses; from later C19 a pair of shops and dwellings. Early C19 and C20 alterations. Ashlar facing on brick, slate roofs, brick stack on party wall. 3 storeys.

The building has been on the City Council's BAR Register as 'One to Watch' since 2005. Continuing lack of maintenance, in particular the need to re-point the stone to the parapet, decorate/replace windows and re-point the rear brick wall, plus the fact that the upper floors remain vacant, means that the building should remain on the register as 'Vulnerable'.

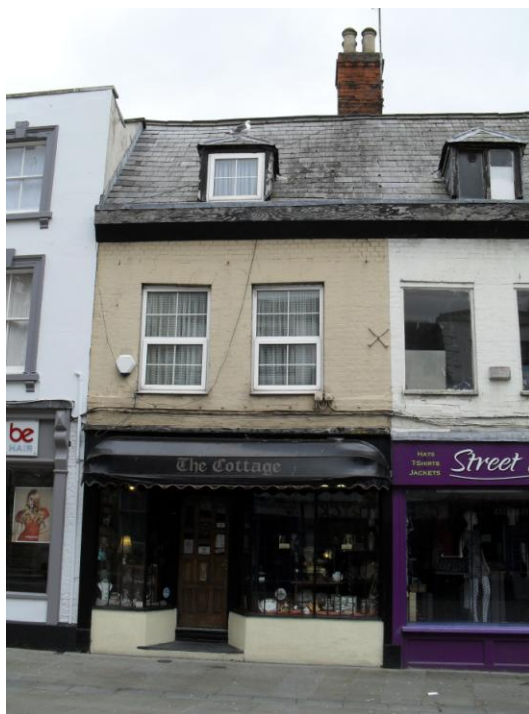
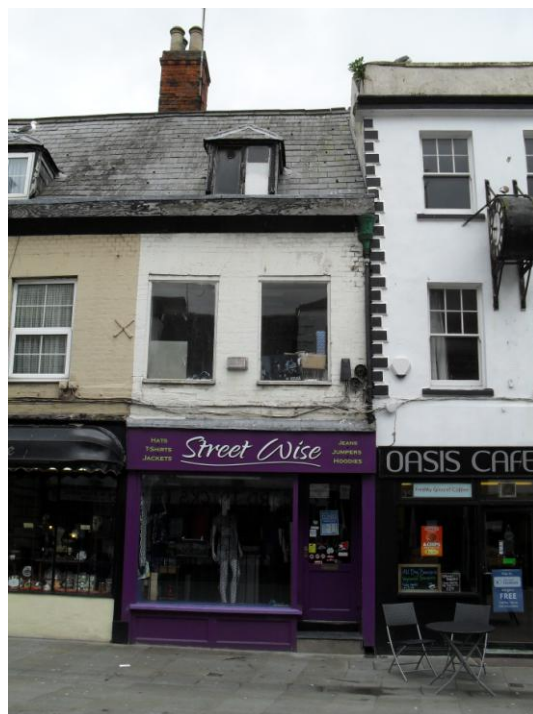
55 & 57 Southgate St.

A pair of shops and former dwellings. Early 18C with later alterations. White painted brick and slate roof with hipped roof dormer above each unit.

No 57 has been on the City Council's BAR Register as a 'Building to be watched' since 2005. Given its condition it is felt that No 55 should join it in the new 'Vulnerable' category.

No 57 has been identified as a Priority Project in the Southgate St. Townscape Heritage Initiative, whilst No 55 is on the reserve list. The City Council will work with the owners to get the necessary repairs carried out.

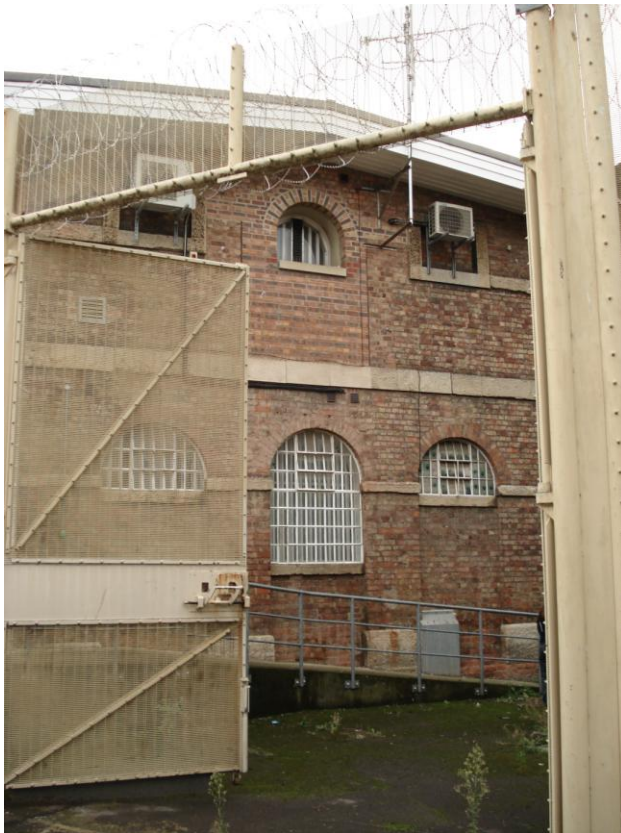
Cell Block (formerly the Debtors Prison) at former HM Prison, The Quay

This much altered building was originally constructed as a Debtors Prison in 1826. At some point a third storey was removed & a modern low pitched composite roof added. The walls are brick with stone detailing. The building is part of a larger prison complex surrounded by a high perimeter wall.

The prison closed in March 2013 and the building is currently vacant. It is already showing signs of neglect in the form of blocked/leaking rainwater goods, vegetation on walls, broken windows and pigeons inside the property. As a result it has been classed as 'Vulnerable'. It is understood that the whole site will be marketed shortly as a redevelopment project.

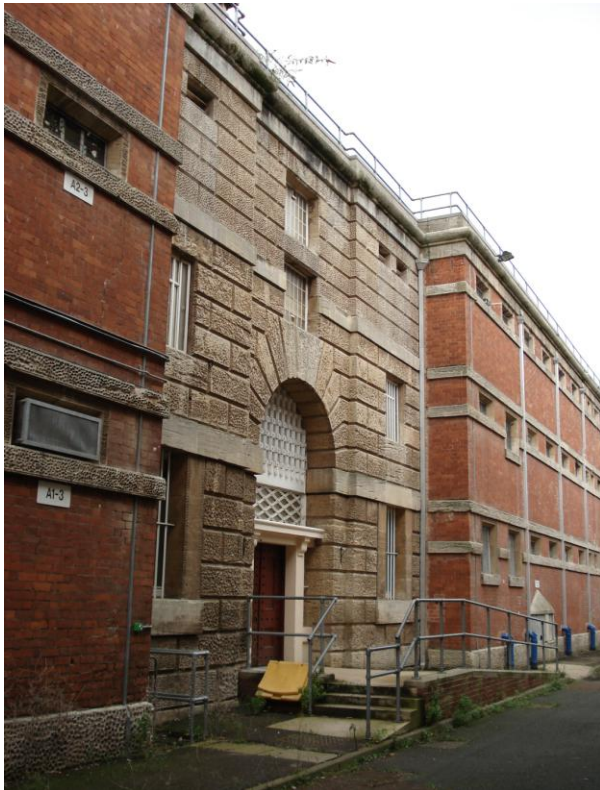
Central Block to former HM Prison, The Quay

This original prison building was begun in 1784 and finished c1810. It was altered & enlarged twice in the 19C, with a few minor changes in the 20C. It consists of a long east facing range, with a slightly recessed entrance block and a chapel wing to the rear. The entrance is constructed in stone (mainly rusticated), whilst the two side wings are brick with stone detailing. The roof is natural slate. The building is part of a larger prison complex surrounded by a high perimeter wall.

The prison closed in March 2013 and the building is currently vacant. It is already showing signs of neglect in the form of blocked/leaking rainwater goods, vegetation on walls, broken windows and pigeons inside the property. As a result it has been classed as 'Vulnerable'. It is understood that the whole site will be marketed shortly as a redevelopment project.

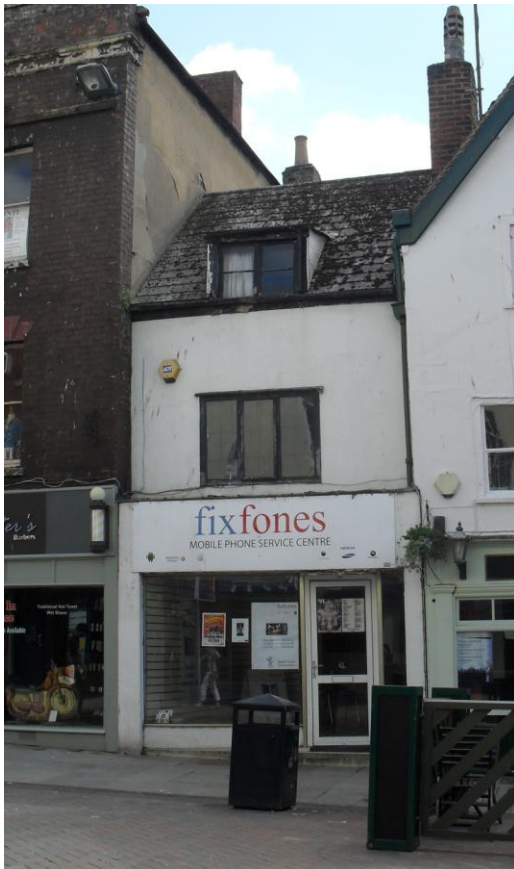
41 Westgate St.

C16 timber framed building with 20C alterations & extension to rear. Rendered to front with bituminous slate roof. Last used as a shop but currently vacant.

The property is showing signs of neglect and is considered to be 'Vulnerable'.
