Proposed Development  
Snow Capel  
Matson  
Gloucester  
Gloucestershire  
GL4 6EQ

## GEO TECHNICAL AND PHASE II CONTAMINATION REPORT

REPORT NO. 1826, August 2017

Proposed Development  
Geotechnical and Phase II Contamination Report  
Snow Capel  
Matson  
Gloucester  
Gloucestershire  
GL4 6EQ

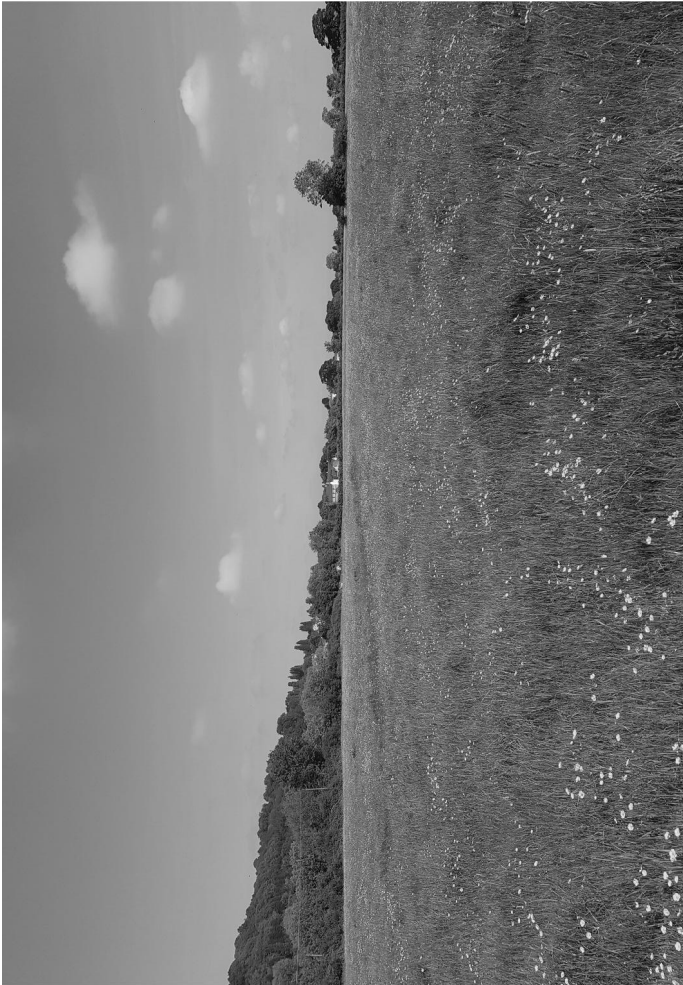
View from S boundary looking N at western half of site.

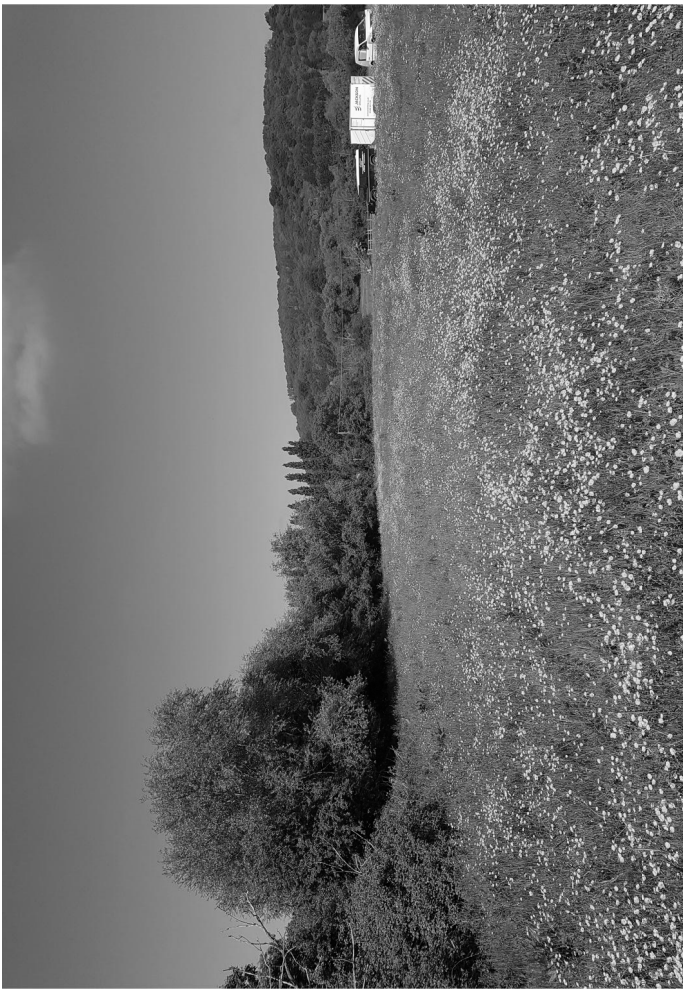
View from SE corner looking W along S boundary.

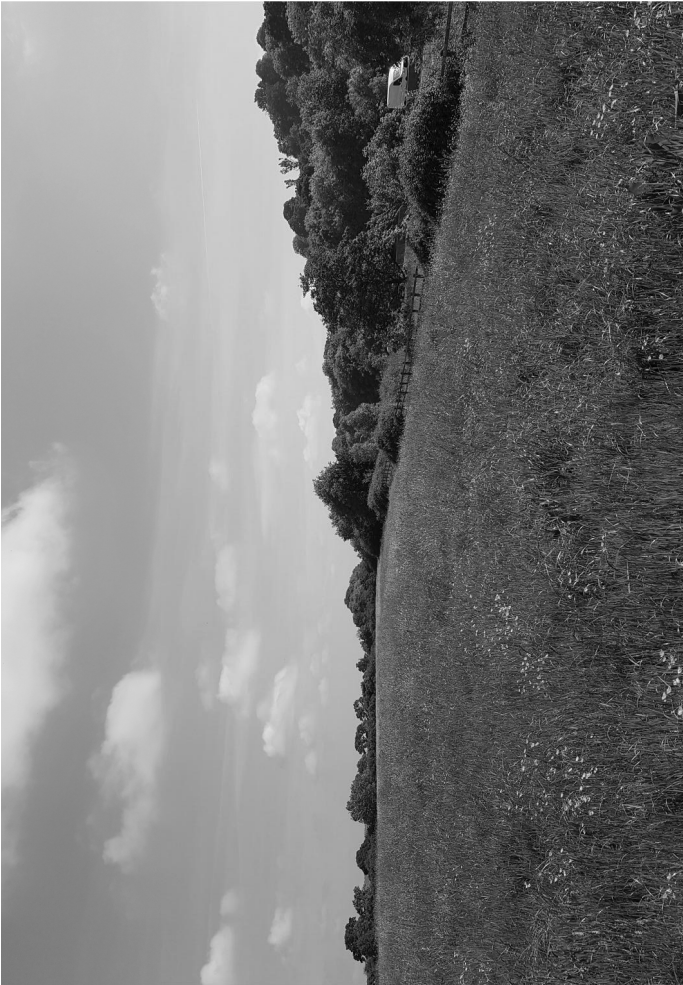
View from SE on raised area looking NE showing slope down to M5 motorway beyond E boundary.

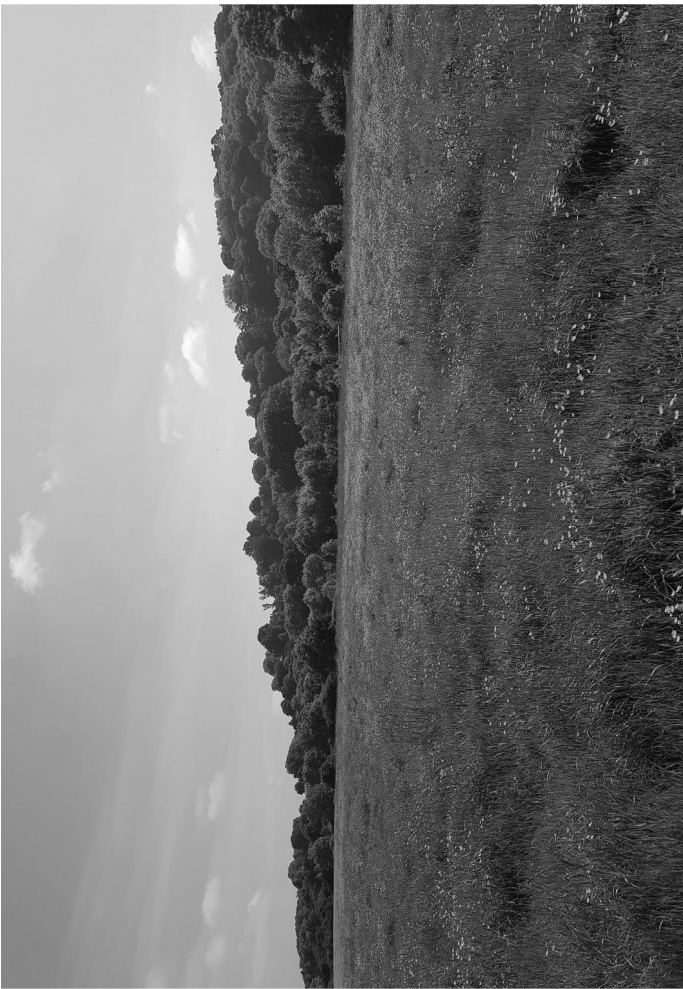
View from S boundary looking E at eastern half of site.

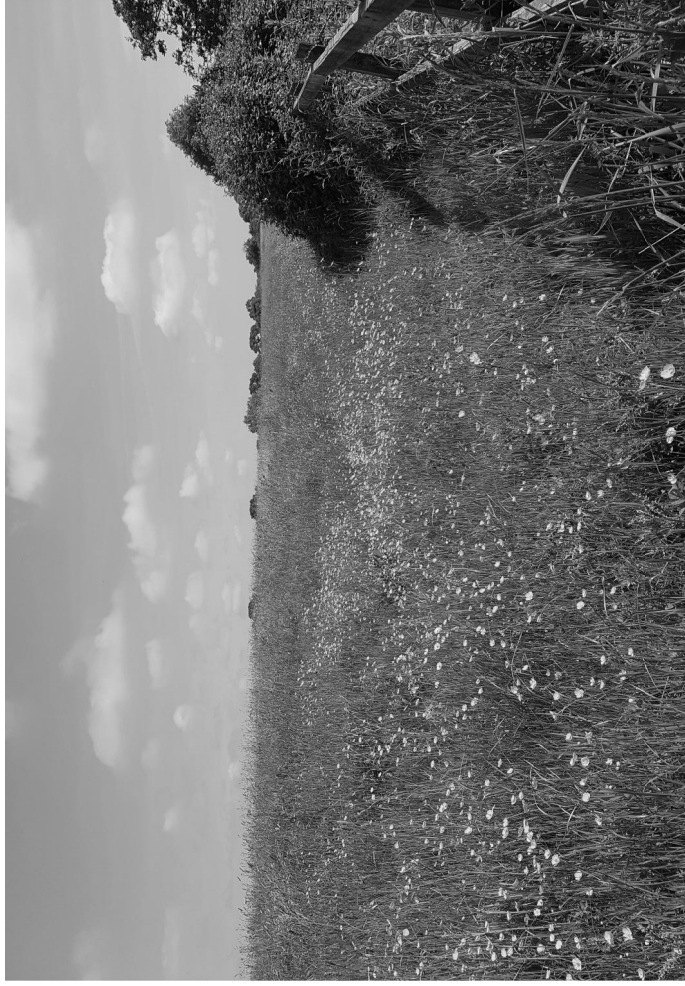
View from SE corner looking NE along E boundary showing raised bank.

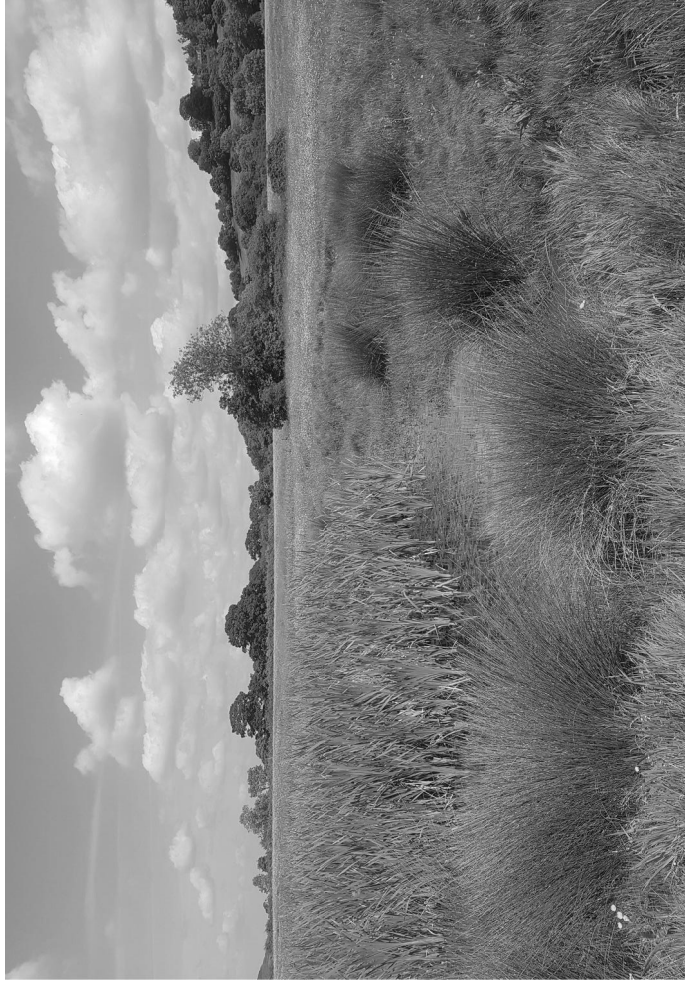
View from SW corner of fenced moat looking E showing standing water.

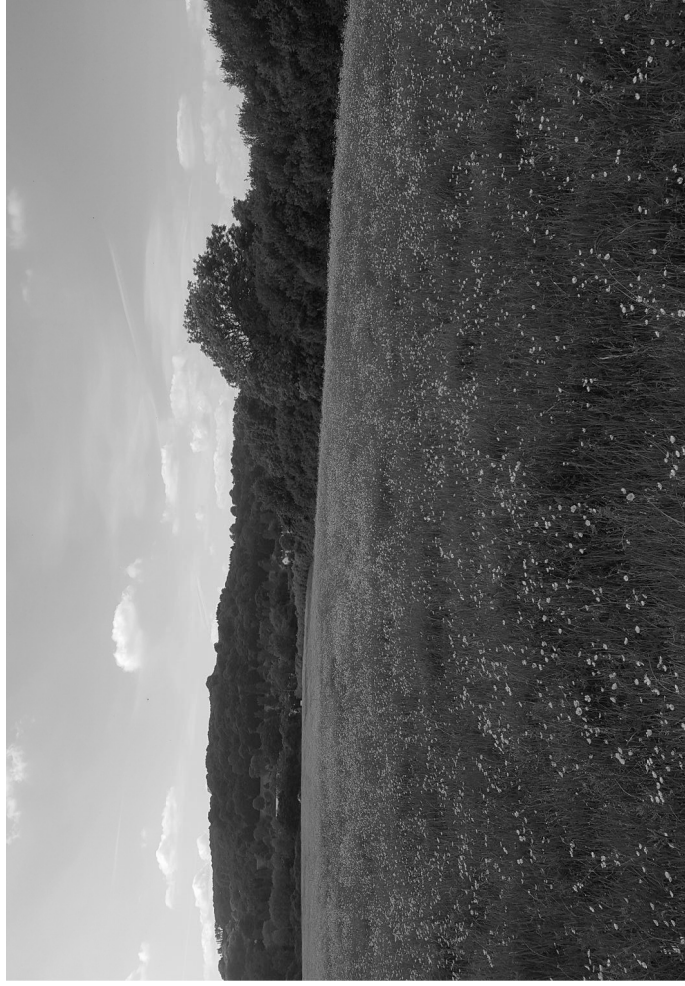
View from NE corner looking NW along N boundary.

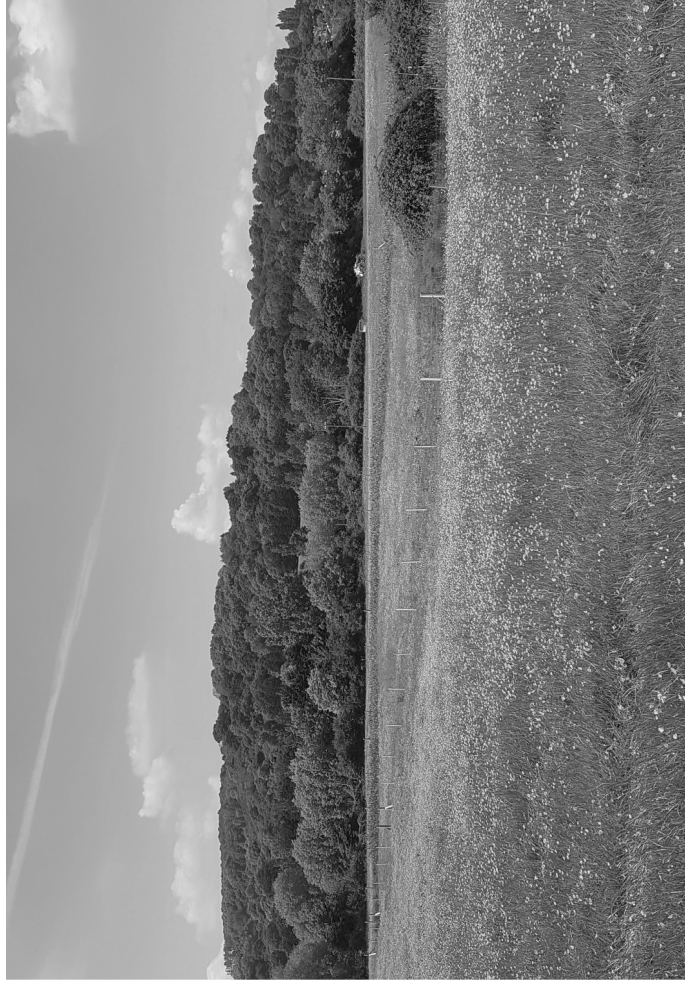
View looking NW showing small slope down to moat.

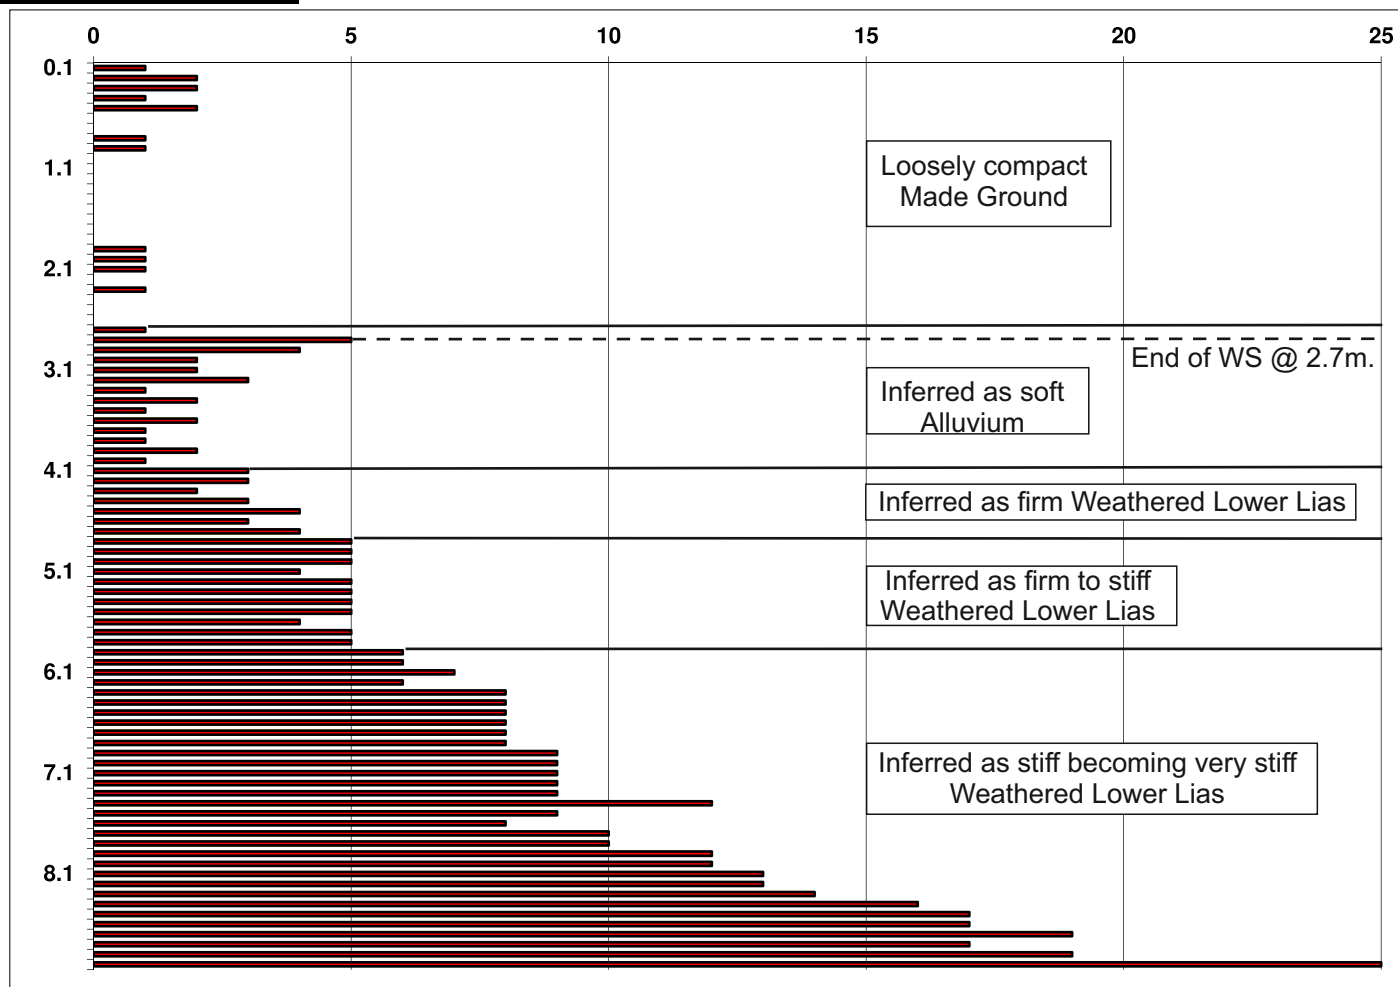
# Super Heavy Dynamic Probe Records

Depth (m)	Blow Count	Depth (m)	Blow Count	Depth (m)	Blow Count	Depth (m)	Blow Count
0.1	1	2.6	0	5.1	4	7.6	8
0.2	2	2.7	1	5.2	5	7.7	10
0.3	2	2.8	5	5.3	5	7.8	10
0.4	1	2.9	4	5.4	5	7.9	12
0.5	2	3	2	5.5	5	8	12
0.6	0	3.1	2	5.6	4	8.1	13
0.7	0	3.2	3	5.7	5	8.2	13
0.8	1	3.3	1	5.8	5	8.3	14
0.9	1	3.4	2	5.9	6	8.4	16
1	0	3.5	1	6	6	8.5	17
1.1	0	3.6	2	6.1	7	8.6	17
1.2	0	3.7	1	6.2	6	8.7	19
1.3	0	3.8	1	6.3	8	8.8	17
1.4	0	3.9	2	6.4	8	8.9	19
1.5	0	4	1	6.5	8	9	25
1.6	0	4.1	3	6.6	8	9.1	
1.7	0	4.2	3	6.7	8	9.2	
1.8	0	4.3	2	6.8	8	9.3	
1.9	1	4.4	3	6.9	9	9.4	
2	1	4.5	4	7	9	9.5	
2.1	1	4.6	3	7.1	9	9.6	
2.2	0	4.7	4	7.2	9	9.7	
2.3	1	4.8	5	7.3	9	9.8	
2.4	0	4.9	5	7.4	12	9.9	
2.5	0	5	5	7.5	9	10

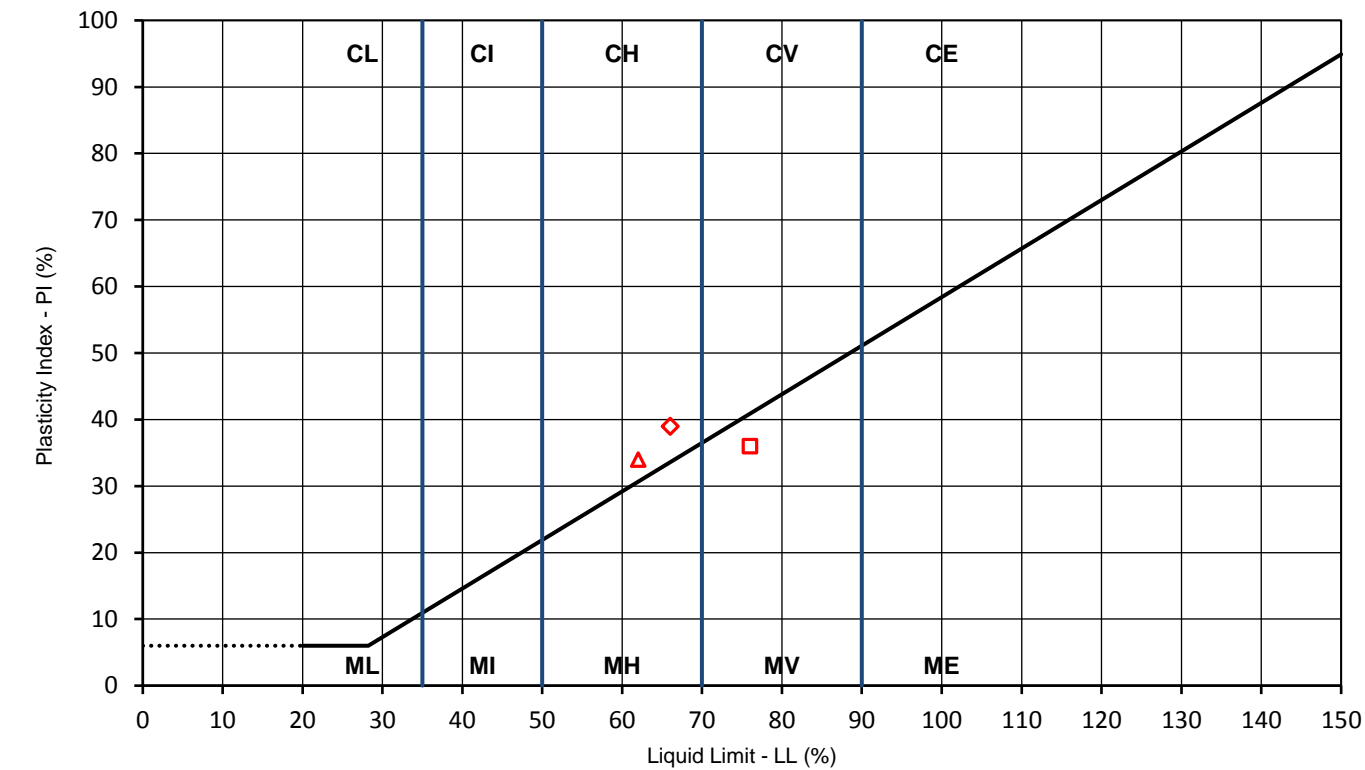
BH/TP No.		depth (m)	LL	PL	PI	remarks
□	WS3	2.50	76	40	36	
◇	WS4	3.50	66	27	39	
△	WS7	1.25	62	28	34
