Environmental Statement, Non-Technical Summary

Land East of Winnycroft Lane, Snow Capel, Matson, Gloucester

Prepared by Black Box Planning on behalf of *Bromford Housing*

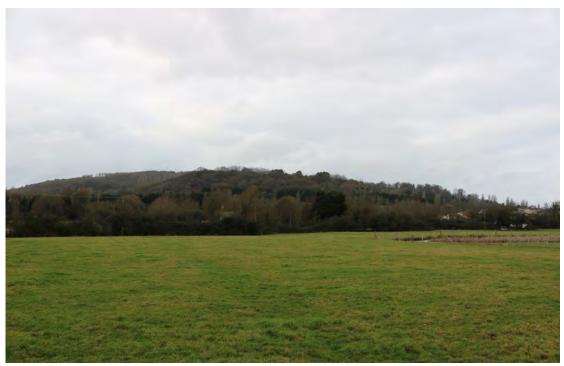
Image EDP A2.1: Improved grassland dominates the Application Site.

- A2.8 The Application Site is dominated by improved grassland heavily grazed by cattle and as such is characterised by a relatively short sward (approximately 10cm height) as shown in Image EDP A2.1. A grassland community characterised by false oat-grass (Arrhenatherum elatius), cock's foot (Dactylis golmerata), perennial rye-grass (Lolium perenne), white buttercup clover (Trifolium repens) and creeping (Ranunculus repens), with occasional scattered occurrences of creeping thistle (Cirsium arvense), daisy (Bellis perenne), broad-leaved dock (Rumex obtusifolius) and rarely bristly oxtongue (Helminthoides echioides).
- A2.9 The field's margins have been heavily poached by cattle and thus are of limited diversity. Given its low botanical diversity and limited structure, improved grassland which dominates the Application Site is considered to be of **Site** Importance.

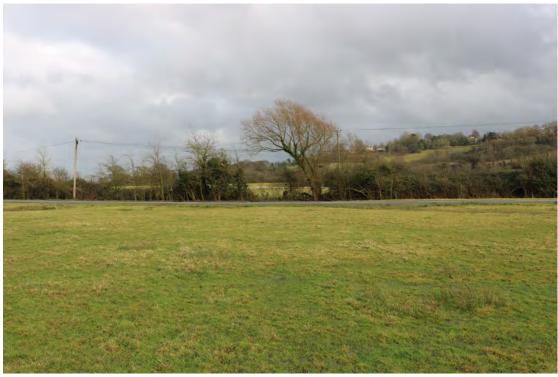
Image EDP A2.2: View of H1 looking east from offsite.

A2.11 The western boundary is delineated by a native species-poor, relatively unmanaged hedgerow (**H1**) approximately 3m high and 2m wide as shown in **Image EDP A2.2**. The hedgerow is dominated by hawthorn and blackthorn (*Prunus spinosa*). Bramble is abundant whilst immature willow (*Salix* sp.) and elder (*Sambruca nigra*) are also present. Ground flora is typically limited and characterised by scattered patches of common nettle (*Urticia dioica*) and common cleaver (*Galium* aparine), likely further reduced due to poaching and browsing by livestock. Indeed, the northernmost sections of this hedgerow largely comprise semi-mature ash and willow. **H1** has further been subject to minimal management works, including the coppicing of semi-mature trees. Log and brash piles were, therefore, frequently recorded at the base of this hedgerow.

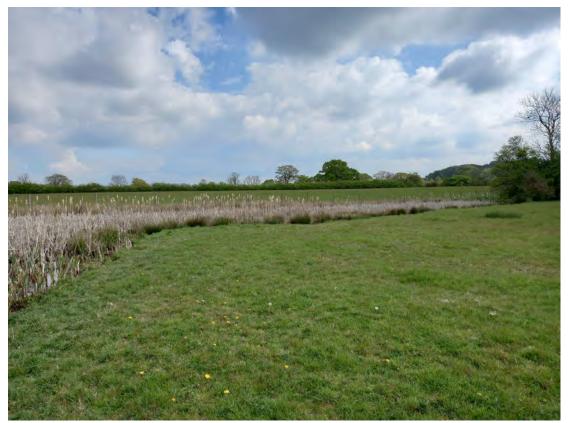
Image EDP A2.3: Onsite moat (P5).

A2.15 A large waterbody comprising a former moat (**P5**) is located within the centre of the field and enclosed within stock-proof fencing. The moat supports shallow, grassy banks, albeit with dense bramble and hawthorn scrub encroaching its eastern corner. Bulrush (*Typha* sp.) dominates the centre of this feature, with hard rush (*Juncus effusus*) present along the bankside as shown in **Image EDP A2.3**. Submerged species include brooklime (*Veronica beccabunga*), water forget-me-not (*Myosotis scorpioides*), floating sweet-grass (*Glyceria fluitans*), fool's water cress (*Apium nodiflorum*) and water starwort (*Callitriche stagnalis*).

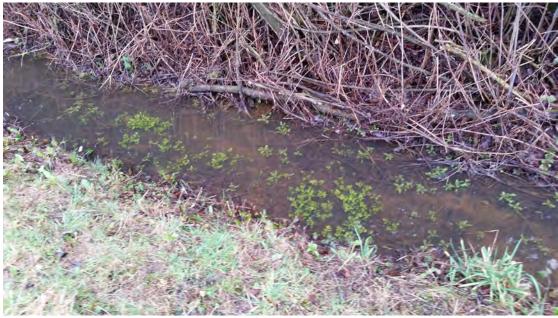
Image EDP A2.4: Wet ditch along part of western boundary.

A2.18 A wet ditch is present along the southern half of the Application Site's western boundary adjacent to hedgerow **H1**, connecting to ditches offsite to the south. The watercourse is subject to bankside cutting. The ditch itself comprises a relatively shallow, narrow watercourse with moderate flow and a channel substrate dominated by gravel with occasional leaf litter as shown in **Image EDP A2.4**. The ditch is otherwise heavily shaded by overhanging hedgerow trees adjacent, with aquatic flora limited to occasional occurrences of fool's water-cress. Given its managed nature combined with a limited macrophyte assemblage and flow diversity, this feature is considered to be of **Site** importance.

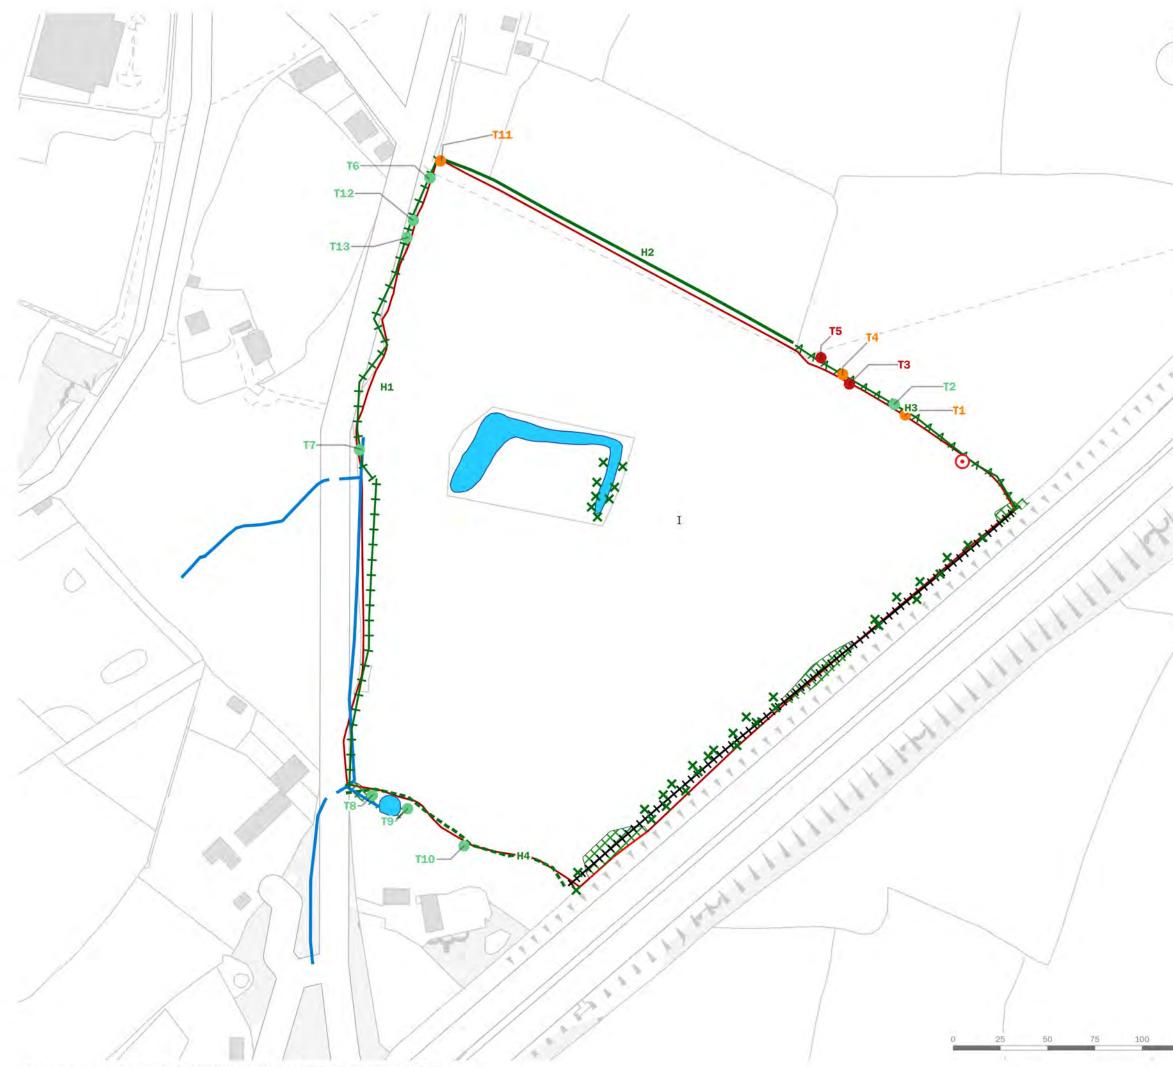
Site Boundary
****	Dense Continuous Scrub
I	Improved Grassland
	Standing Water
~ ~ ~ ~	Intact Species-rich Hedgerow
	Intact Species-poor Hedgerow and Trees
	Intact Species-poor Hedgerow
	Defunct Species-poor Hedgerow
	Running Water
•••••	Fence
×	Scattered Scrub
O	Target Note
Trees with Ba	at RoostPotential
•	Hìgh
•	Moderate
•	Low
client	
Bromford H	lousing
project title Land East of Matson	of Winneycroft Lane, Snow Caple
drawing title	
Plan EDP 1	: Phase 1 Habitat Plan
	12 MAY 2022 drawn by V

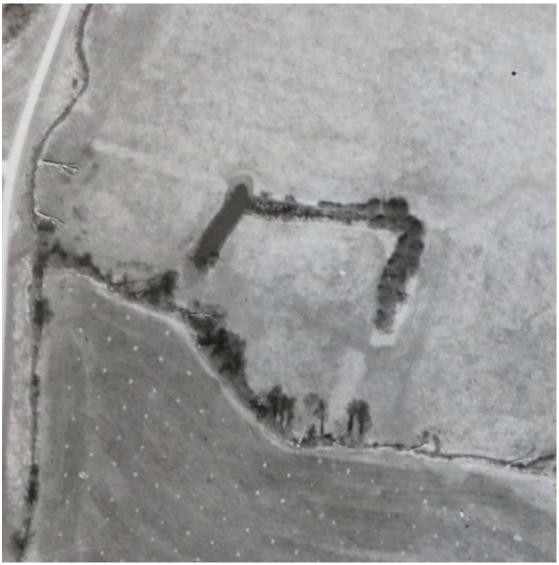
Figure EDP 1: Extract from aerial photograph taken 15 April 1955 (RAF/82/1152) showing a close up of the moated site.

- 4.76 Later aerial photographs do not illustrate archaeological earthwork features quite so clearly. An image from 1955 (An extract is at **Figure EDP 1**) shows well the water bodies associated with the moat. The northern part (which is extant) is slightly larger than at present with an extended part at its north-west corner. It may be that originally the moat was at this width along its entire northern return but had since silted up and reduced in width. The southern part of the moat is represented by a widening of the field boundary ditch which runs into the former moat from the east. To the west, this wider ditch then remains broad until it meets the brook that runs along the western edge of the site. This difference in character between the ditch to the west and those to the east of the moated site may suggest that this western ditch could have been established at a different time and it may have been associated with the function of the original moat, draining its water to the west into the brook.

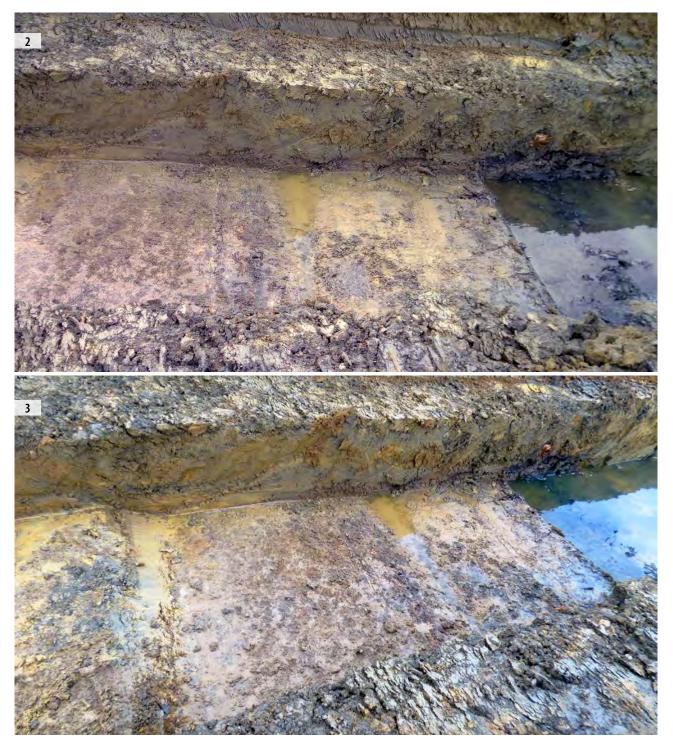
ILLUS 2-3 East facing section of Trench 1, area of boundary ditch

Geotechnical investigations undertaken in 2017, found evidence for made ground to approx. 2m below current ground level across most of the site, surrounding the moated enclosure. This appears to comprise construction phase material from the M5 excavation in the 1960's, overlying buried topsoil.

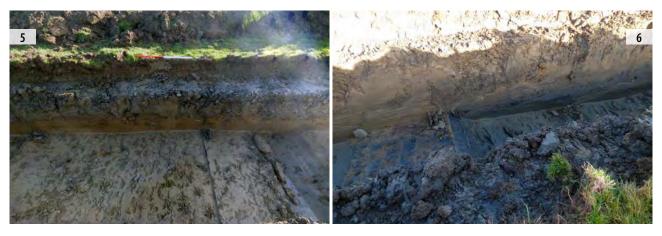
ILLUS 5 South-east facing section of Trench 2 ILLUS 6 South facing section of Trench 3

A layer of mid reddish brown silty clay topsoil was present across all three trenches, measuring 0.25m in Trench 1, 0.22m in Trench 2 and 0.20m in Trench 3.

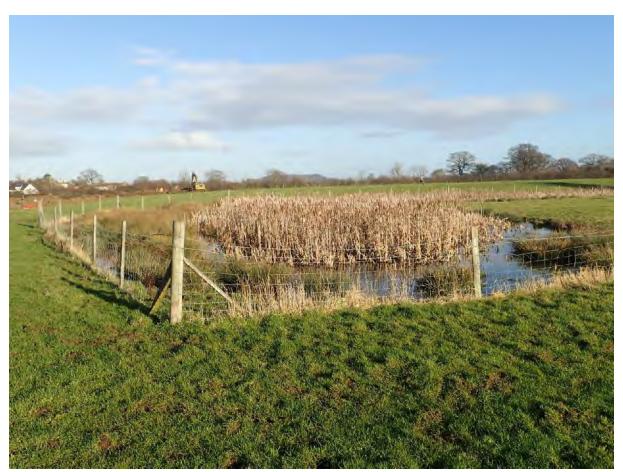
Image EDP 1: View to the north across the western end of the moat illustrating its setting including the presence of modern houses to the north-west.

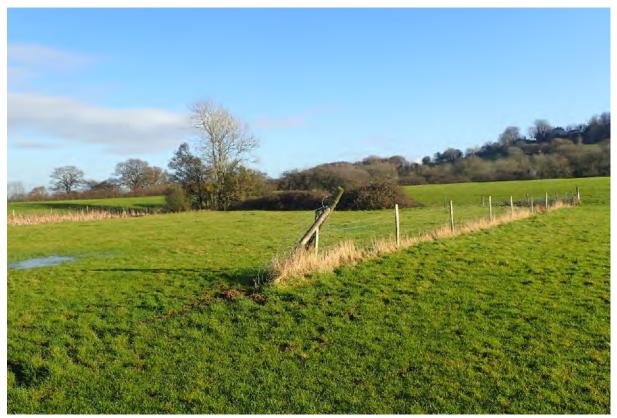
Image EDP 2: View to the north-east across the eastern end of the moat across the site illustrating the difference in ground level between the land at the moat and that to the east.

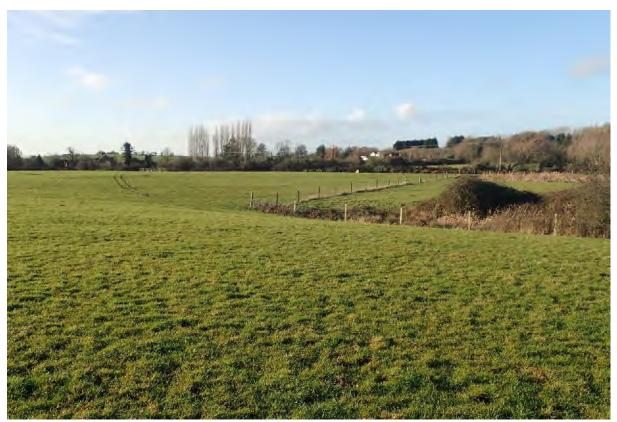
Image EDP 3: View south-west across the moat from the higher ground to the east illustrating how the moat is set within a gentle basin within the site and also its more 'rural' setting to the south.

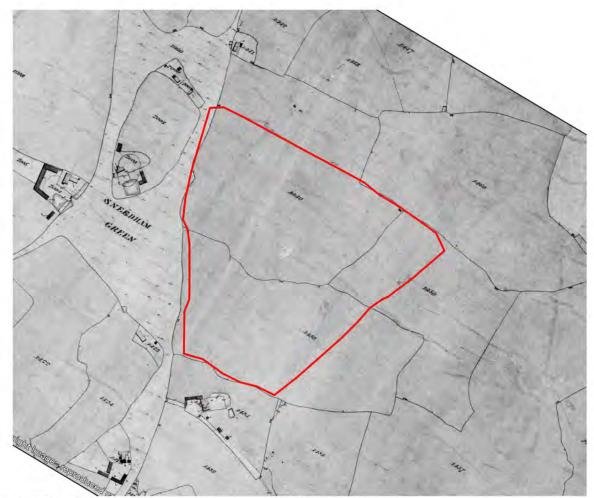
Extract from Tithe map of Upton St Leonard's parish (1840)

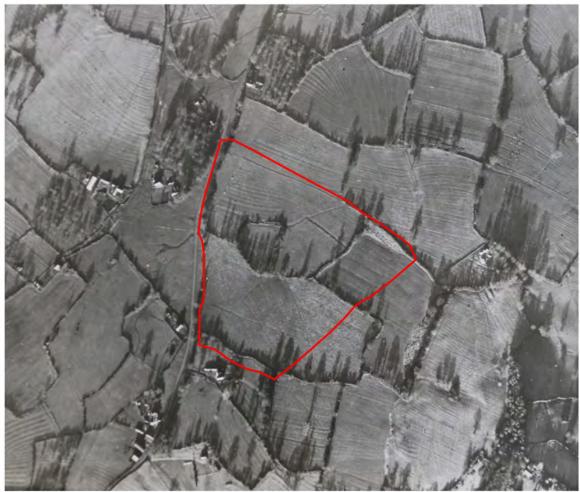
Extract from Aerial photograph taken 12 Dec 1946 (RAF/CPE/UK/1897)

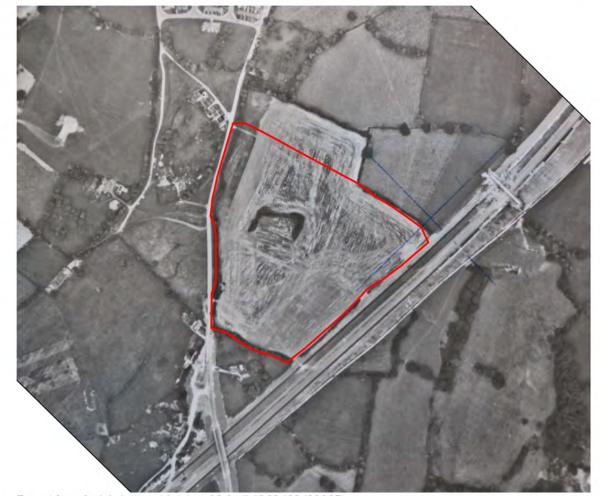
Extract from Aerial photograph taken 09 April 1969 (OS/69097)

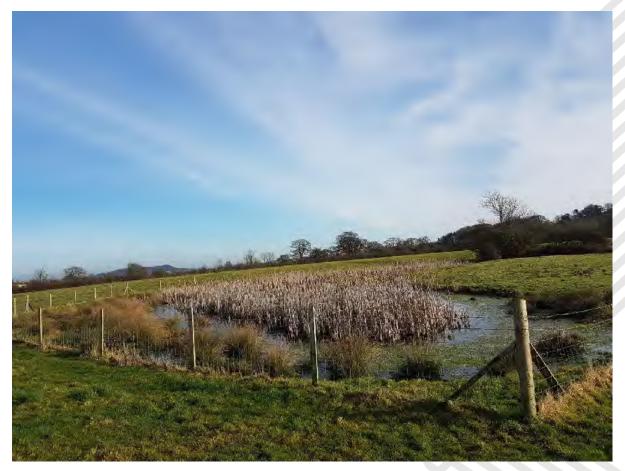
Figure 1 - Moated Site at Sneedham's Green

The moat remains lie within a 'bowl' in the landscape formed by placement of material from the construction of the adjacent M5 motorway, and its edges are overgrown with vegetation. Fluctuating water levels have, at times, flooded the surrounding area, and have resulted in a recent drainage ditch being cut west towards the lane-side ditch to alleviate this.

The site lies within the headwaters of the Sud Brook, a lower catchment tributary of the River Severn, which emerges close to the road at Snow Capel Farm, immediately southwest of the moat (Figure 1). This ditch flows northeast around the north (downgradient) side of the moat to join another tributary of the Sud Brook (NGR 385550 215300) before flowing north through Gloucester to join the Severn close to the intersection of the Severn with the Gloucester and Sharpness Canal.

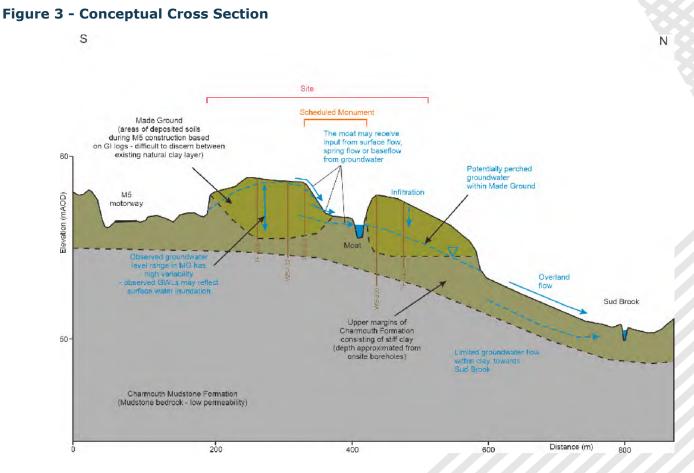
A preliminary conceptual model for the Moated Site and surrounding environment has been developed based on the information available, and is outlined in Figure 3, which has been constructed based upon the topography for the Moated Site and the site-specific data regarding depth of Made Ground and water levels.

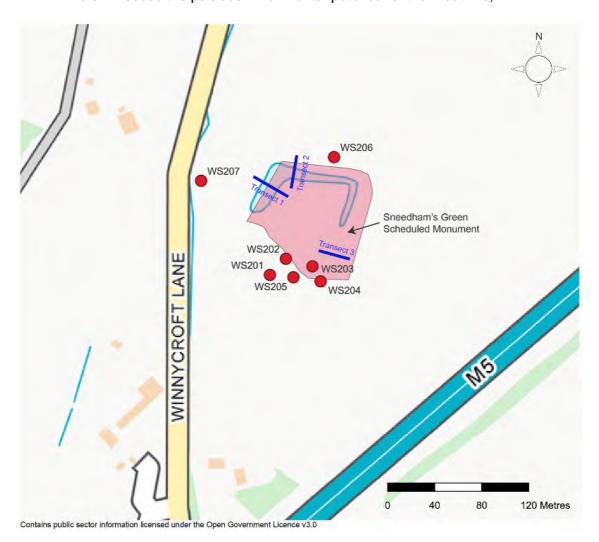
Figure 2. Proposed borehole transects plotted against locations of geotechnical boreholes
