Appendix B

Approved dismantling sequence and extents

# Hutton + Rostron Environmental Investigations Limited

Hutton + Rostron Environmental Investigations Limited carried out a site visit to Bakers Quay, Gloucester on 14 May 2020 in accordance with instructions from Adrian Goodall by email dated 13 May 2020 11:54 with attached Order Form. Drawings provided by the client were used for the identification of structures. For the purpose of orientation in this report, the entrance to the building was taken as facing east onto High Orchard Street

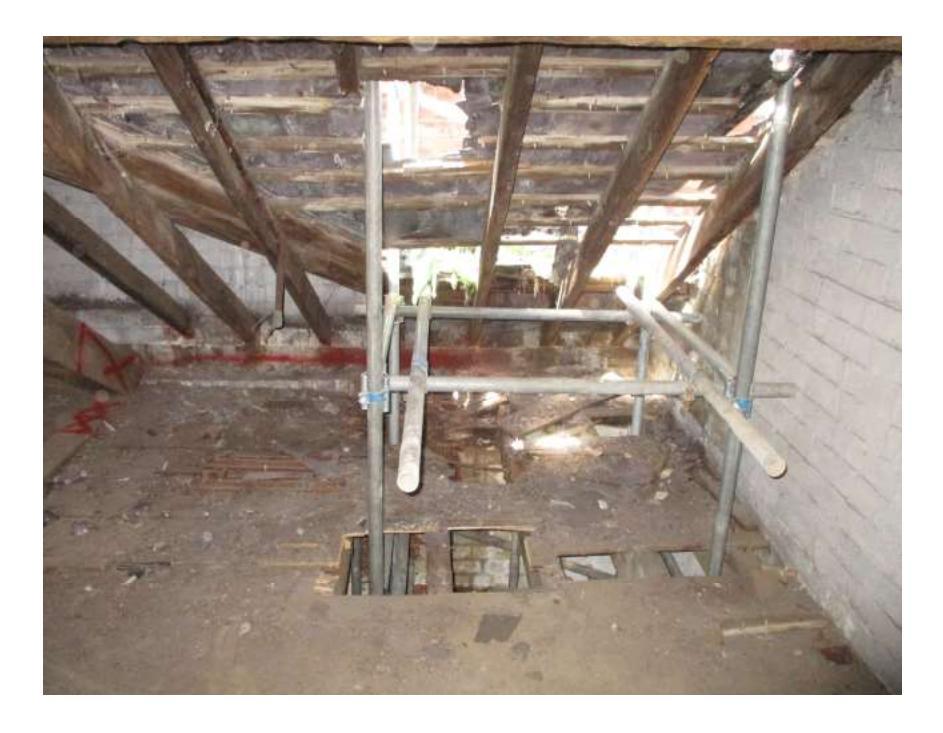
## Fig 9 :

Interior, roof; showing a view of the north-west corner. A large part of the timber roof structure was not in place which was allowing water into the structure which may be hastening timber decay in this area

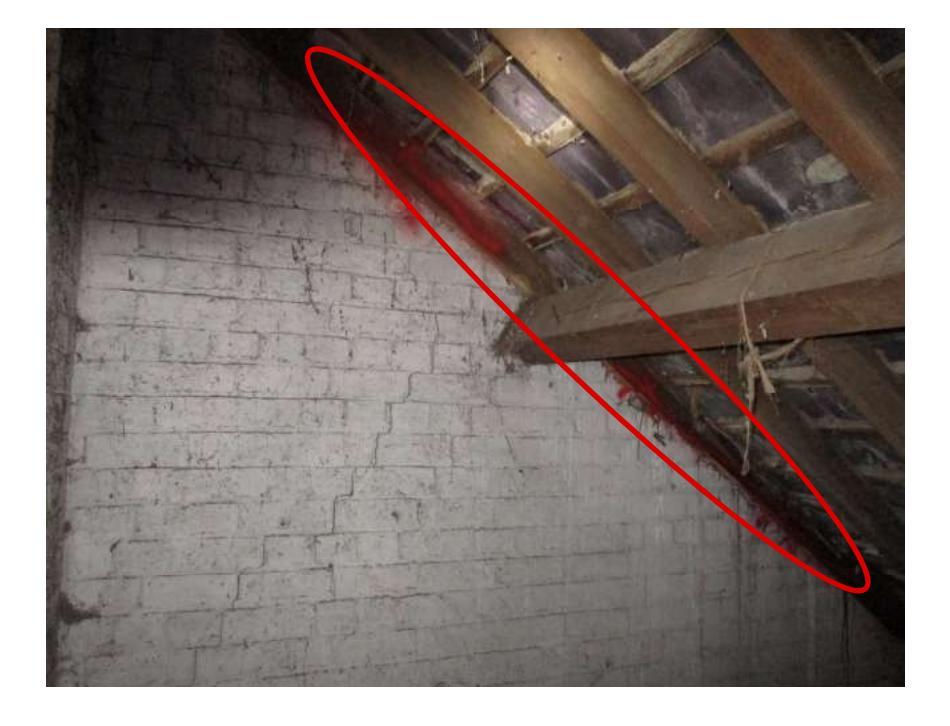
## Fig 11 :

- d) Structural decay to 1no. principal rafter foot and 1no. tie beam bearing end at the middle of the west pitch both for a length of approximately 500 mm each

Interior, roof; showing a view of structural decay to the principal rafter bearing end and tie beam bearing end at the middle of the west pitch

All decayed roof timbers should be replaced with new timber of suitable properties. This may be done by cutting back decay to rafter feet/beam ends to sound timber and partnering with new timber secured with coach bolts. It may be prudent to reinforce significant joints with steel plates. Where decay is seen at mid-sections, consideration should be given to replacing the full length of the timber with new. All new timbers should

be isolated from the masonry by way of an appropriate plastic damp-proof membrane, plastic packing pieces or hangers, ensuring there is an air-gap between the end grain and the masonry. All repairs should be under the direction of the Structural Engineer and/or Conservation Officer

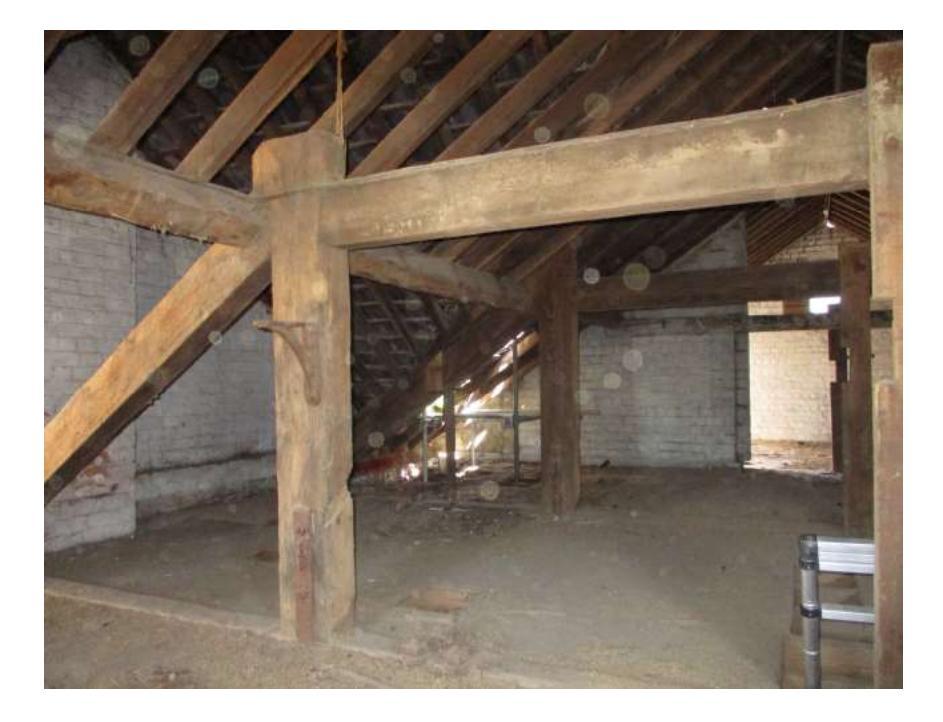
## Fig 14 :

- c) Structural decay to the mid-section of 1no. valley rafter for a length of approximately 300 mm and to 1no. purlin for a length of 300 mm at the southwest corner

Interior, roof; showing a view of structural decay to approximately 300mm of valley rafter and 300mm of purlin at their mid-sections

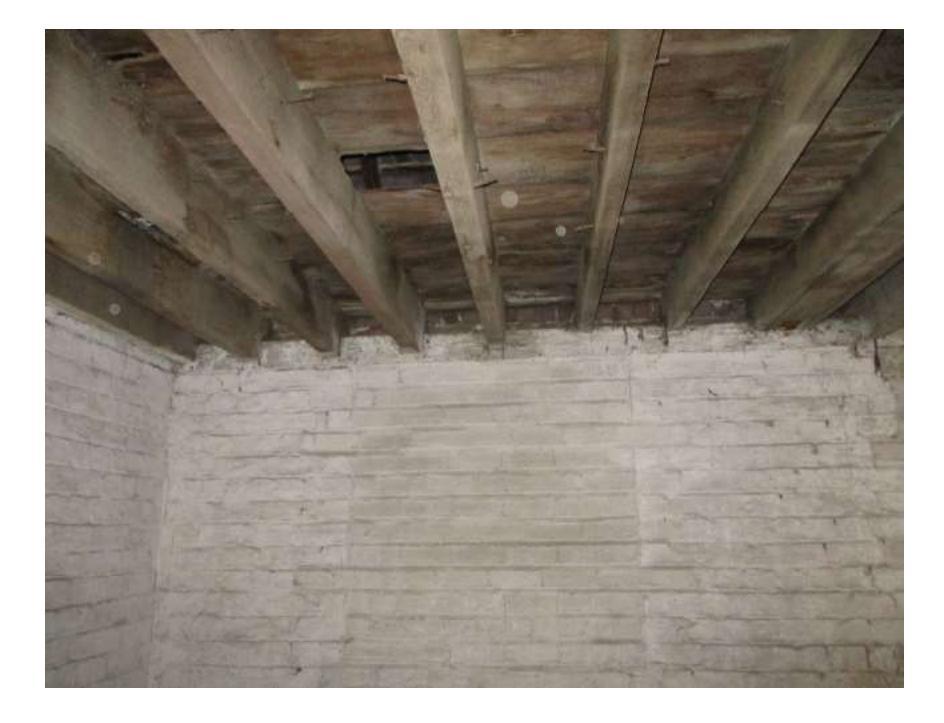
## Fig 17 :

Interior, third floor structure from below; showing a view of the floor structure towards the south-east corner. Joists and plate were found to be free from structural decay at the time of the survey. However, moisture contents were around 20 per cent leaving them vulnerable to decay in the future

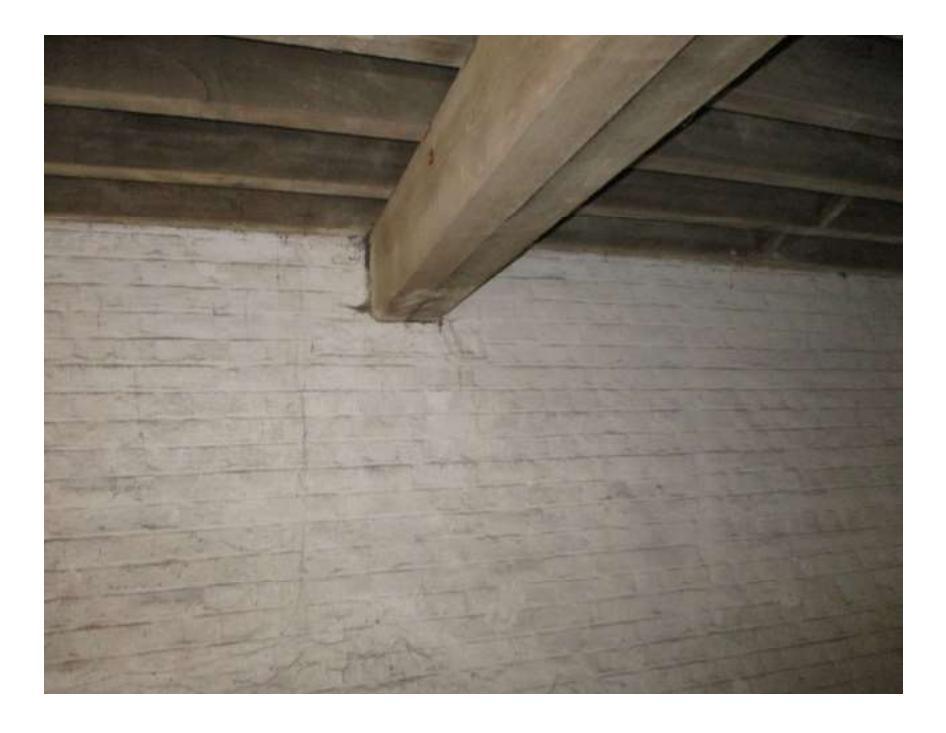
#### Fig 19 :

Interior, third floor structure from below; showing a view of the floor structure at the north-east corner. No structurally significant decay was identified on inspection

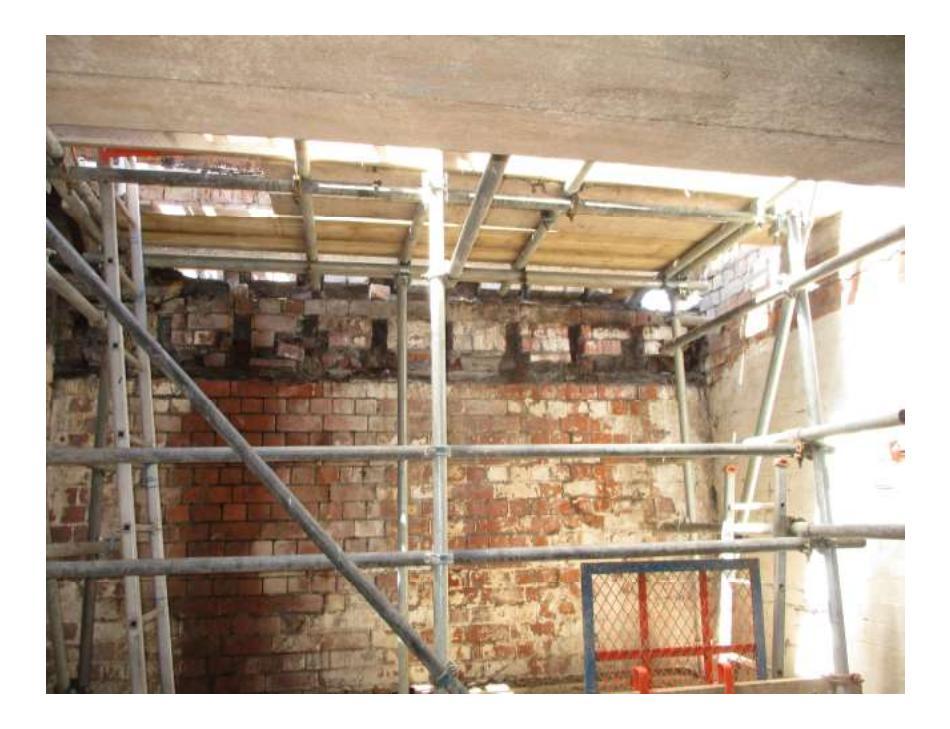
#### Fig 23 :

Interior, third floor structure from below; showing a view of the twin element primary beam where no structurally significant decay was identified on inspection

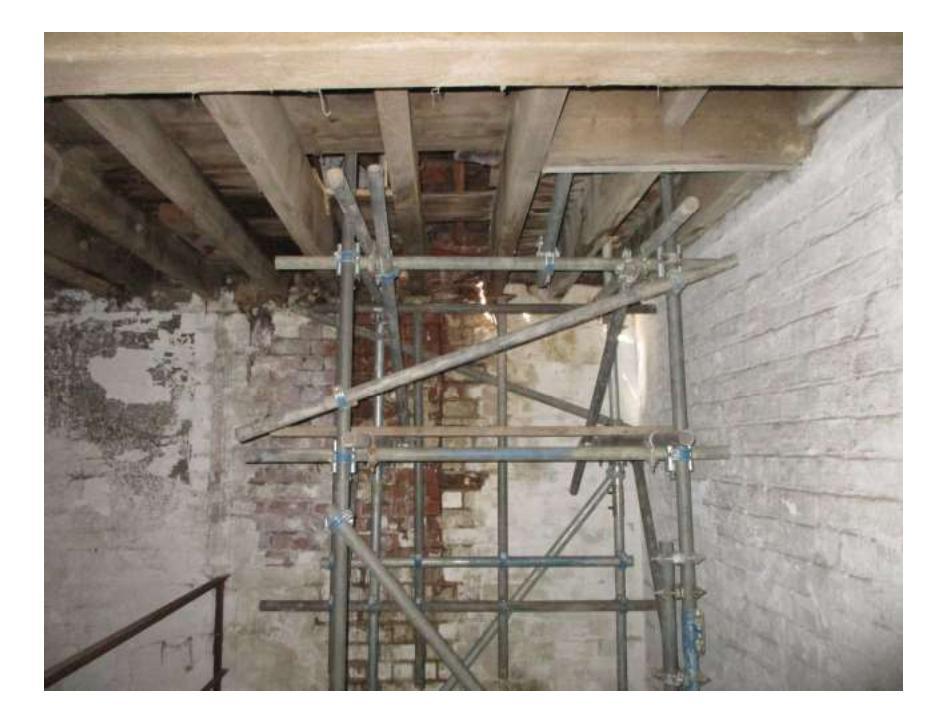
## Fig 25 :

Interior, third floor structure from below; showing a view of floor structure that had already been determined as decayed and was not part of the H+R survey

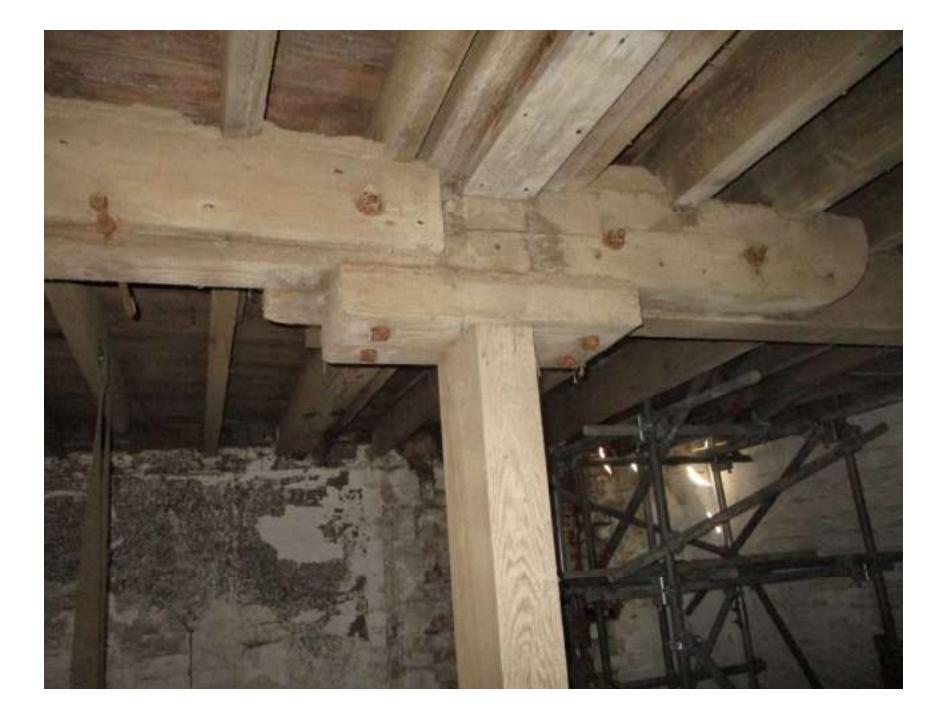
## Fig 27 :

Interior, third floor structure from below; showing a view of a primary beam bearing into a wall where no structurally significant decay was identified

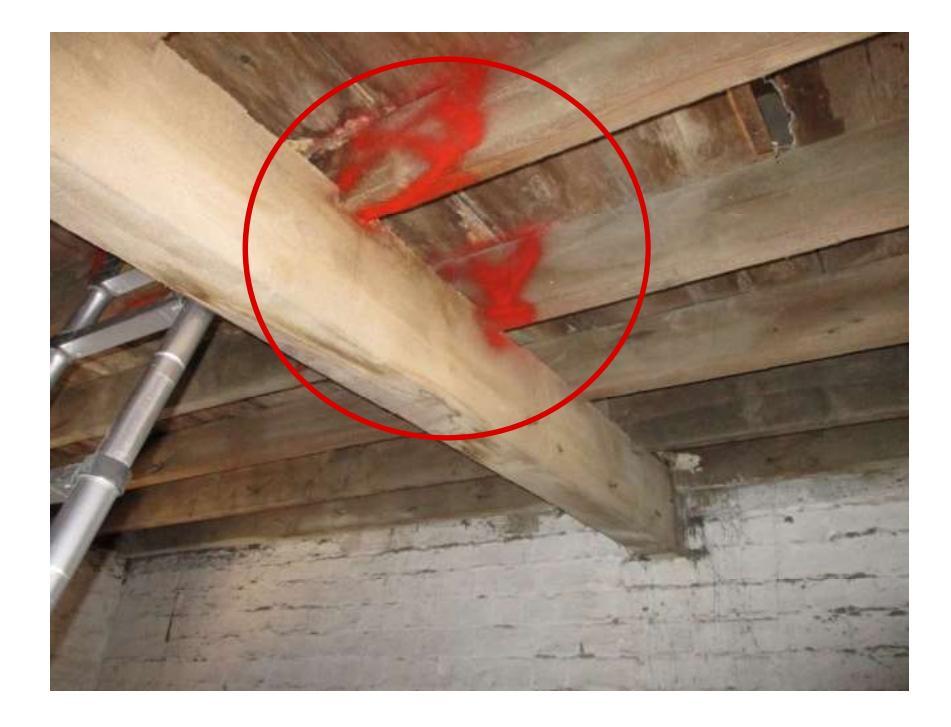
## Fig 30 :

Interior, third floor structure from below; showing a view of decay to 2 no. floor joists at their mid-section caused by water ingress from above

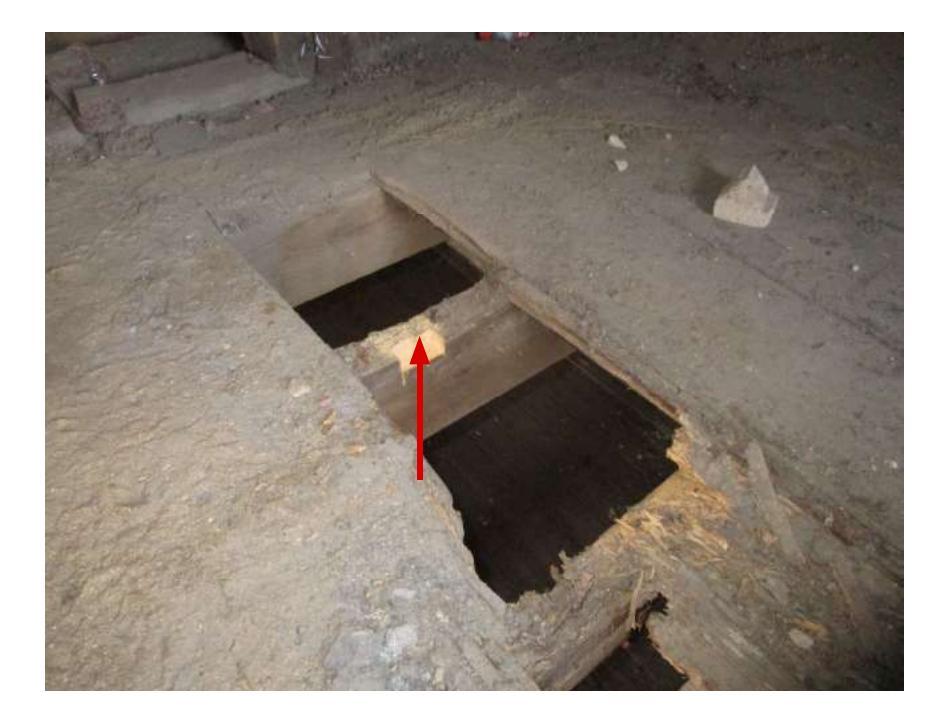
#### Fig 32 :

Interior, third floor structure from below; showing a view of location where a timber sample was extracted for analysis for species ID

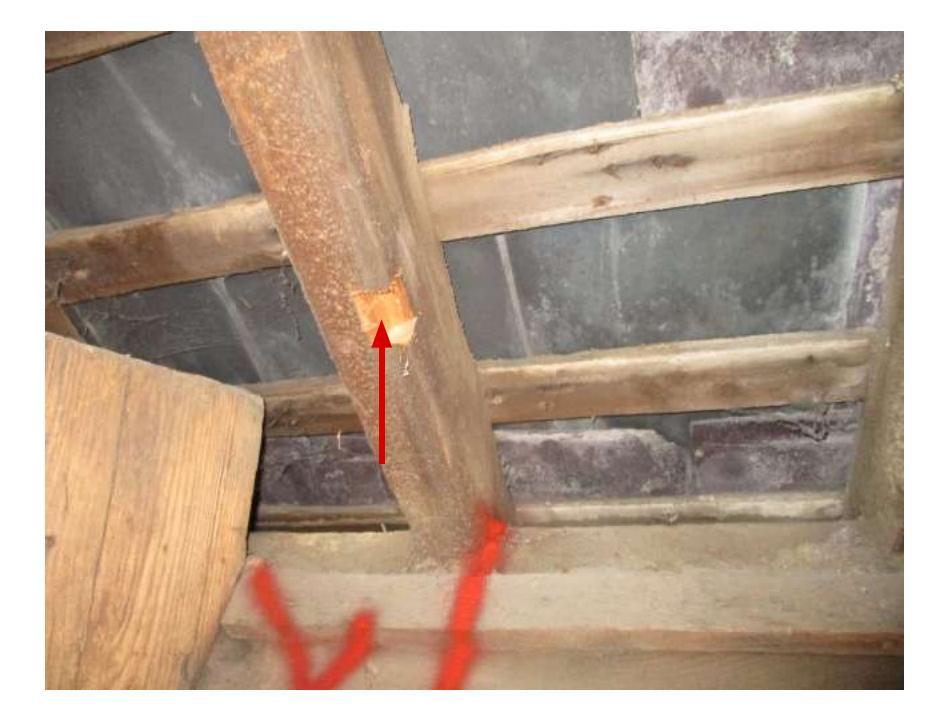
## Fig 33 :

Interior, third floor structure from below; showing a view of location where a timber sample was extracted for analysis for species ID

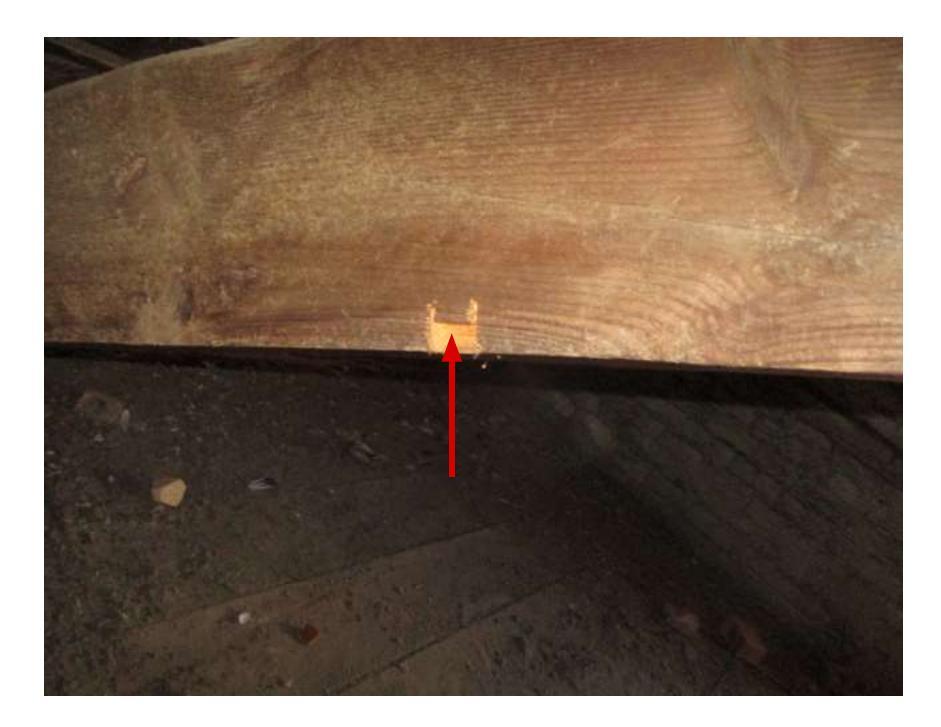
## Fig 34 :

Interior, third floor structure from below; showing a view of location where a timber sample was extracted for analysis for species ID

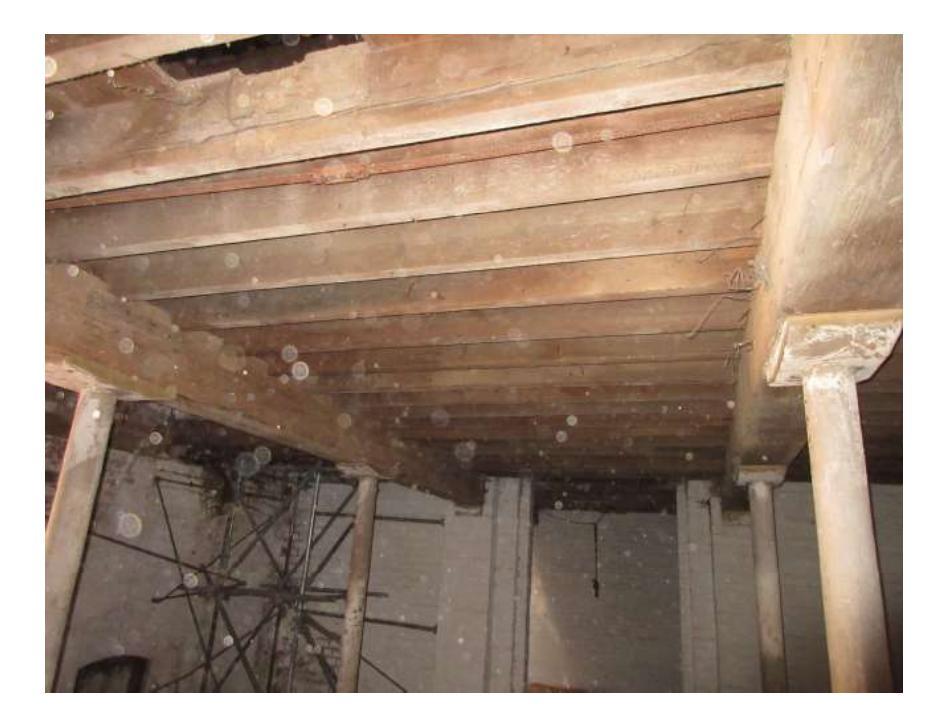
#### Fig 35 :

Interior, second floor as seen from below; showing a general view of the floor structure

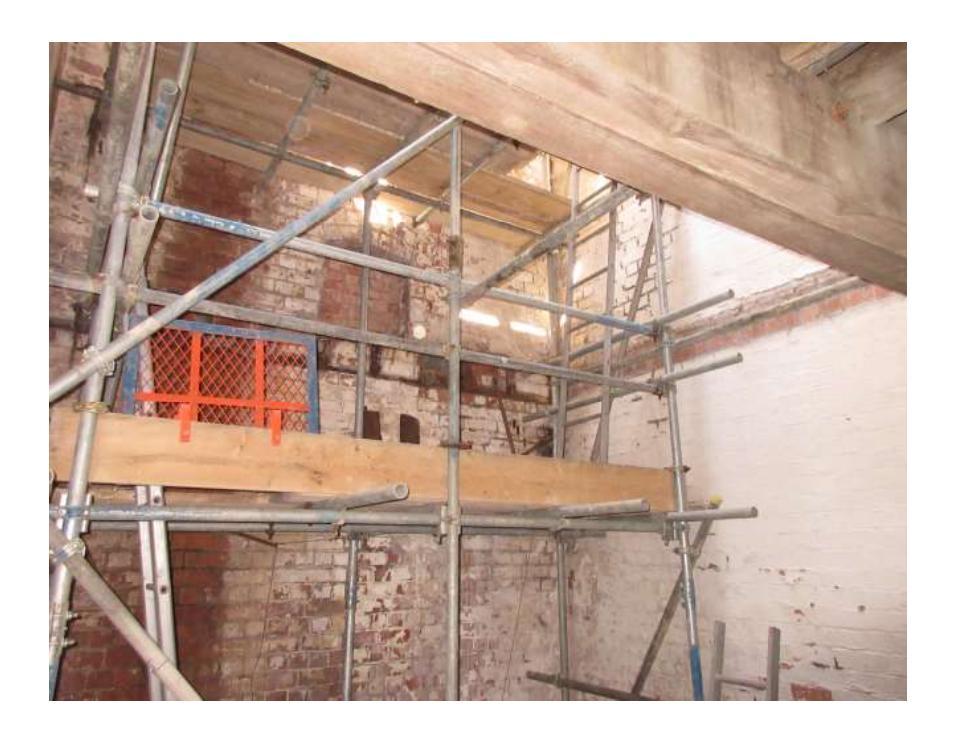
# Fig 36 :

Interior, second floor as seen from below; showing a view of timber floor structure that had been removed at the north-west corner to allow scaffold access

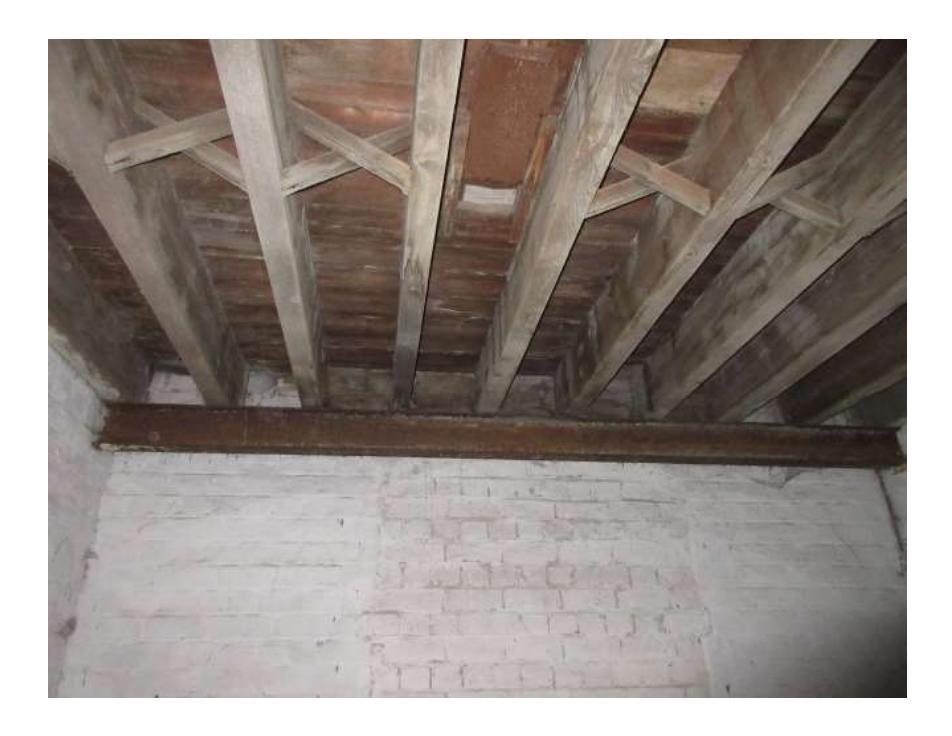
## Fig 38 :

Interior, second floor as seen from below; showing a view of the floor structure at the north-east corner. Floor joists were supported into the wall and onto a timber plate and in this location additional support was provided by a steel I beam. There was no structural decay identified in this area

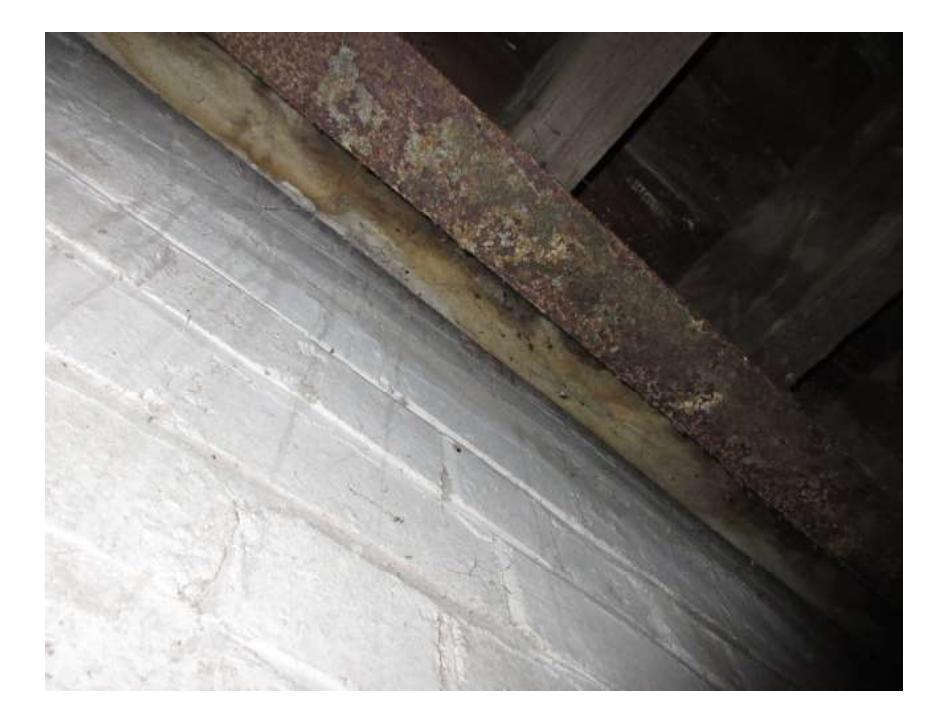
#### Fig 39 :

Interior, second floor as seen from below; showing a view of beneath the area described in fig. 38

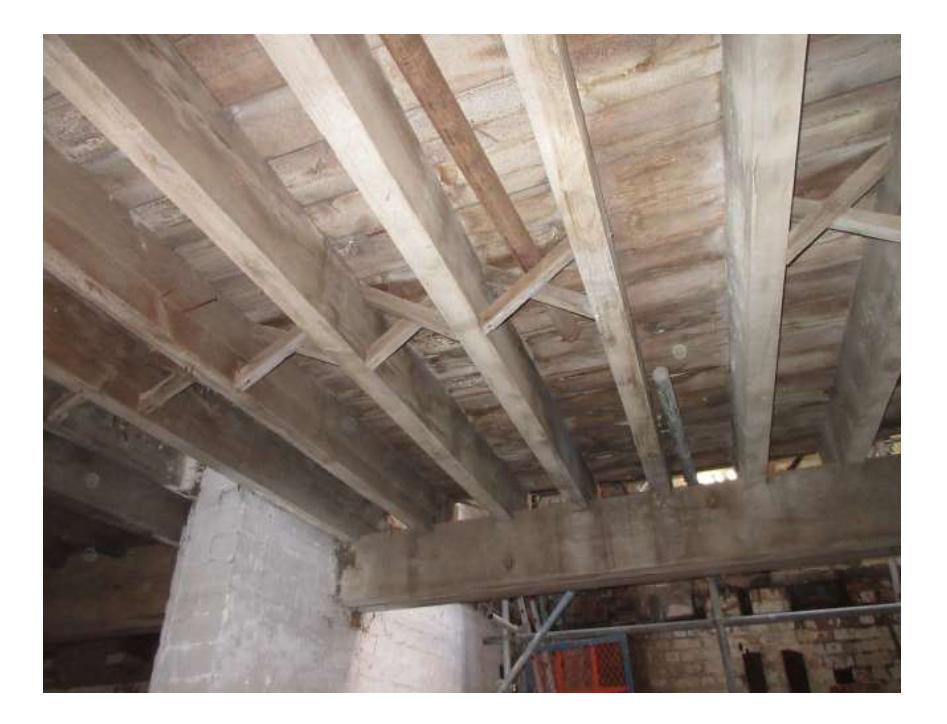
## Fig 40 :

Interior, second floor as seen from below; showing a general view of the floor structure at the north end being supported onto the primary beam

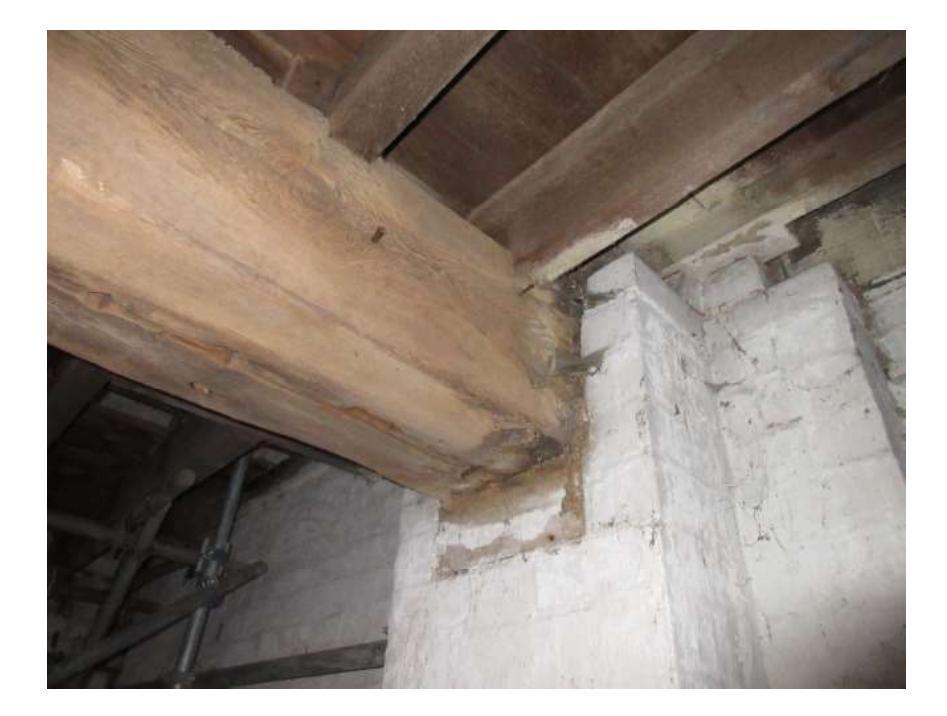
## Fig 41 :

Interior, second floor as seen from below; showing a view of the primary beam bearing end at the north end and no structurally significant decay was identified on inspection

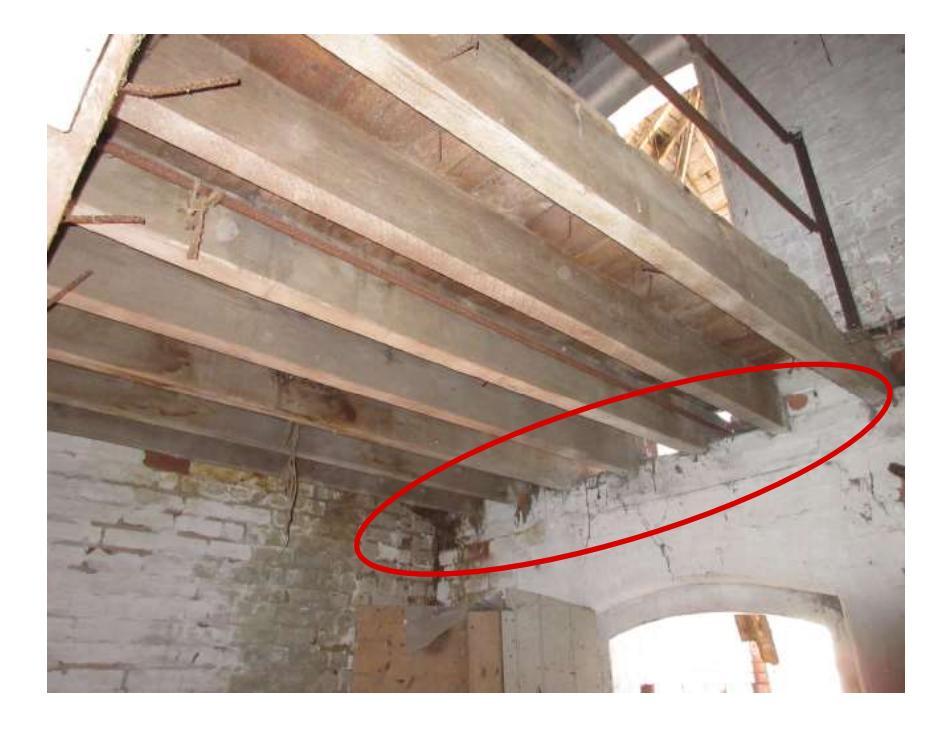
#### Fig 44 :

Interior, second floor as seen from below; showing a view of floor joists at the south-west corner which had already been identified as being structurally decayed prior to H+R's inspection

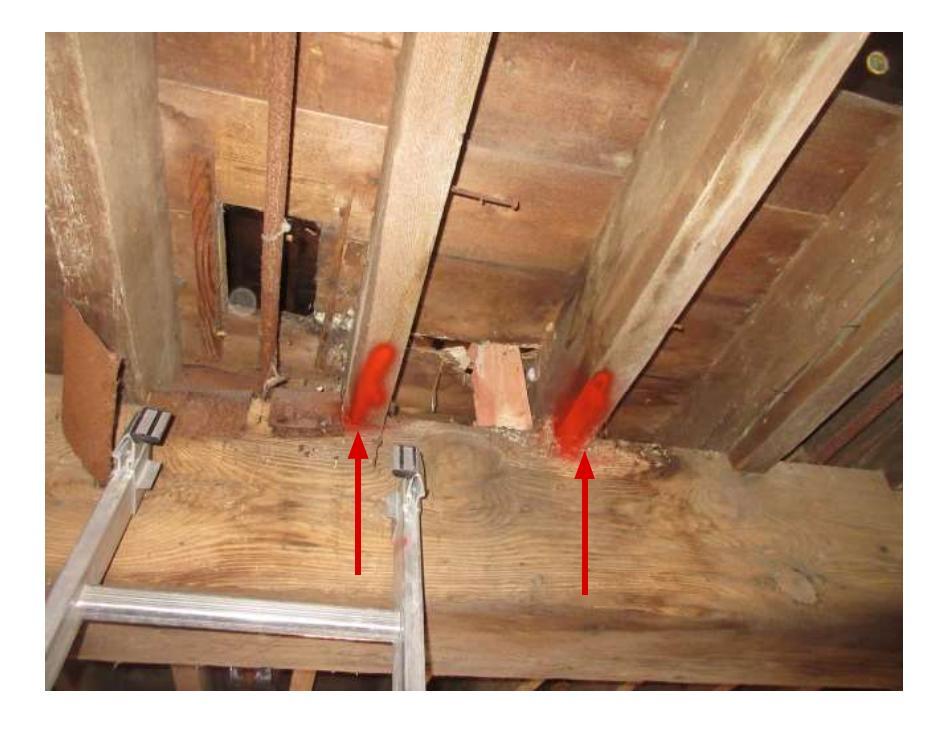
#### Fig 48 :

Interior, second floor as seen from below; showing a view of 2 no. floor joists that were decayed at their mid-section

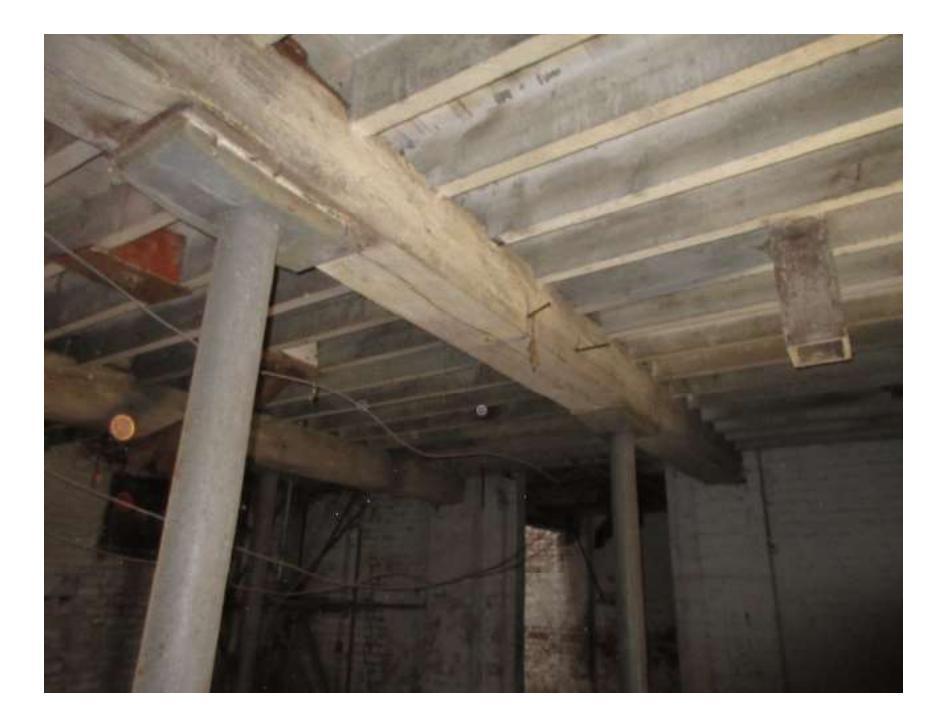
#### Fig 49 :

Interior, first floor as seen from below; showing a general view of the floor structure from beneath

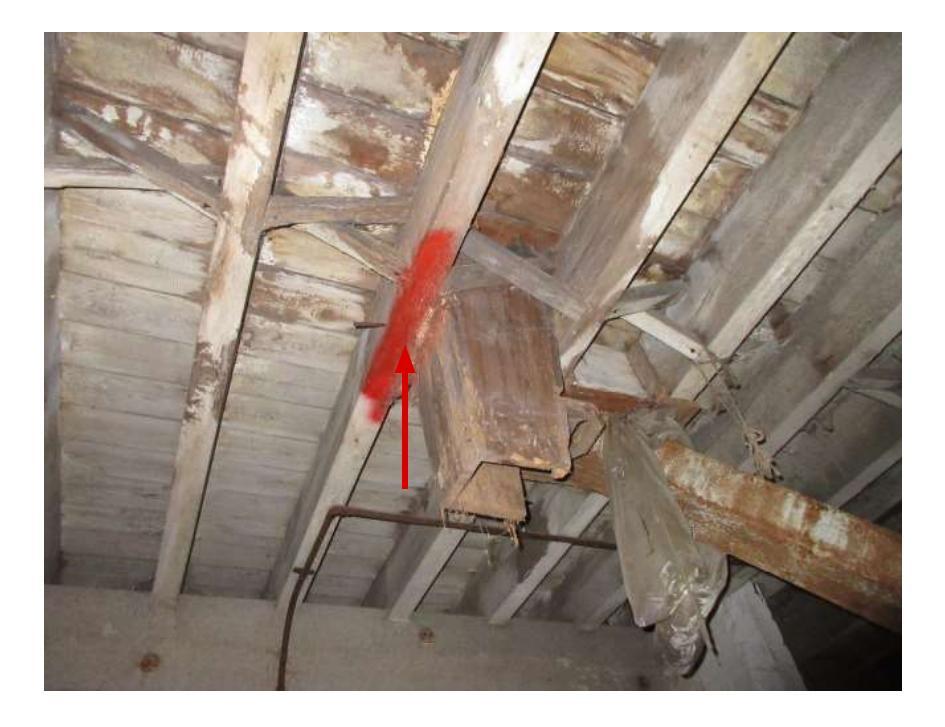
## Fig 51 :

Interior, first floor as seen from below; showing a view of a twin beam primary beam at the north-west corner. There was no structurally significant decay identified at the time of the survey. However, deep moisture contents were found to be around 30 per cent leaving the timber very vulnerable to decay starting

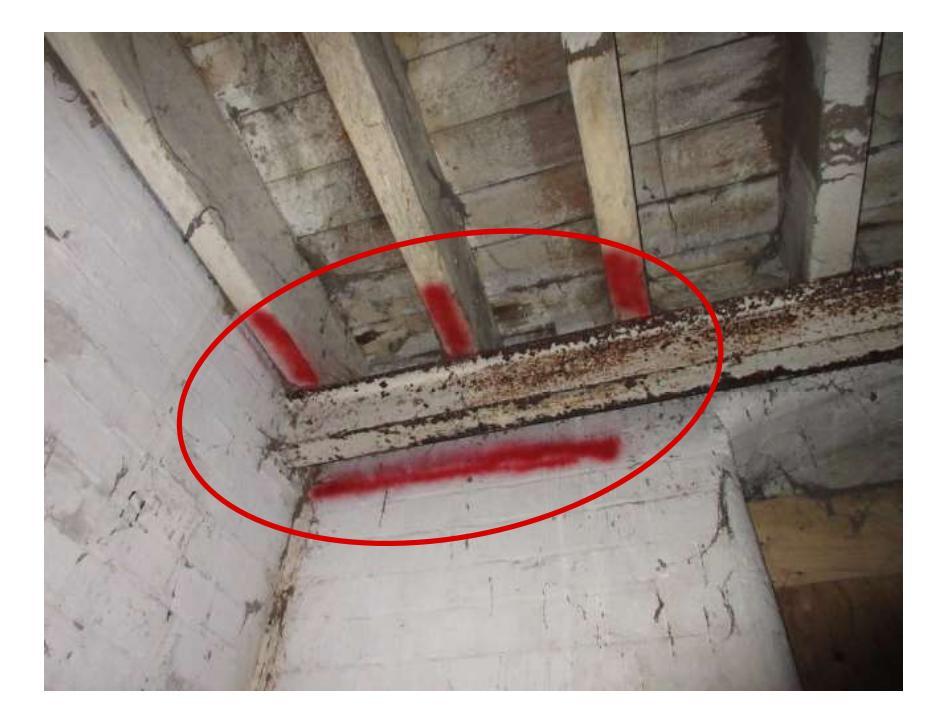
#### Fig 53 :

Interior, first floor as seen from below; showing a view of primary beam and floor joists at the north end, all of which were free from structurally significant decay

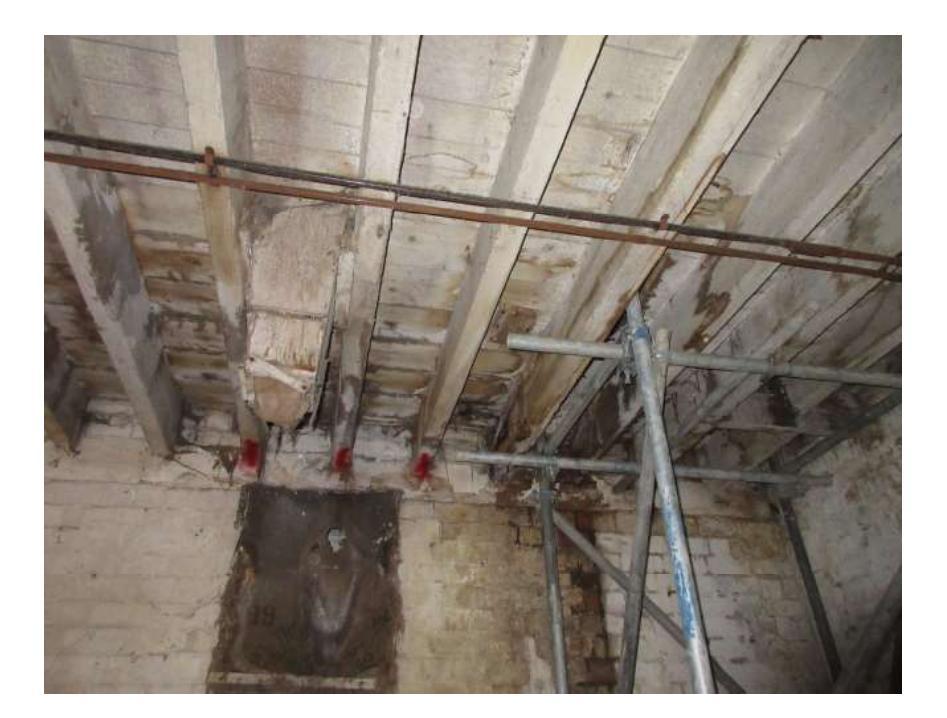
#### Fig 54 :

Interior, first floor as seen from below; showing a view of structural decay to 3 no. floor joists and bearing ends and approximately 750mm of underlying wall plate. These were located at the northeast corner

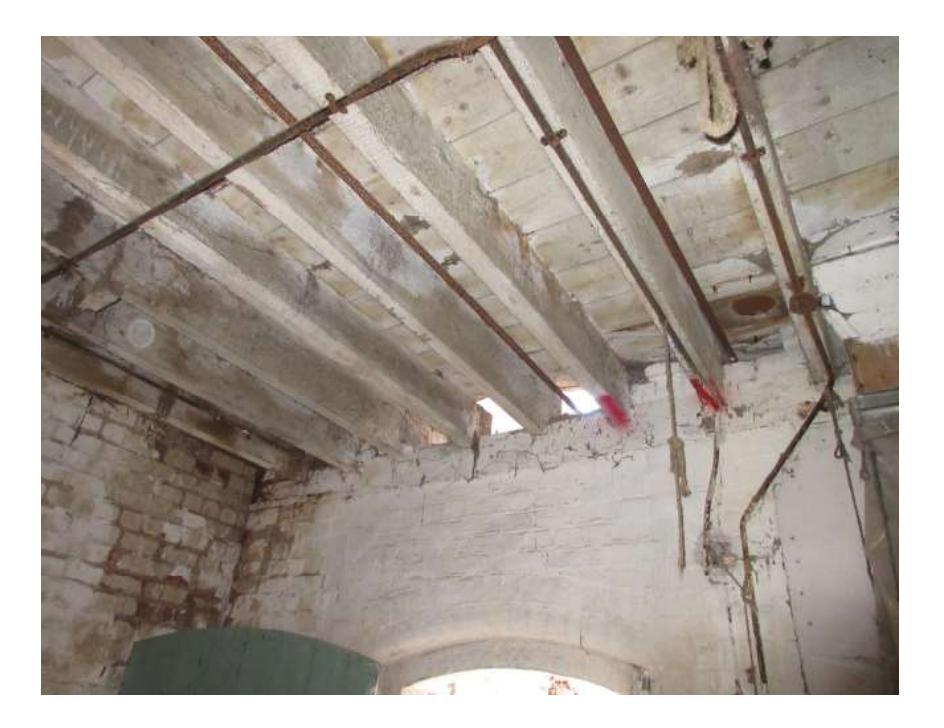
## Fig 55 :

Interior, first floor as seen from below; showing a view of timber floor structure already designated as decayed prior to H+R's inspection

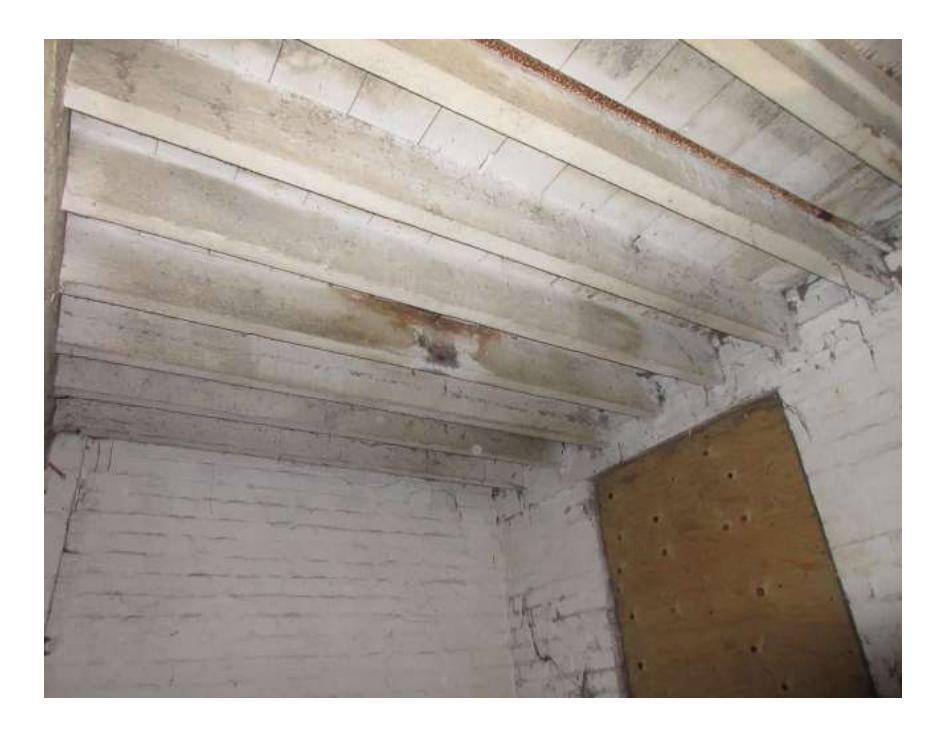
#### Fig 59 :

Interior, first floor as seen from below; showing a view of the timber floor structure at the south-east corner. All timbers were found to be free from structurally significant decay at the time of the survey

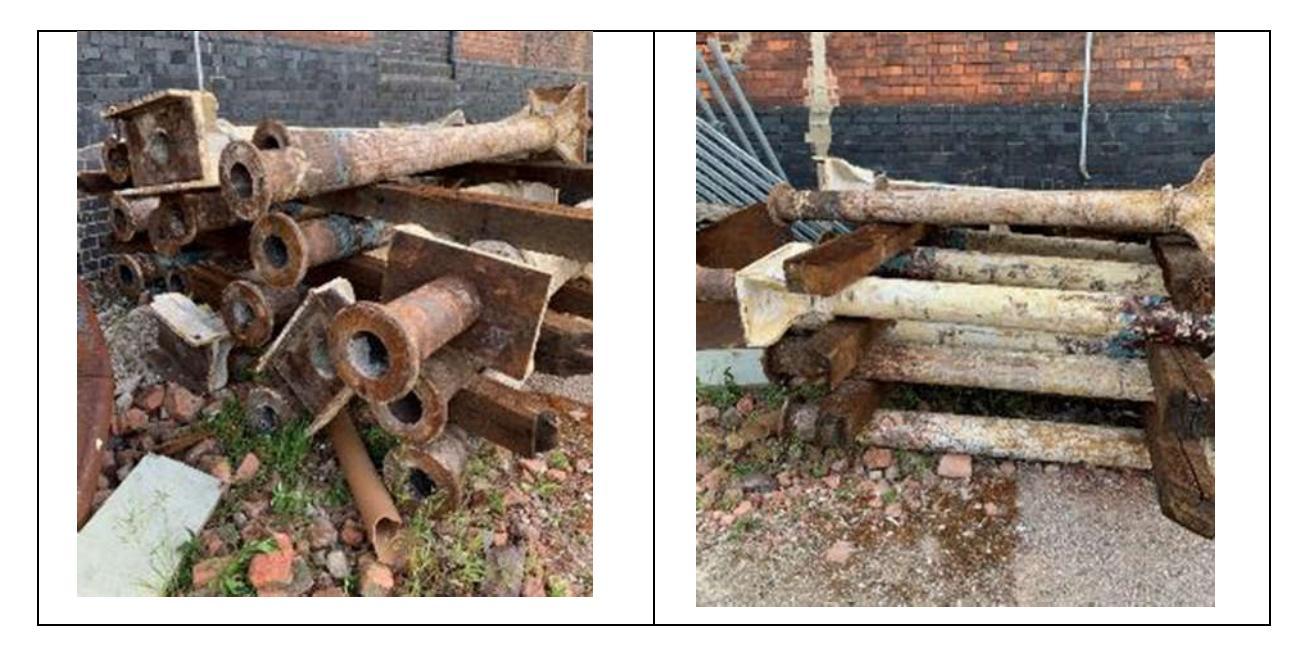
Approval was granted in early 2020 to remove the unstable internal structure of the Malthouse and the adjoining concrete silo. Surveys following demolition were undertaken to confirm the condition of the remaining structure. During stabilisation works a significant area of the malthouse floor collapsed which ultimately led to limited recovery rates and some minor damage to remaining structural walls. At this time 18 intact columns have been salvaged and set aside together with 10,000 palletized bricks as shown in the photographs below.
