Appendix B

Approved dismantling sequence and extents

# Hutton + Rostron Environmental Investigations Limited

Hutton + Rostron Environmental Investigations Limited carried out a site visit to Bakers Quay, Gloucester on 14 May 2020 in accordance with instructions from Adrian Goodall by email dated 13 May 2020 11:54 with attached Order Form. Drawings provided by the client were used for the identification of structures. For the purpose of orientation in this report, the entrance to the building was taken as facing east onto High Orchard Street

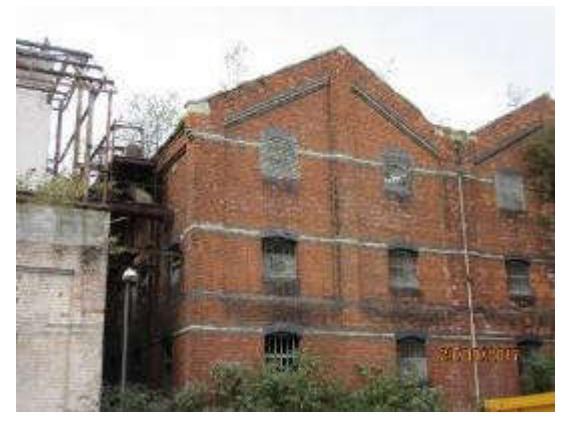
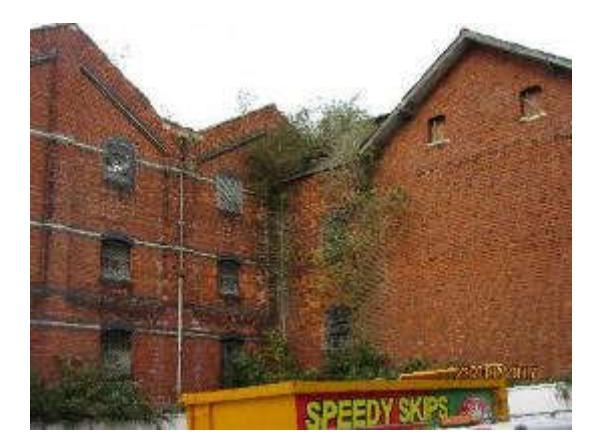
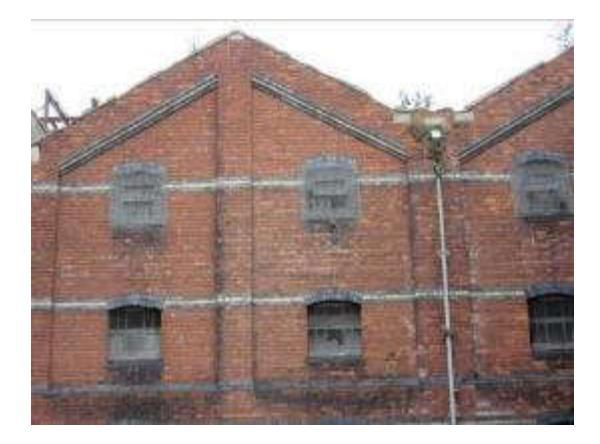
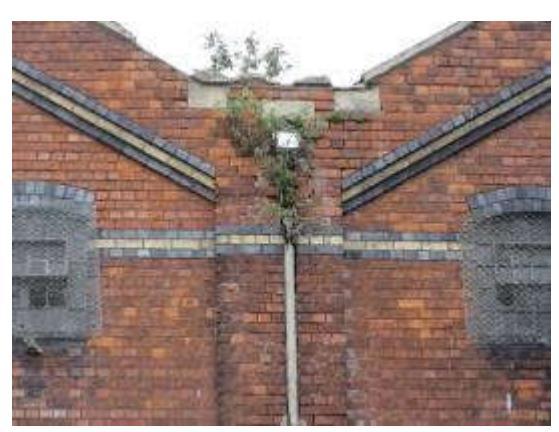
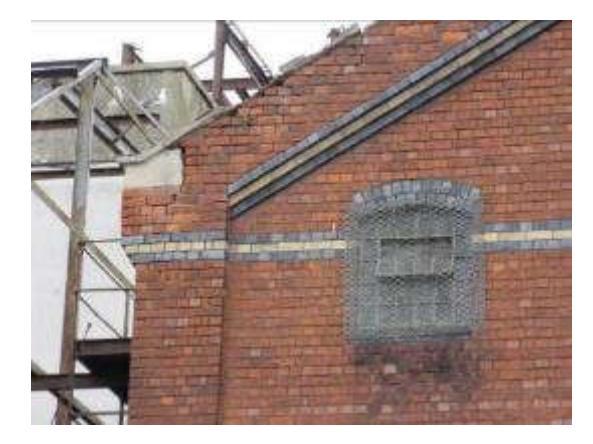
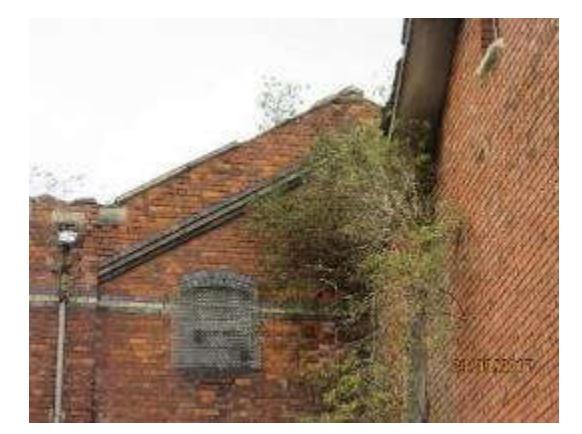
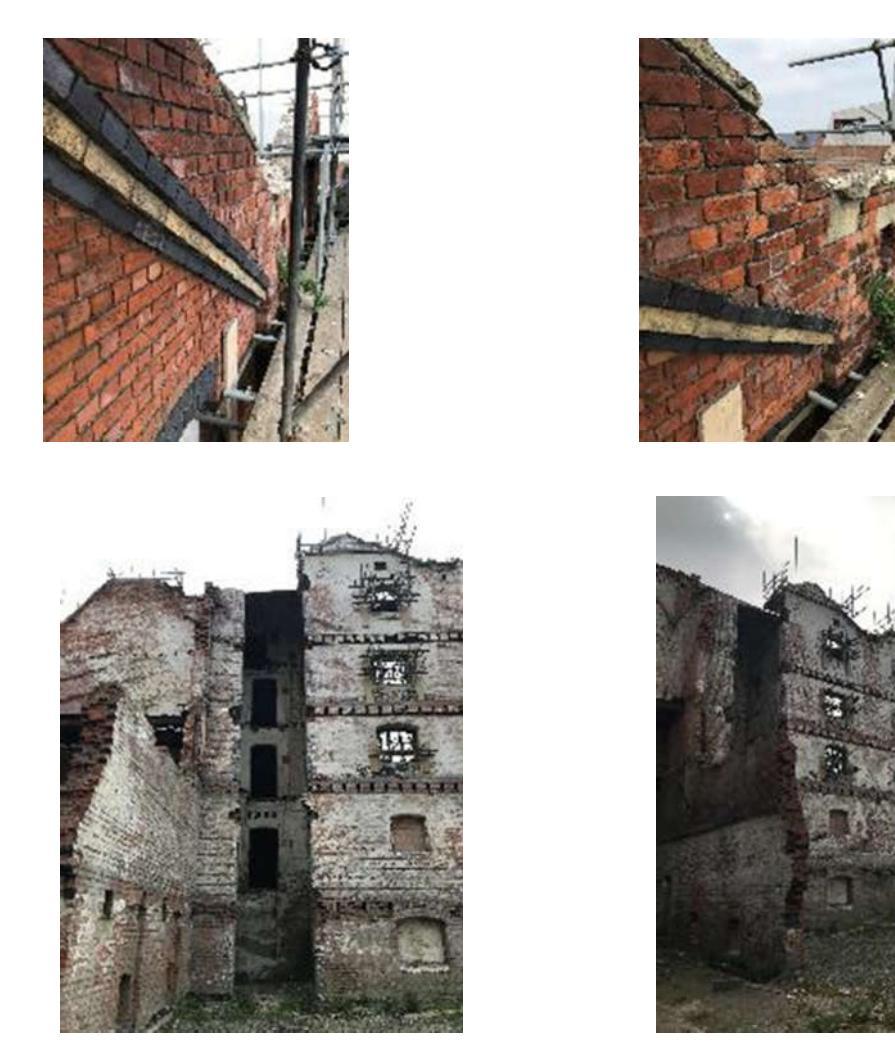
## 4.2 East Elevation

Description: Masonry elevation consisting of the rear of the gables ends of the malthouse which are partly obscured by the historic warehouses on Orchard Street. The masonry consists of recessed brick panels with brick arched windows between high masonry piers.

There is significant water staining due to failed water goods leading to spalling brickwork and loss of mortar.

There is much vegetation growth surrounding the parapets and spalling to the stone copings.

During the demolition process the left hand gable has been damaged with cracking and horizontal displacement noted. The right hand gable has also been partially lost over the access door into the circulation core.

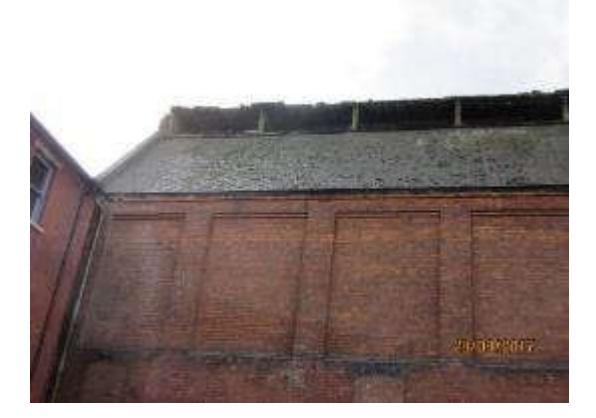
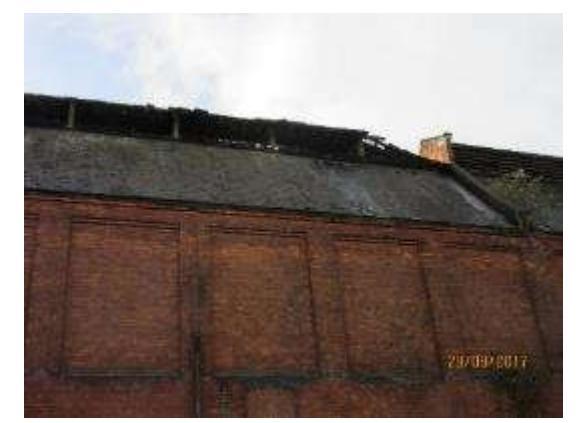
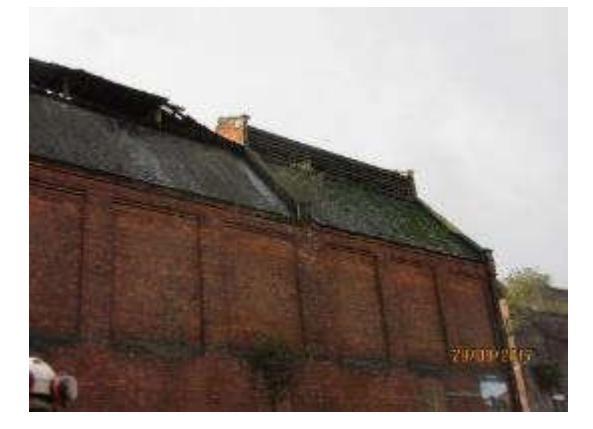
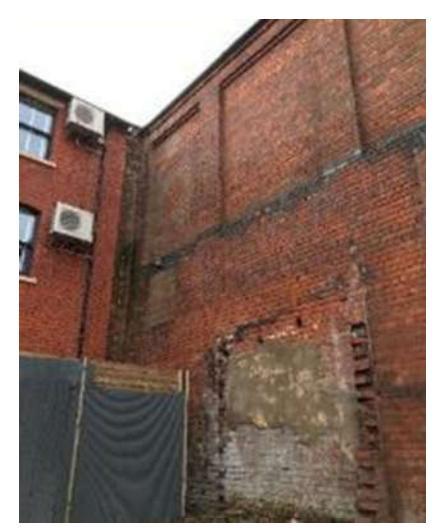
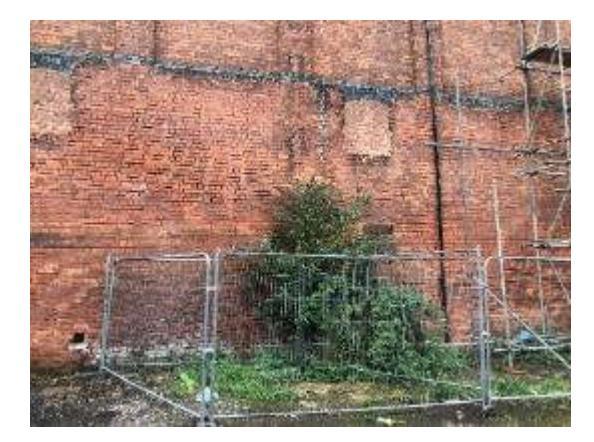
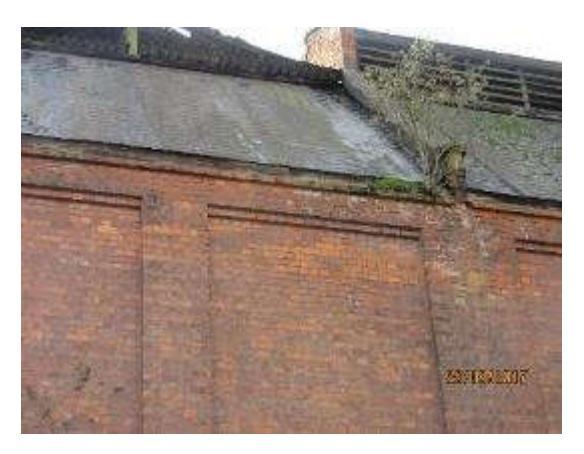
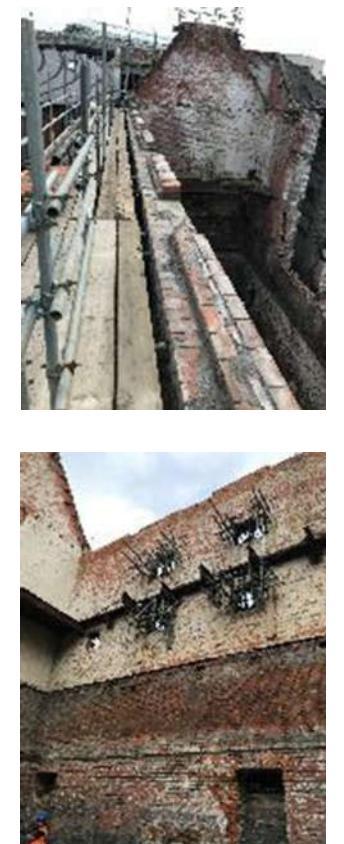
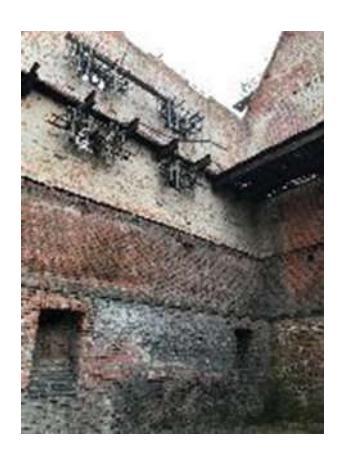
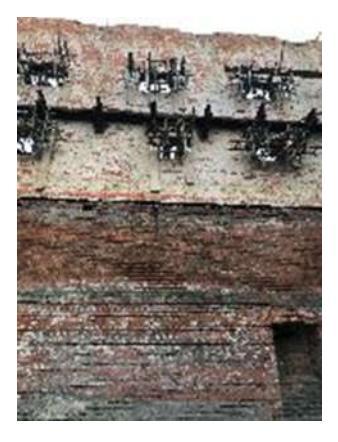
## 4.3 North elevation

Description: Historic external photographs due to restraint scaffold. Roof over left hand side has been removed.

Masonry elevation consisting of recessed brick panels between brick piers.

There are bricked up arched windows at first floor level. These have been opened to provide tie locations for the restraint scaffold. Additional openings have also been created in locations close to proposed windows to minimise damage to existing building.

The masonry generally appears structurally sound and is in fair condition with the exception for the eaves where repointing and some rebuilding will be required due to water damage, vegetation growth and the demolition works.

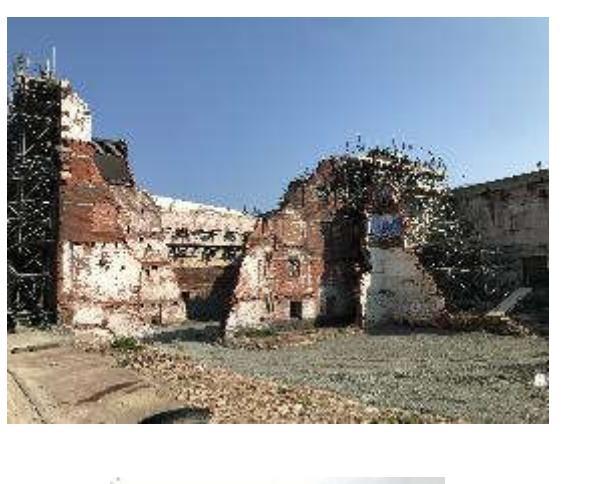
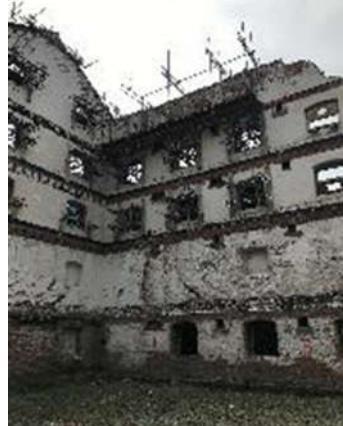
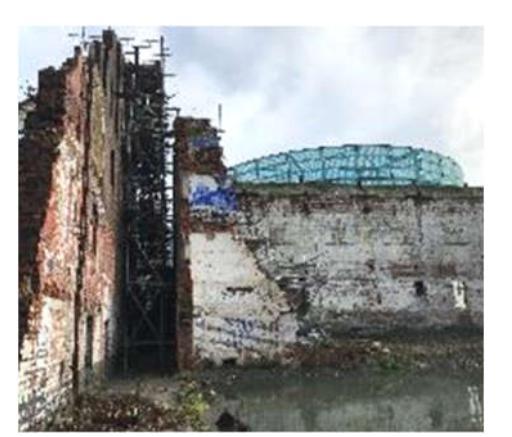
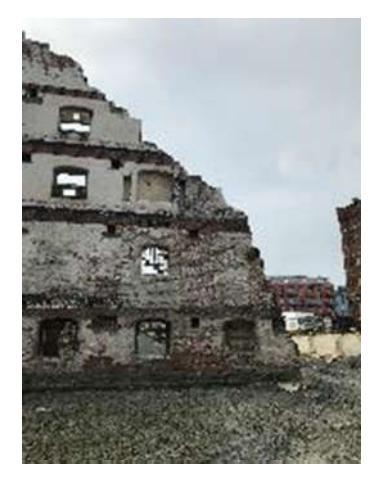
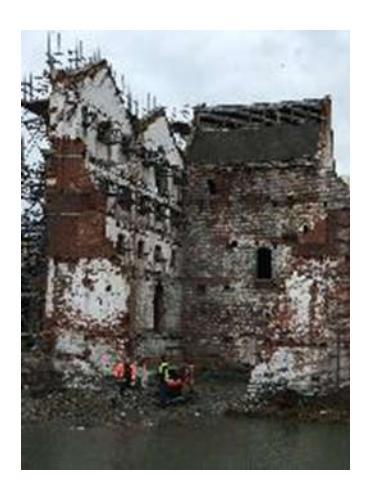
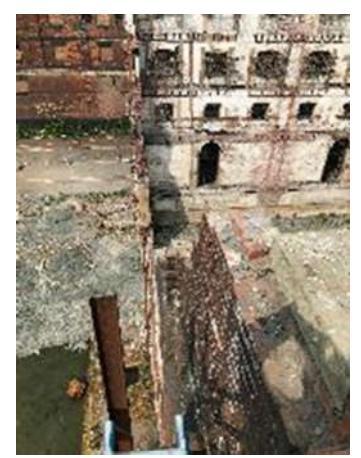
#### 4.4 South elevation

Masonry elevation consisting of recessed brick panels with masonry arched windows between brick piers. The elevation was originally part of a light well opposite a similar building where the concrete silo was situated.

At eaves level the masonry is in very poor condition due to extensive water ingress. The remaining elevation is in reasonable condition but will require significant repair, repointing and cleaning.

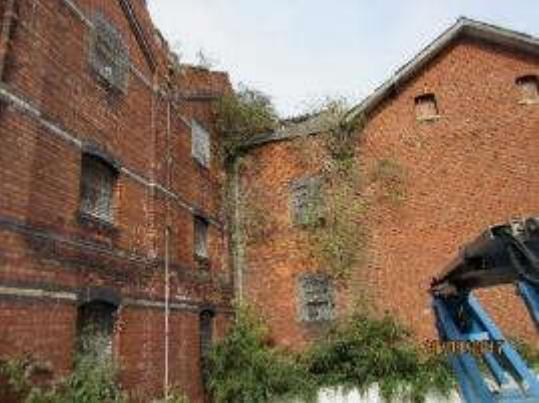
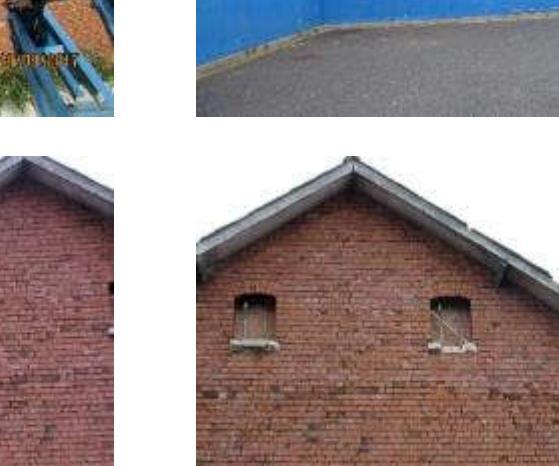
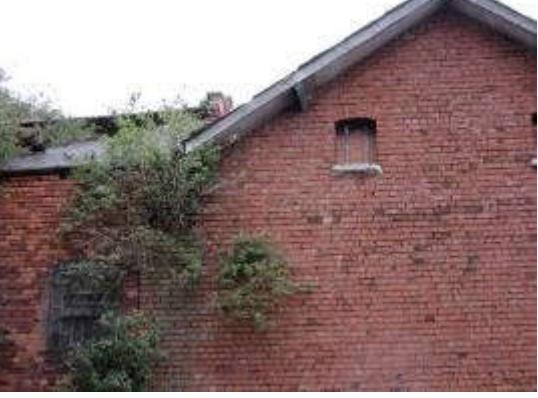
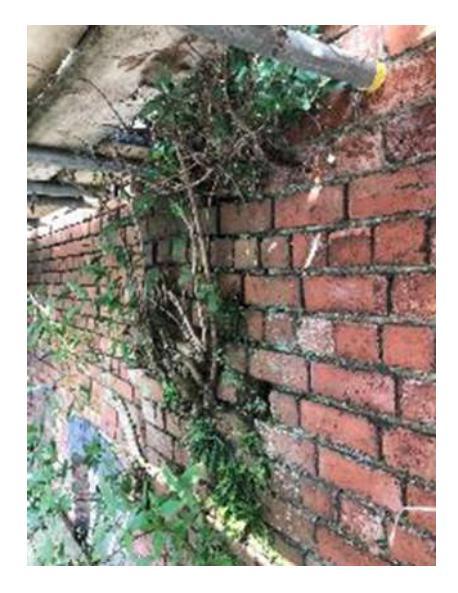
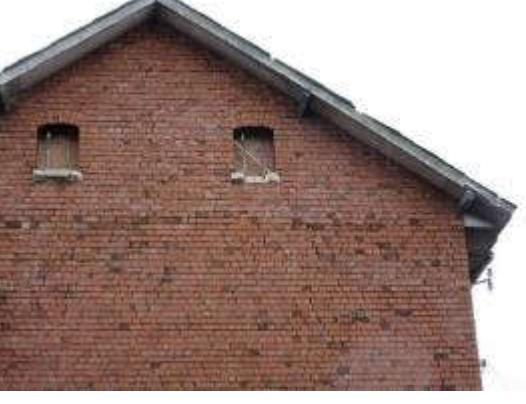
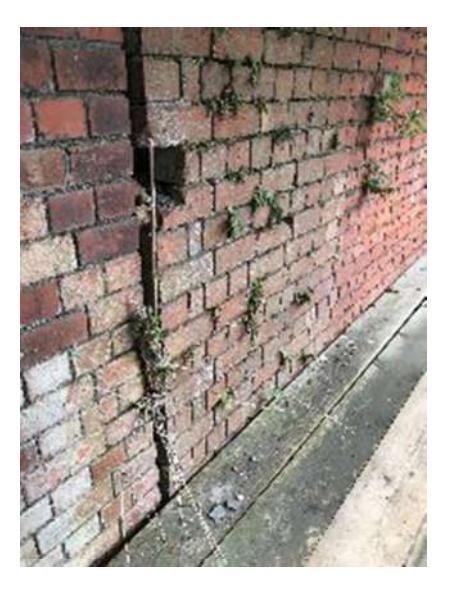
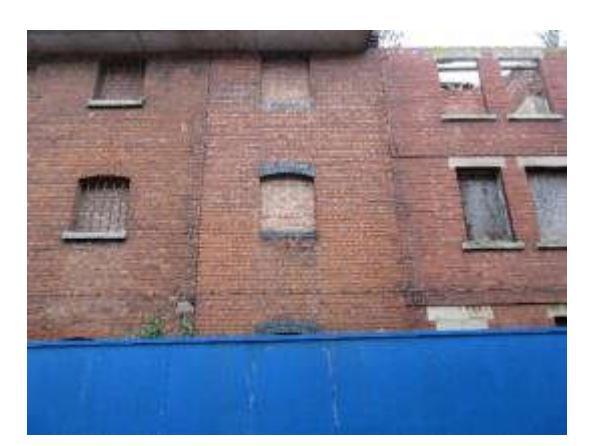
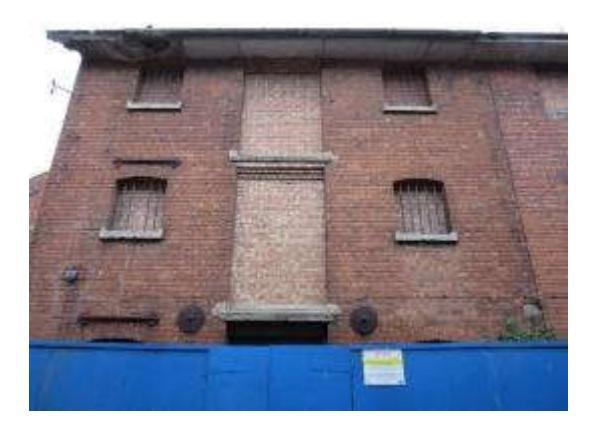
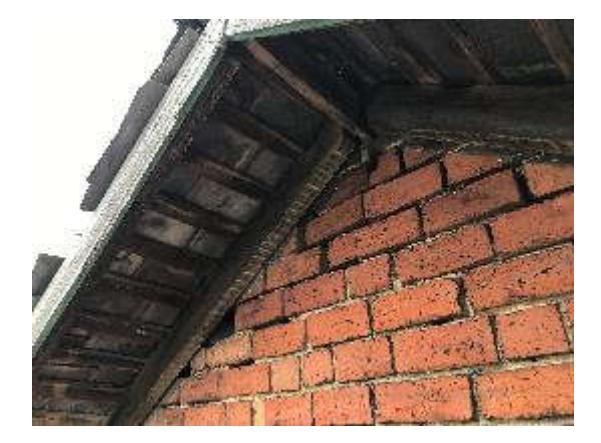
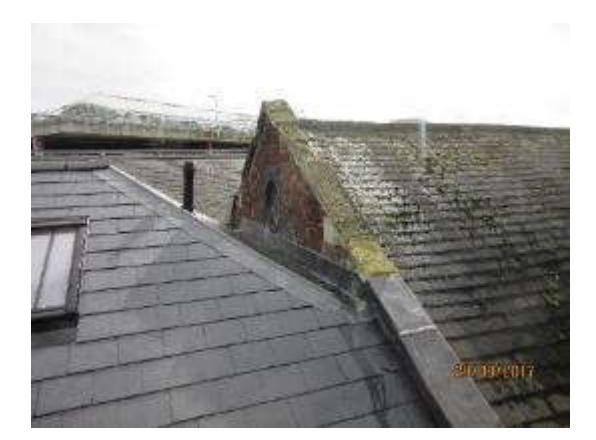
High Orchard Street Warehouse Elevations 4.5

- Description: Photographs largely historic due to access scaffold. Plain brick elevations built in a number of phases.
  - On the south gable elevation there is a significant vegetation growth at the connection to Downings Malthouse therefore extensive rebuilding and general repointing will be required.

- The gable only has two small windows at high level that has spalled stone cills with vertical spanning bars. The elevation will require repointing.

- The east elevation appears to consist of original warehouse to the south with a latter infill to the cottages to the north.
  - There are cracks in the masonry between the windows as identified in appendix B. Much of the elevation will require repointing and then stone cills are spalling.

- The walls appear structural around however considerable repair works are required.
  - The north elevation extends above the adjacent cottages. The parapet coping stones are in poor condition and will require replacing.

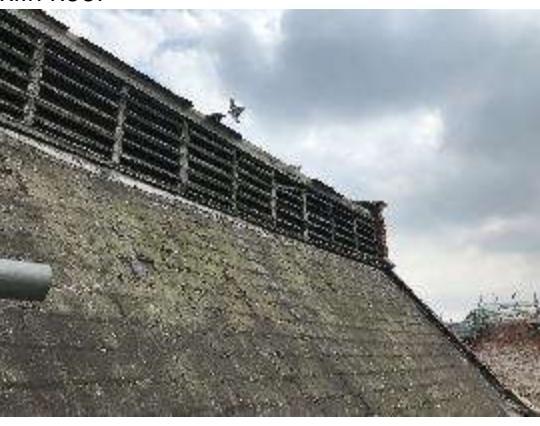
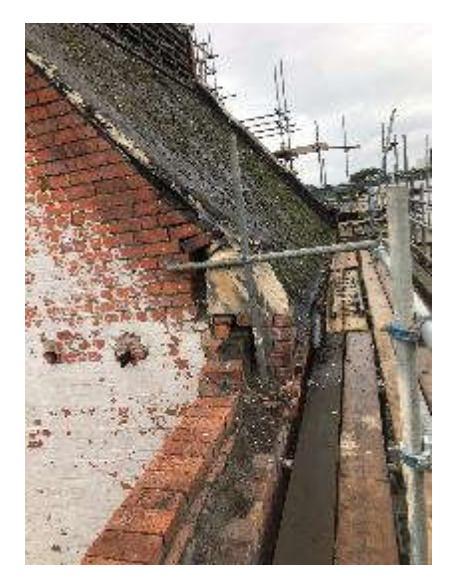
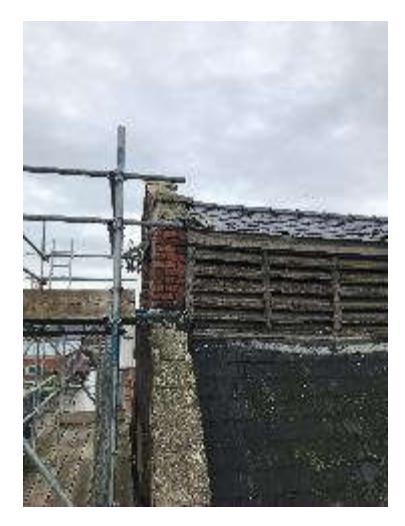
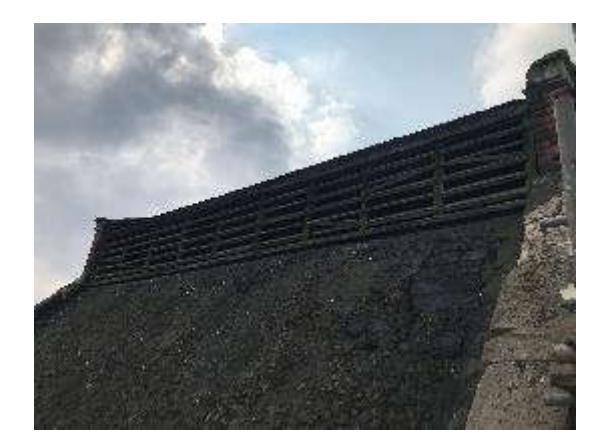
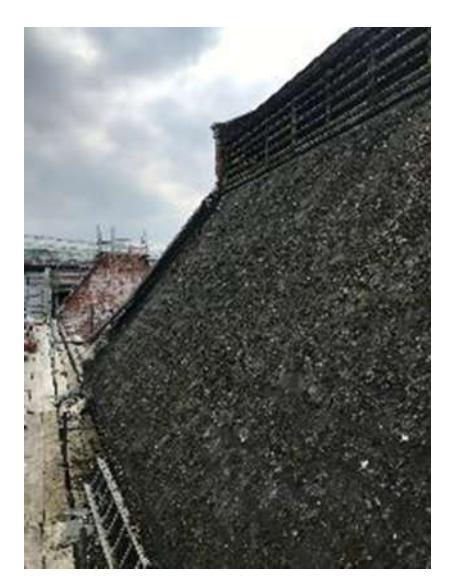
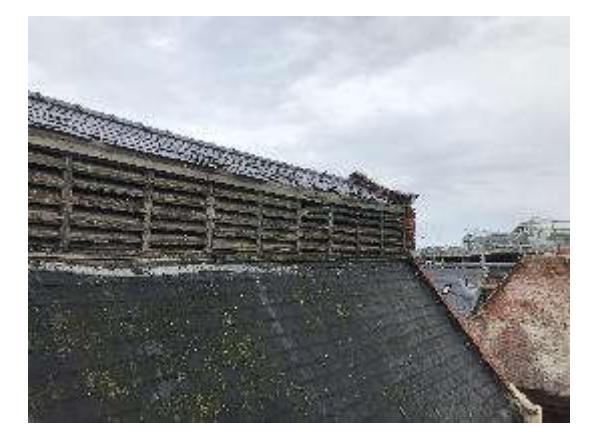
4.7 Kiln Roof (Continued)

The steeply sloping sections are generally well protected by the roof finishes however where this shed water onto a concealed gutter on the south side adjacent to the malthouse the gutter failed allowing water to penetrate below. There was vegetation growth in the valleys and parapets and it is considered likely that there is decay to the truss ends however they cannot currently be observed as there is no high level access within the remaining kiln.

The parapet coping stones are generally in a poor condition and are dislodged on the old internal wall line.

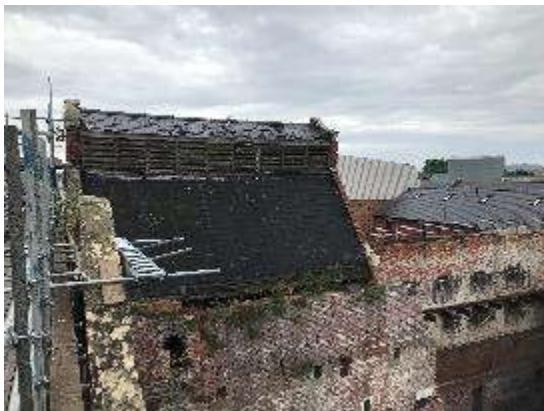
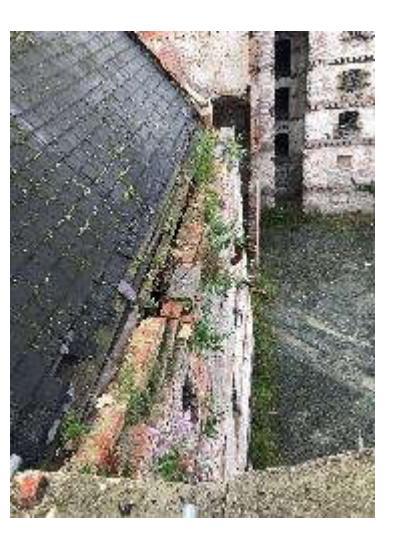
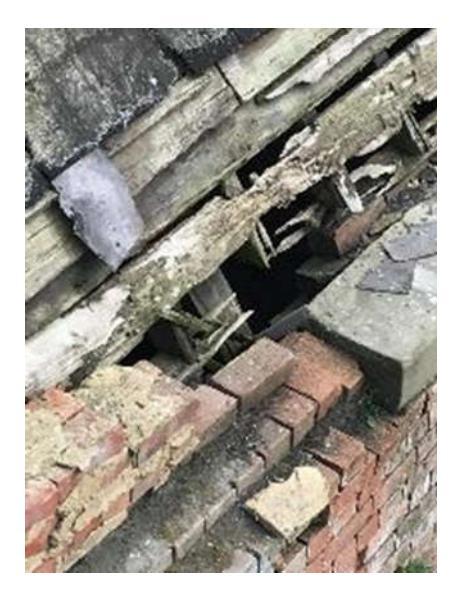
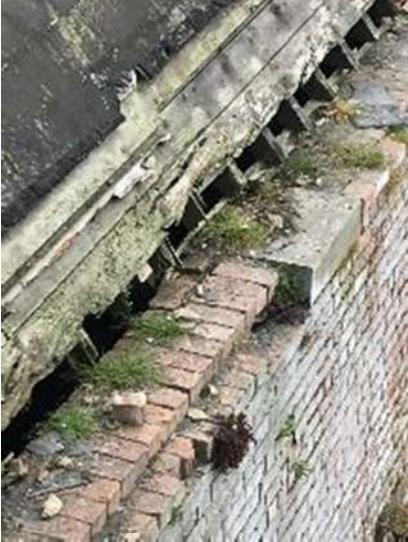
Only the front third of the roof remains following the demolition works. The roof over steeply pitched and slate tiled which has been covered in bitumen. There is a projecting central section which originally provided ventilation to the kilns below.

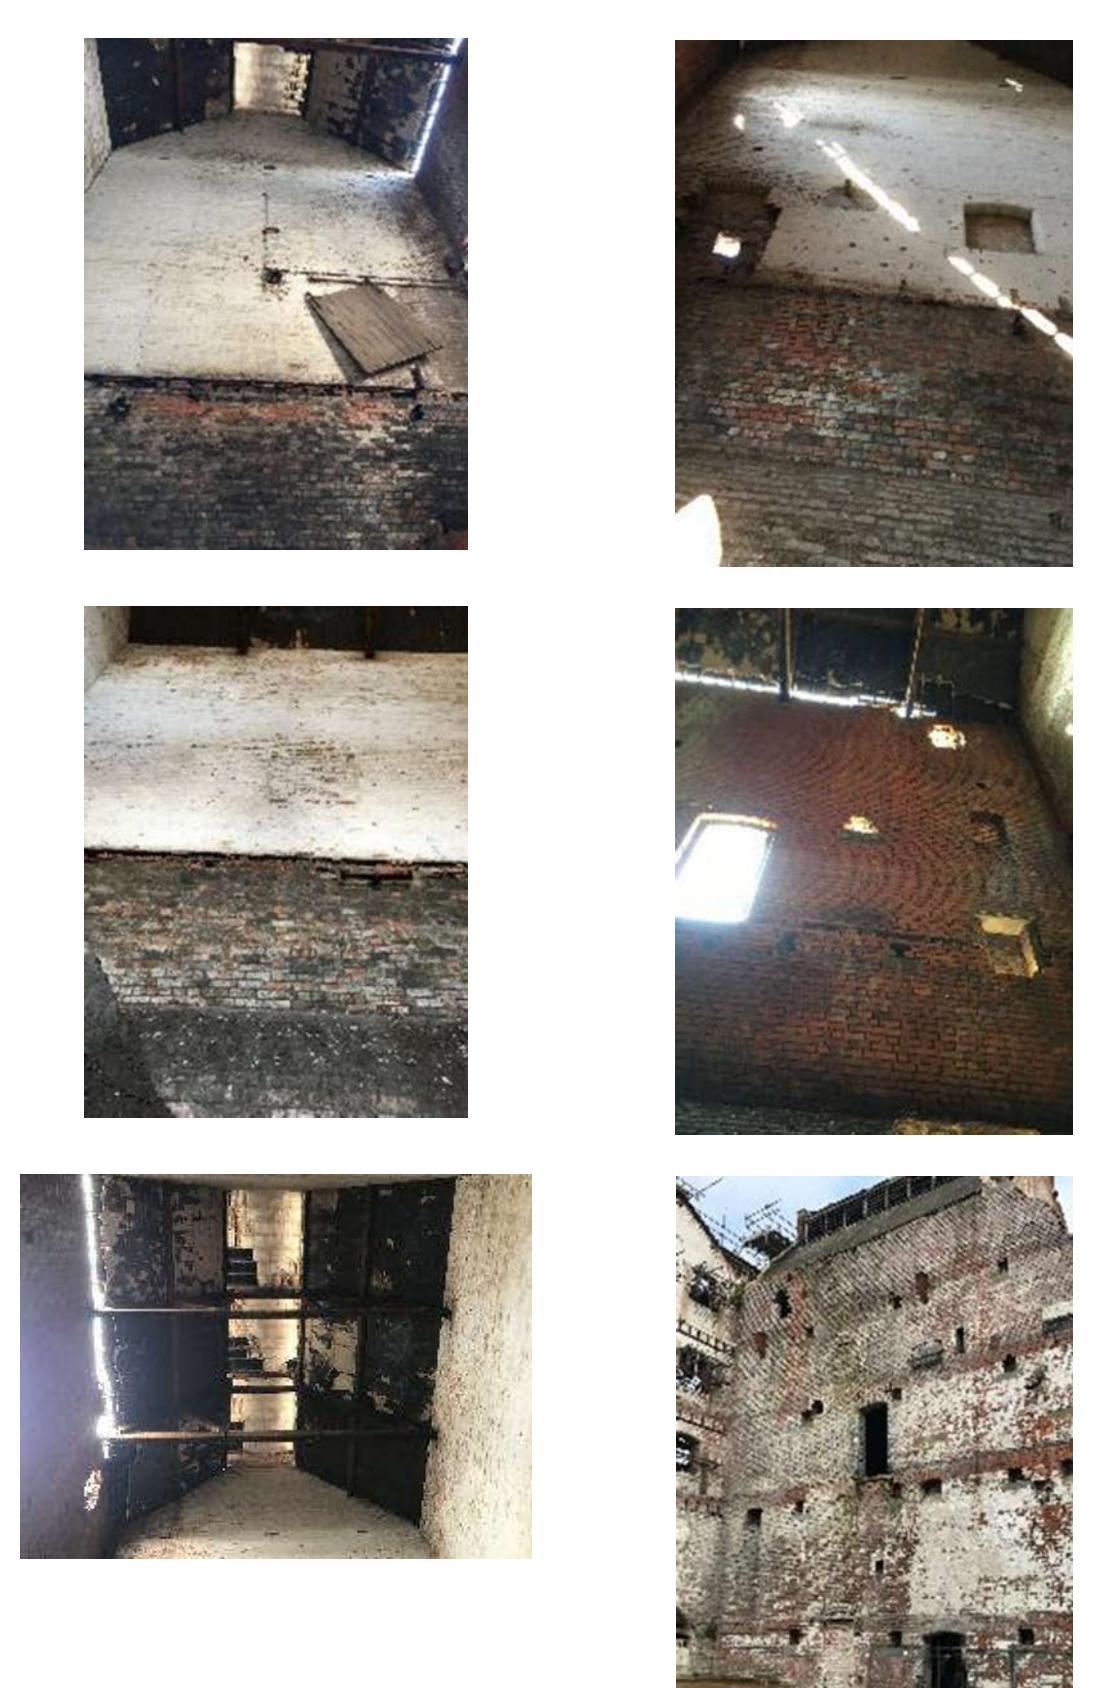
## 4.8 Kiln (Continued)

Description: There were two separate kiln areas one smaller on to the west and a larger on to the east. The larger area has been demolished.

The internal walls are generally in a reasonable condition. There is a vertical crack between the northern wall and internal wall. There are numerous openings in the southern wall either from doorways or service holes some of which have failed lintels.

The significant water ingress on the old valley line may have caused some decay to the two remaining truss ends however this is not clear from ground level or the external scaffold.

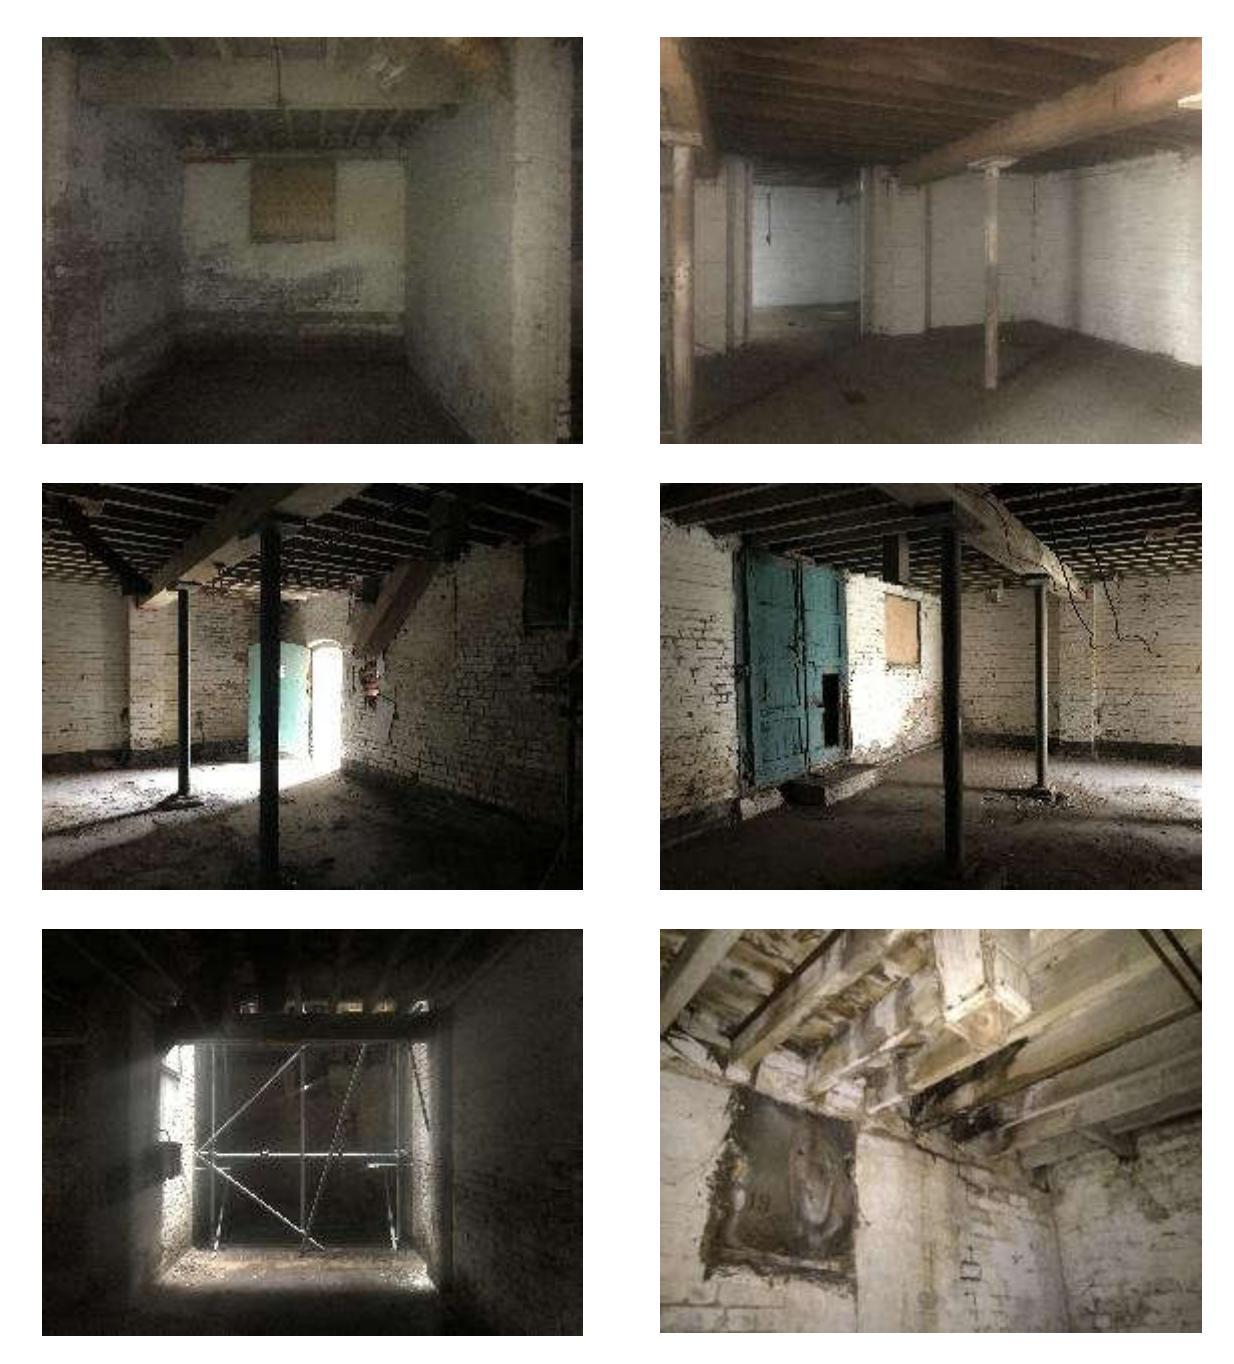
#### 4.9 High orchard Street Ground floor

The floor consists of two rooms both with concrete ground floors and exposed timber floors beams and joists above.

The floor joists between the NE internal wall and first supporting timber floor beam have been removed as they were decayed. A scaffold stair tower has been installed to provide access to all levels.

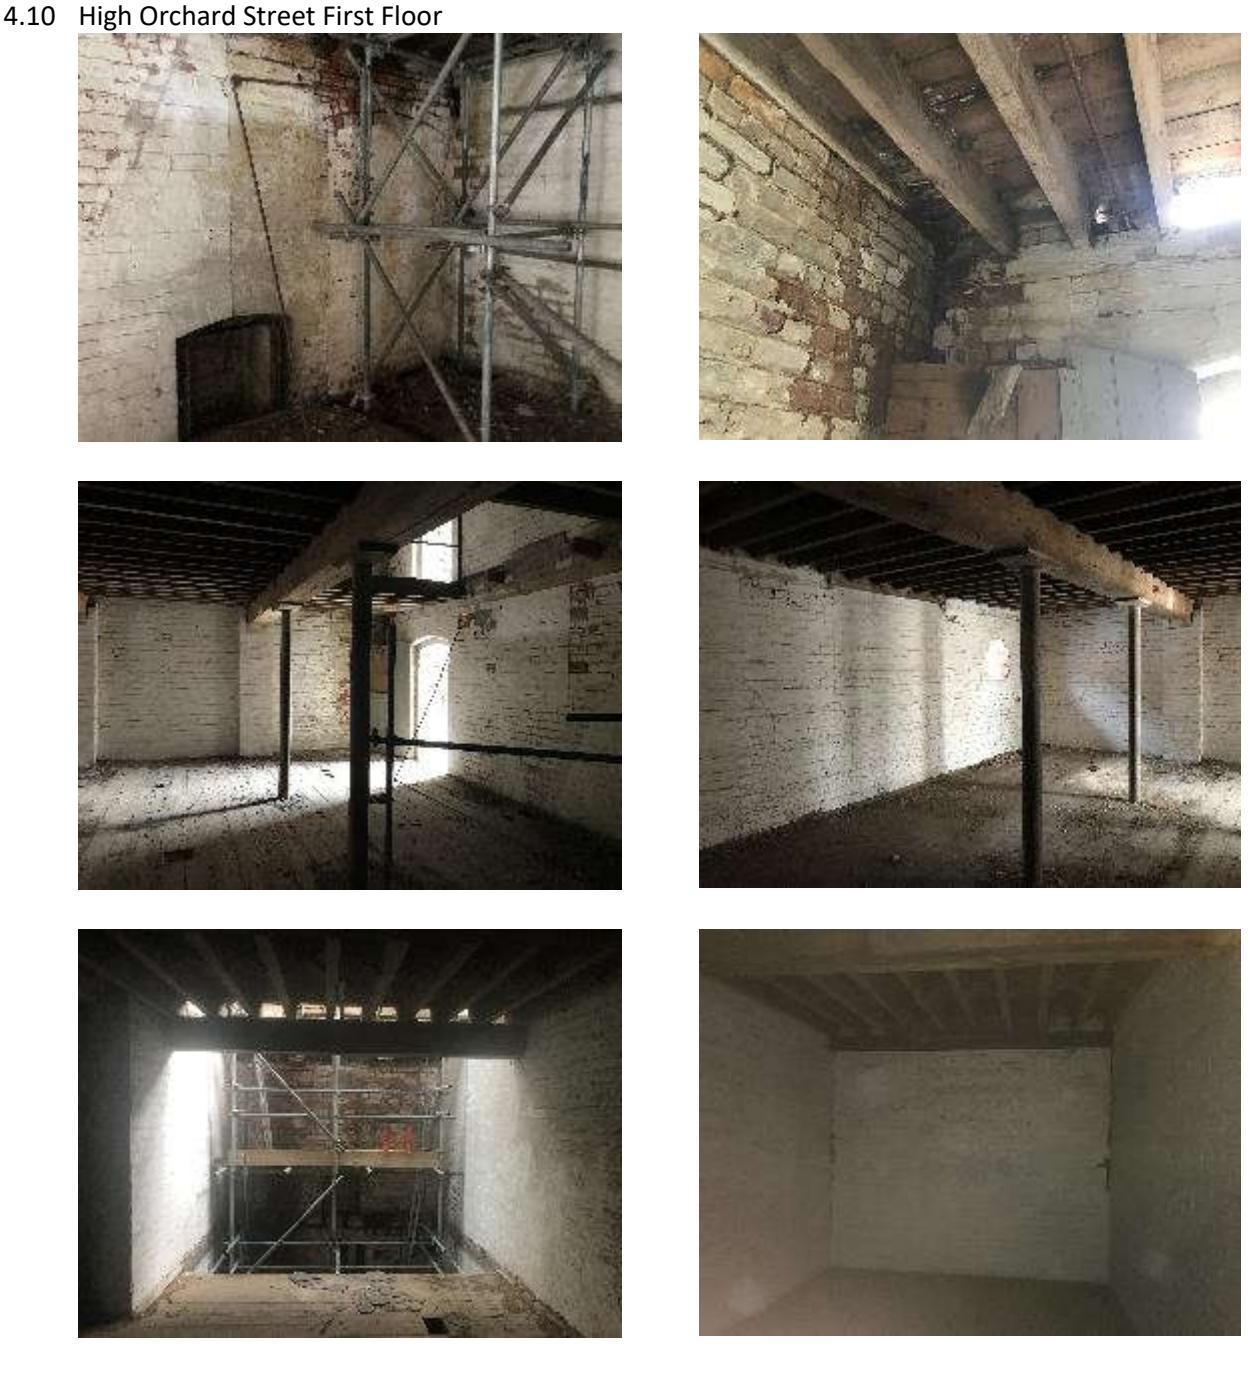
The floor consists of two rooms both with timber floors and exposed timber floors beams and joists above.

There is a large opening to the floor above in the middle of the west wall. There is a vertical crack in the brickwork in the south western corner of the room due to vegetation growth.

The floor joists between the NE internal wall and first supporting timber floor beam have been removed as they were decayed. A scaffold stair tower has been installed to provide access to all levels.

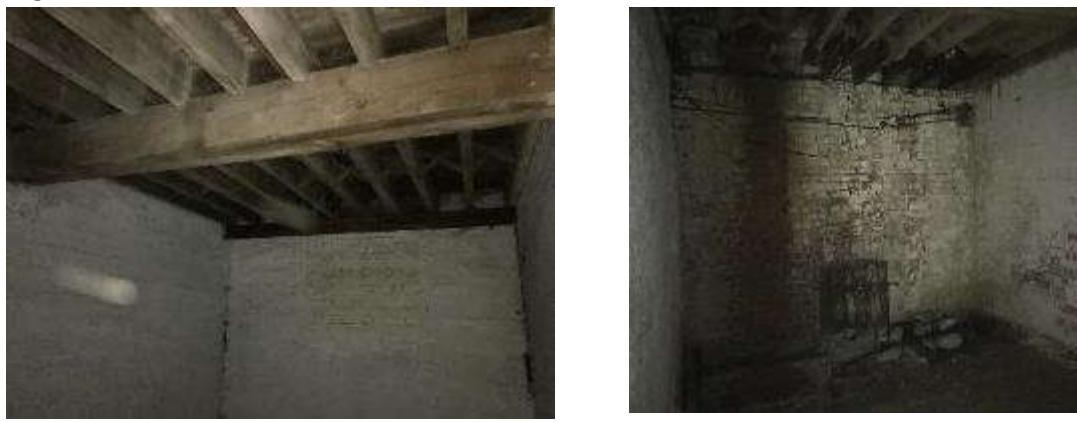
4.11 High Orchard Street Second Floor (Continued)

Description: The floor consists of two rooms both with timber floors and exposed timber floors beams and joists above.

The timber beams in the southern room are much smaller than the floor below and may have been added at a late date. These are propped by timber posts to the columns below.

There is a vertical crack in the brickwork in the south western corner of the room and decay to the floor below. It is thought the cracking is caused by the external vegetation growth.

The floor joists between the NE internal wall and first supporting timber floor beam have been removed as they were decayed. A scaffold stair tower has been installed to provide access to all levels.

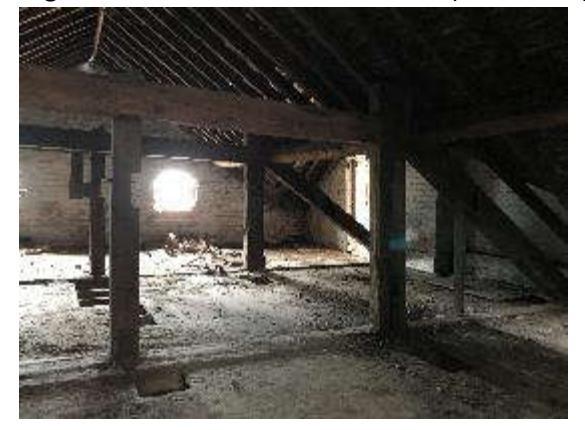
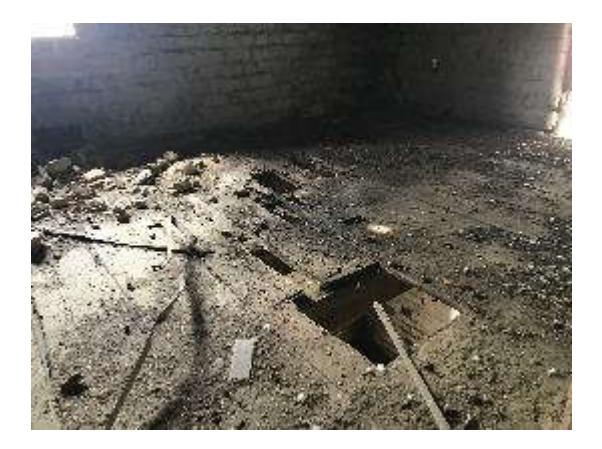
4.12 High Orchard Street Third Elevation (Continued)

Description: The floor consists of two rooms both with timber floors and exposed timber roof structure above.

In the southern room two trusses span west to east supporting purlins running perpendicular at midspan of each roof pitch. The rafters span from a timber wall plate in the wall up to a ridge board. The floor joists below do not span onto the bottom chord of the roof truss and the floor level is set circa 40mm below the top of the bottom chord. A perpendicular interconnecting ridge line runs into the main roof between the two trusses which extends to the east over the circulation staircase. The north eastern purlin has been cut short of the wall to the north leaving the rafter inadequately supported.

There is access to the floor via a loft hatch however there are no ladders below. There is a vertical crack in the brickwork in the south western corner of the room and decay to the floor below.

The floor joists and rafters between the NE internal wall and first supporting timber floor beam have been removed as they were decayed. A scaffold stair tower has been installed to provide access to all levels. There is also water ingress in the south west corner of the larger room causing decay to timber purlins and localised decay to roof rafters.

The masonry surrounding the door to the original circulation core has been damaged during the demolition works. This will require rebuilding during the refurbishment works.

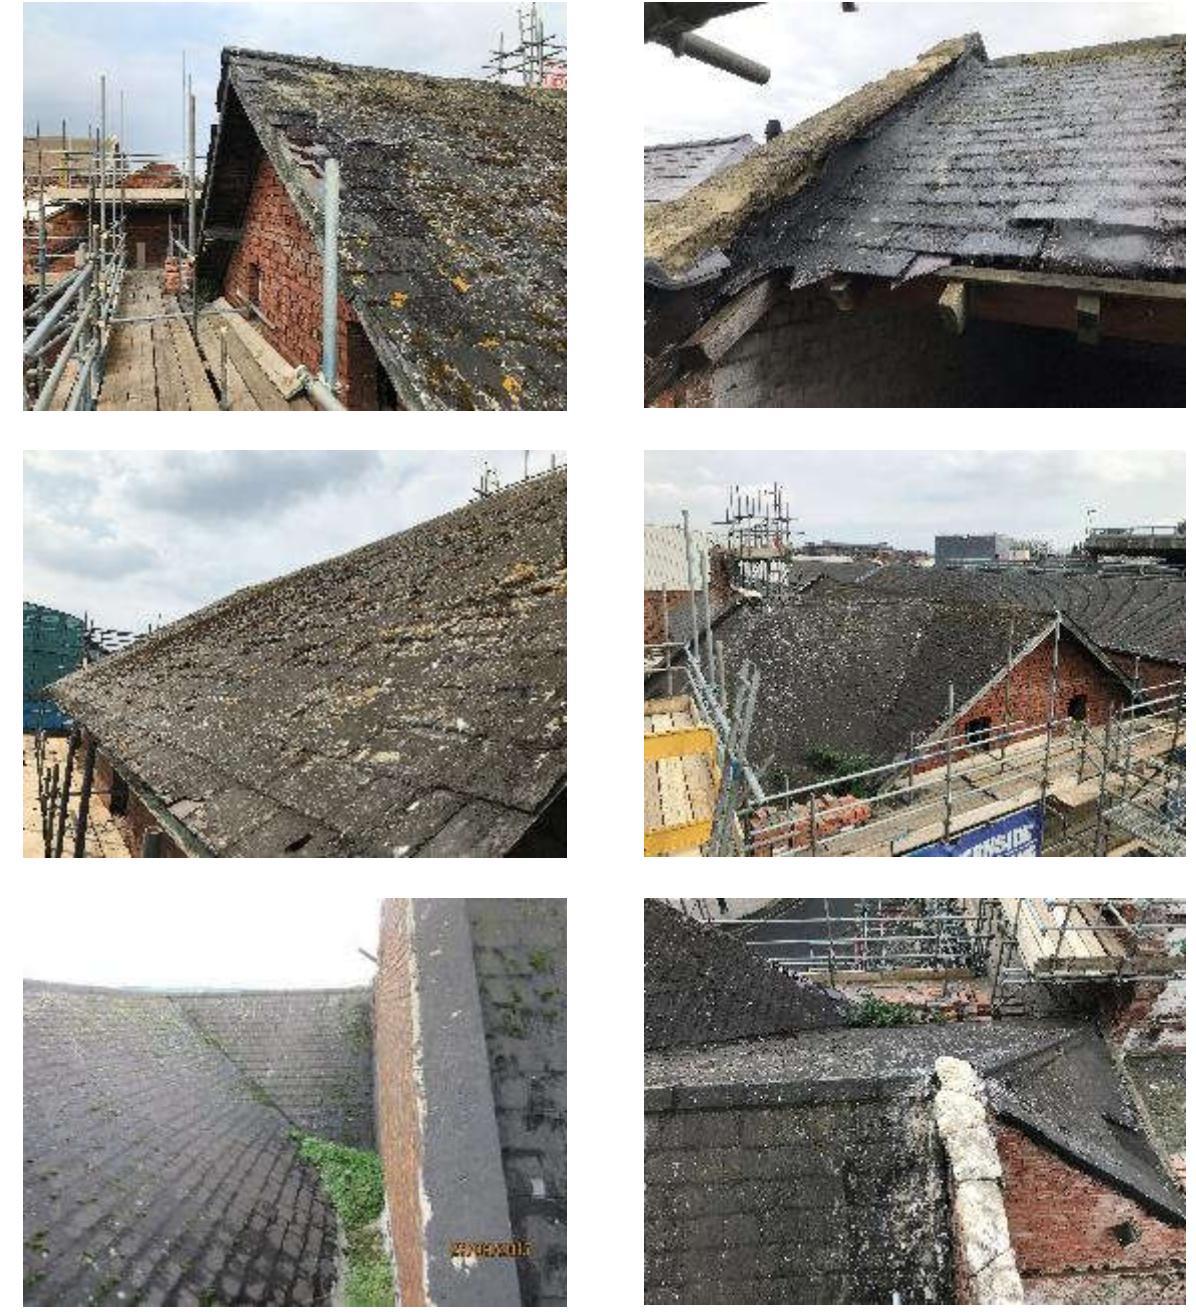
#### 4.13 High Orchard Street Roof

Description: The roof is duo pitched over the warehouse with a return duo pitched roof to the rear over the staircase.

The roof is slate tiled but has been over painted with a bitumen covering. Some loose tiles were noted to the rear near vegetation growth. The roof generally appears in fair condition however the western internal valley gutter has failed where it adjoins the malthouse kiln. The decayed timber has

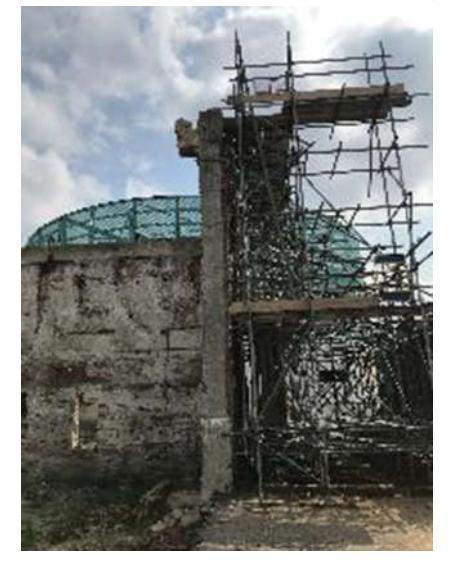
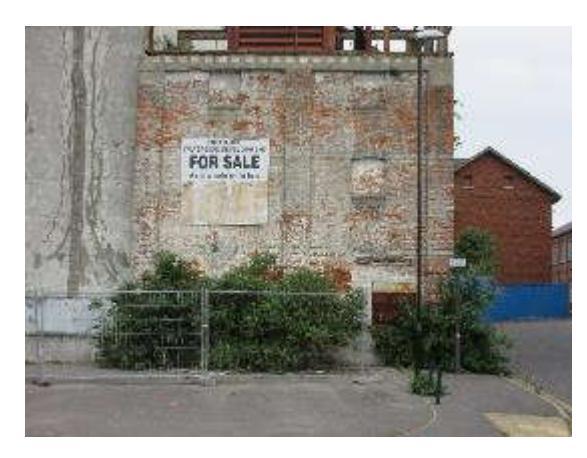
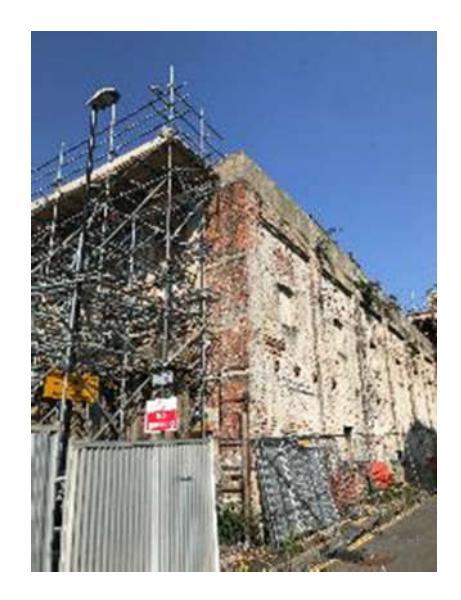
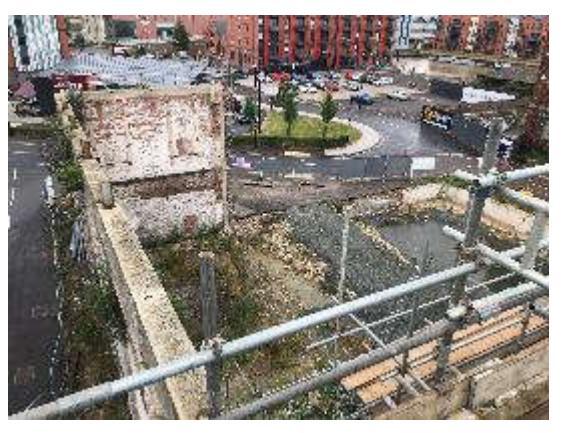
4.14 High Orchard Kiln Elevations (Continued)

Description: Painted masonry elevations to original kiln of demolished second malthouse. The western wall was removed during demolition of the adjacent concrete silo. The remaining gable ends are restrained by a scaffold restraint system.

A concrete ring beam located at eaves level ties the top of the three walls together. All windows have been bricked up.

The masonry consists of recessed brick panels with brick arched windows between regularly spaced masonry piers. There is water staining, spalling brickwork and loss of mortar to all elevations.

The concrete ring beam is generally in a reasonable condition however a few localised areas of spalling concrete were noted caused by corrosion of the reinforcement bars.

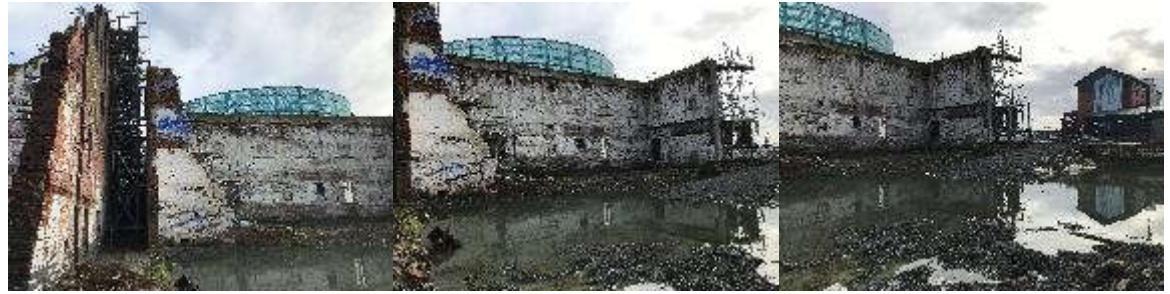
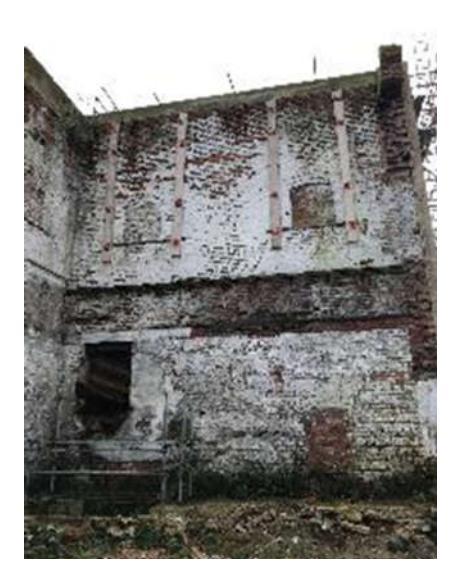
4.15 High Orchard Kiln Internal Elevations

The gable walls and eastern elevation remain. The walls are in a Fair condition however there is much vegetation growth particularly below the ring beam which will require extensive rebuilding. The junction between the old western wall and northern gable is in poor condition and should be dismantled.
