Appendix B

Approved dismantling sequence and extents

# Hutton + Rostron Environmental Investigations Limited

Hutton + Rostron Environmental Investigations Limited carried out a site visit to Bakers Quay, Gloucester on 14 May 2020 in accordance with instructions from Adrian Goodall by email dated 13 May 2020 11:54 with attached Order Form. Drawings provided by the client were used for the identification of structures. For the purpose of orientation in this report, the entrance to the building was taken as facing east onto High Orchard Street

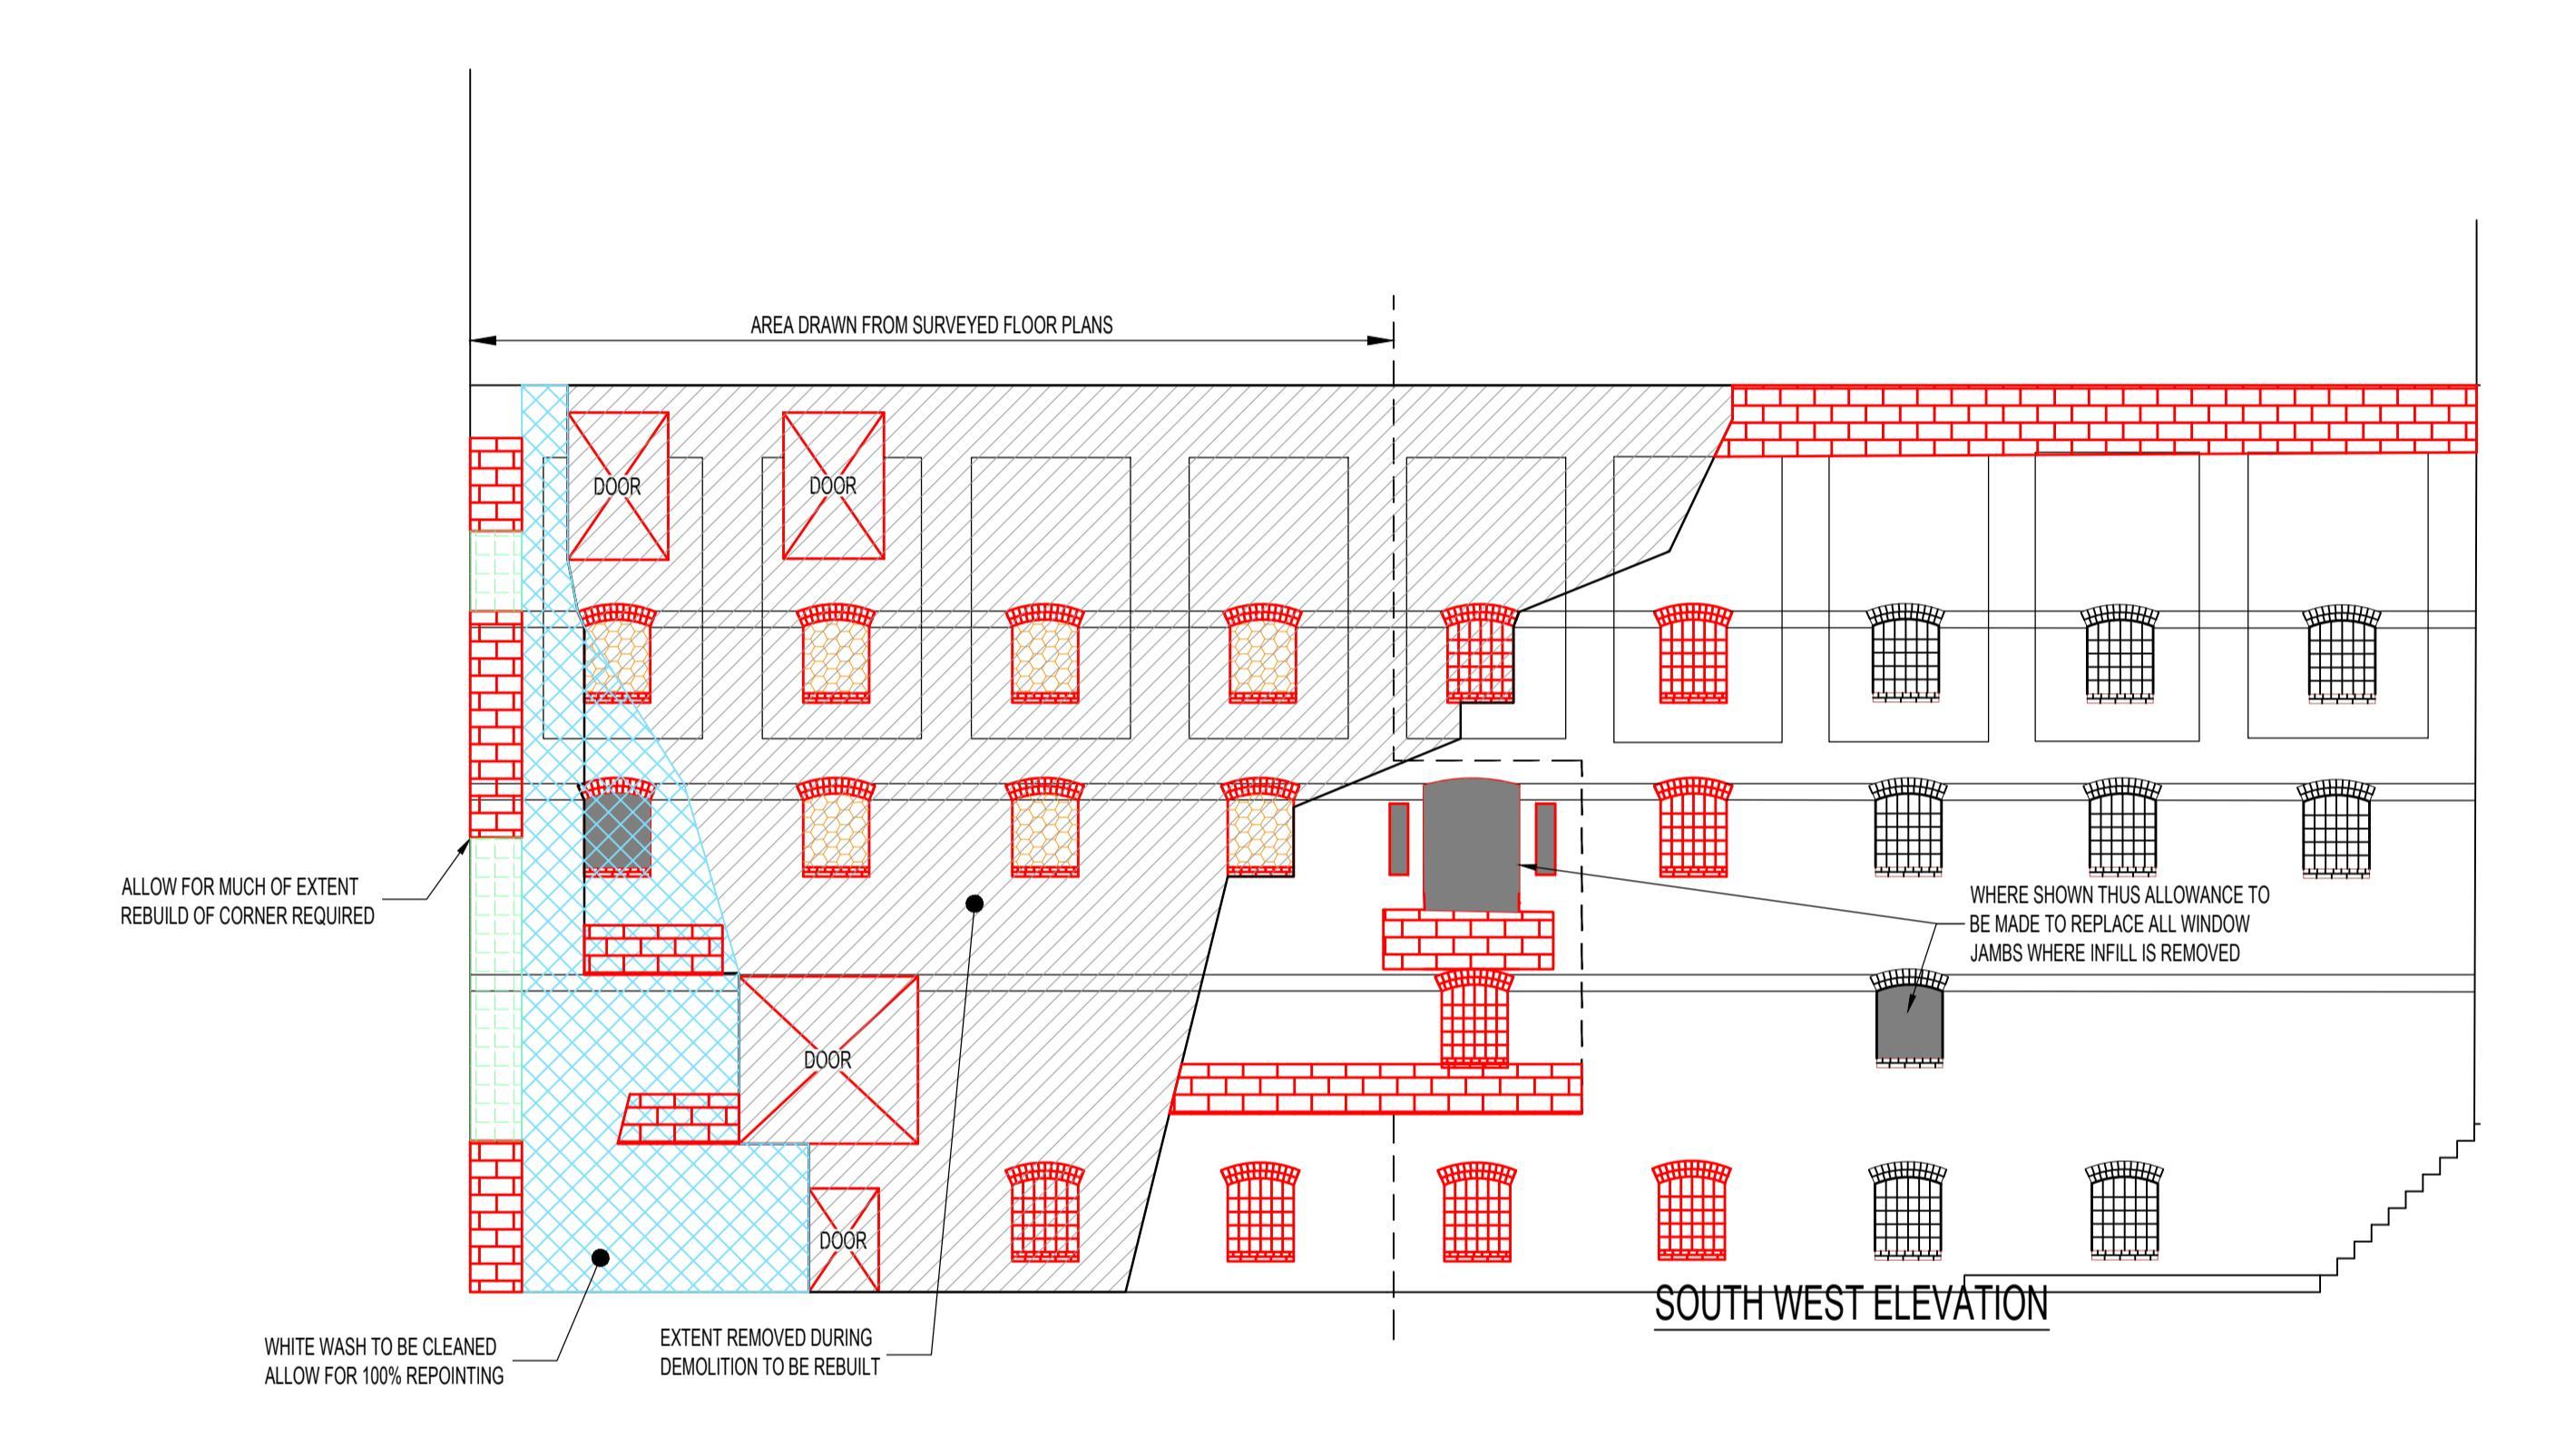
PICTURE 1

EXTENT OF BRICK REPAIR AND REPOINTING HAS BEEN DEFINED BASED ON THE FINDINGS OF AN INSPECTION FOR GROUND LEVEL WITH NO ACCESS TO HIGH MASONRY, CONSEQUENTLY FINDINGS MAY VARY SUBJECT TO THE FINDINGS OF A FULL STRUCTURAL SURVEY
