**GLOUCESTER CITY COUNCIL**  
**2<sup>ND</sup> BAR RESURVEY**

**Revised Buildings At Risk Register**  
**Part I**

**Project No. 6705**

**January 2014**

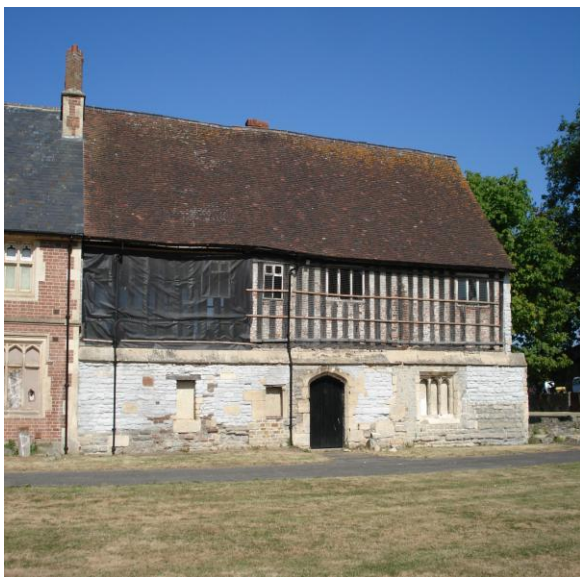
## **Llanthony Priory, Range between Outer & Inner Courts, Llanthony Rd.**

The remains of a long range between the Outer & Inner Courts of the former Augustinian Priory of Llanthony Secunda. The stone ground floor was built in the 14C, probably for use as a guest range. The timber framed upper storey was added in the early 16C.

In 2007 a management trust took over responsibility for the priory from the City Council. Since then the trust has carried out extensive works to stabilise the range and the adjacent farmhouse. Works were carried out to eradicate dry rot and to make the building weathertight by repairing the roof, fitting sheeting to the exposed sides and renewing rainwater goods. The external stonework, oak framing and brick infill panels remain in a poor state of repair. A survey in May 2013 revealed no significant changes to its condition, apart from some graffiti.

The property has been on the City Council's BAR Register since 2001 (Risk Category 1 – Extreme Risk) and remains 'At Risk'. The Trust was recently successful in getting Stage 1 Approval, with development funding, from the HLF to progress with a programme of repair and conservation of all the buildings at the priory, including a new interpretation centre. It is hoped work will start on site in Autumn 2015.

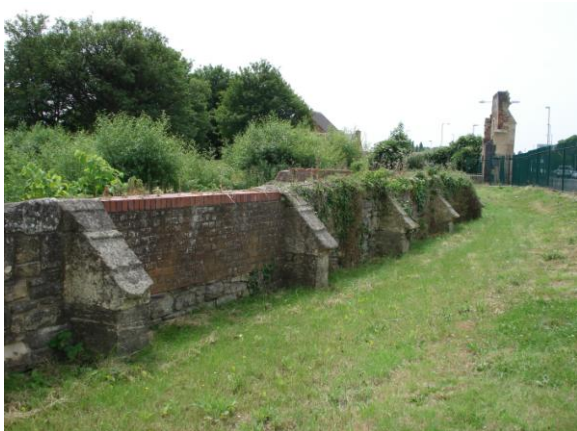
**Llanthony Priory, Remains of Precinct Wall north of Inner Gatehouse,  
Llanthony Rd.**

There are areas of decay and spalling stonework, exacerbated by the past use of cement based mortar and existing vegetation. A survey in May 2013 refers to the south side of the wall, to the west of the blocked doorway, being heavily infested with buddleia & ivy, which should be carefully removed. The lias stone is deteriorating at an increasingly rapid rate but the wall still appears to be structurally sound. The remains of the 19C gable wall, which was vandalised some years ago, are in an extremely poor condition and needs vegetation removing and shoring up. Vegetation is more of a problem on the north side of the wall, where the deterioration of the stone is worse.

The structure has been on the City Council's BAR Register since 2001 (Risk Category 3 – At Risk) and remains 'At Risk'. In 2007 a management trust took over responsibility for the priory from the City Council. The Trust was recently successful in getting Stage I Approval, with development funding, from the HLF to progress with a programme of repair and conservation of all the buildings at the priory, including a new interpretation centre. It is hoped work will start on site in Autumn 2015.

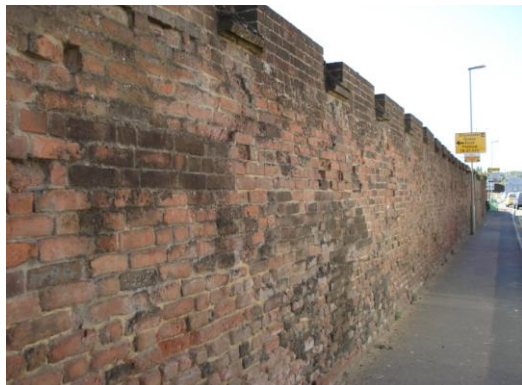
## **Llanthony Priory, remains of Precinct Wall south of Outer Gatehouse,**

The brickwork to the road frontage is badly eroded, especially at low level with recessed pointing & loss of brick faces. Two brick piers were constructed against the east elevation in 1995 in order to provide support. These piers have now rotated away from the back of the wall. A survey in May 2013 highlighted concerns about the amount of vegetation that has taken hold in the area to the east side of the wall and the need to get this removed. The outside face (west side) of the wall has suffered badly from the amount of rain/road splash that has occurred over the last 18 months. The amount of brick fragments and mortar dust on the pavement is described as alarming and it is suggested that works should be undertaken as a matter of priority to protect the wall before the next winter.

The wall has been on the City Council's BAR Register since 2001 (Risk Category I – Extreme Risk) and remains 'At Risk'. The Trust was recently successful in getting Stage I Approval, with development funding, from the HLF to progress with a programme of repair and conservation of all the buildings at the priory, including a new interpretation centre. It is hoped work will start on site in Autumn 2015.

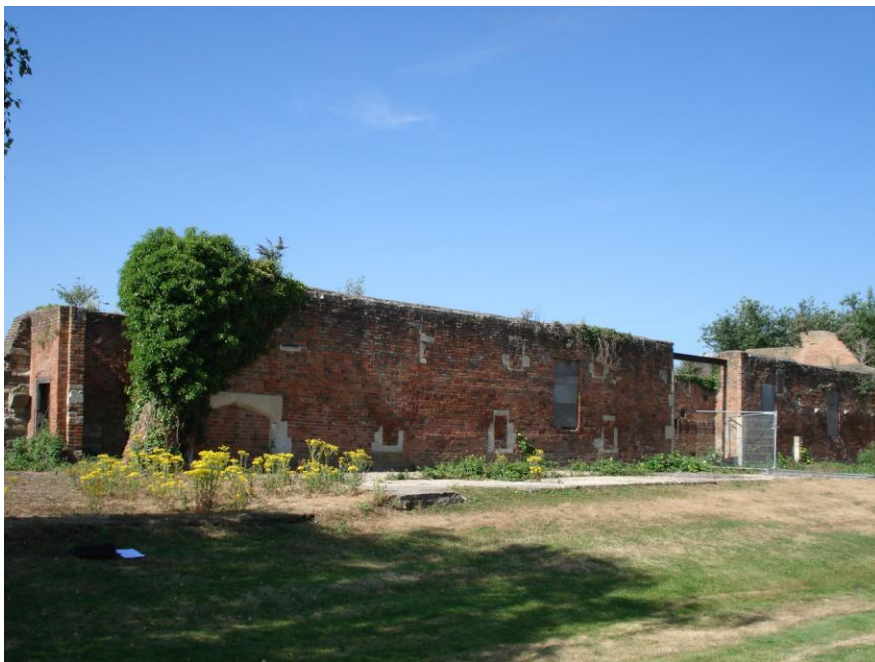
## **Llanthony Priory, Remains of Range on south side of Inner Court, Llanthony Rd.**

The unroofed remains of a range of monastic buildings on the south side of the Inner Court of the former Augustinian Priory of Llanthony Secunda. Built in the early 16C of random bond brick with limestone quoins. The walls display extensive decay due to water penetration and lack of maintenance. There are areas of unstable brickwork, particularly above window openings, together with established vegetation growth. A survey in May 2013 used a hoist to inspect the concrete flaunchings on the wall heads. The conclusion was that they were pretty well in tact and have been doing a good job protecting the brickwork. Similarly, it was felt that the ivy on the north wall is protecting it at present & should remain until works are planned.

In 2007 a management trust took over responsibility for the priory from the City Council. The Trust was recently successful in getting Stage I Approval, with development funding, from the HLF to progress with a programme of repair and conservation of all the buildings at the priory, including a new interpretation centre. It is hoped work will start on site in Autumn 2015.

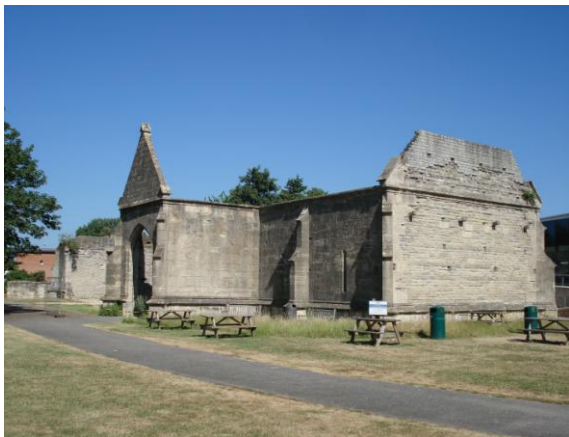
**Llanthony Priory, Remains of Tythe Barn on north side of Inner Court,  
Llanthony Rd.**

For some time the surface of the limestone rubble and brick has been decaying. A survey in May 2013 revealed that the prolonged wet weather & severe frosts of the last two winters have accelerated the decay and caused structural damage. As a priority the internal face of the gable to the south porch needs re-pointing. The erosion of the lias on the internal face of the west gable is considerable & in the NE corner stones are fractured through frost action and unstable. There is a similar problem in the SE corner where stabilisation work is necessary before the next winter. There is a continuing problem with vegetation and graffiti.

The property has been on the City Council's BAR register since 2001 (Risk Category 4 – One to be watched) but based on the latest information should be classed as 'At Risk'. In 2007 a management trust took over responsibility for the priory from the City Council. The Trust was recently successful in getting Stage I Approval, with development funding, from the HLF to progress with a programme of repair and conservation of all the buildings at the priory, including a new interpretation centre. It is hoped work will start on site in Autumn 2015.

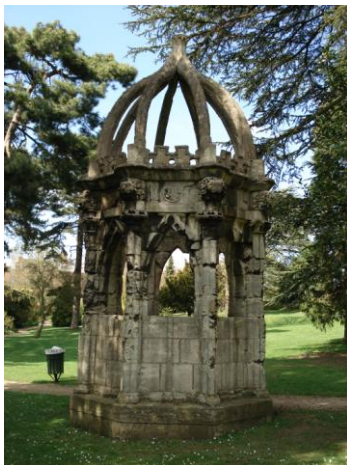
## **Scriven's Conduit, Hillfield Gardens, London Rd.**

The monument has been on the City Council's Buildings at Risk Register since 2001. It is extremely weathered throughout with losses and spalling to all decorative masonry pieces. The entire structure below parapet level is blackened from sulphation. Exposed ferrous cramps are rusting. Inappropriate cement repairs have been carried out in the past. In the last 15 years the statues of both Jupiter & Sabrina have had to be removed from the top of the central boss to which the ribs are attached. Both figures are in a very poor state of repair and are currently being stored away from the site. Early in 2011 repairs were carried out to the ribs and boss to stabilise the upper part of the structure. This was when Sabrina was removed.

The building is still at risk from further decay to the stone work. A programme of cleaning, re-pinning and the replacement of previous cement repairs with lime mortar would assist in the slowing down of the decaying process.

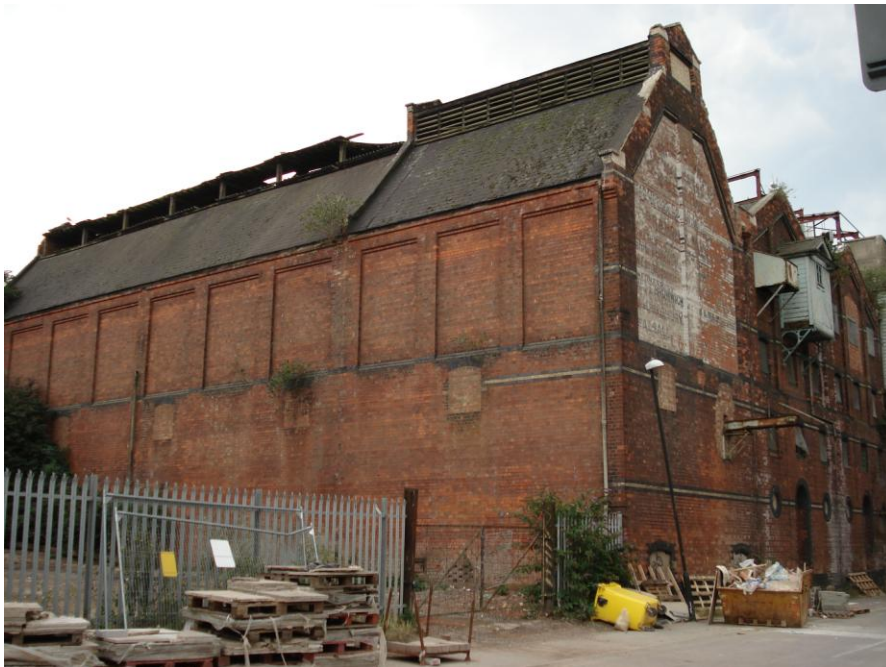
## **Downing's Malthouse, Merchants Rd.**

The building has been vacant for many years. There is a considerable amount of vegetation on the walls and in the guttering. Almost all the windows are missing with wire mesh over the openings. One bay of the vented roof ridge to the north range has collapsed.

The building forms part of the Gloucester Quays regeneration scheme. In Feb 2010 detailed planning and listed building consent was granted on a site which includes the malthouse for a conversion/new build scheme to provide office, leisure uses and 12 residential units. The site is currently on the market.

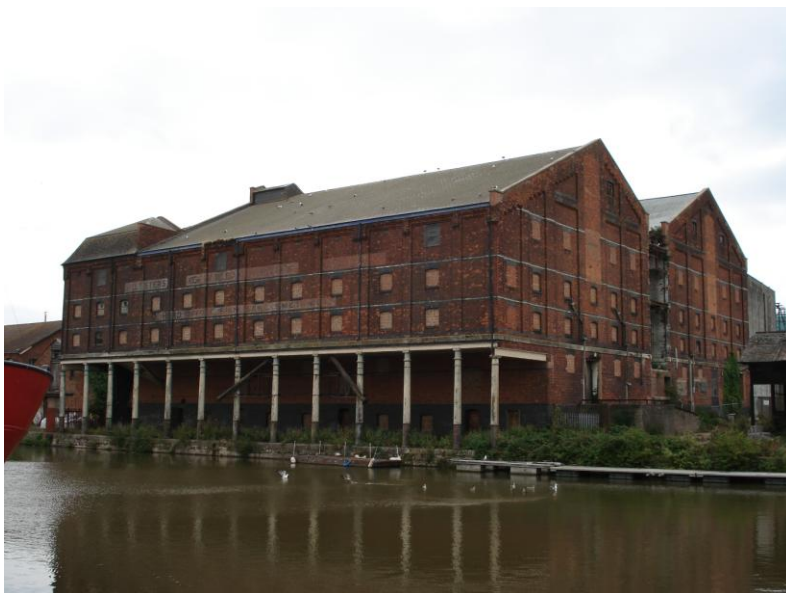
## **Downing's Malthouse Extension, Merchants Rd.**

The building has been vacant for many years. There is a considerable amount of vegetation on the walls and high level details due to defective rainwater goods. Most window openings are bricked in. The timber clad gallery bridge is in a very poor condition.

The building forms part of the Gloucester Quays regeneration scheme. This mixed use development was granted Outline Planning Permission in 2006. Since then the owner has not submitted any detailed proposals for the building. The City Council continues to work with the owner to progress with a scheme.

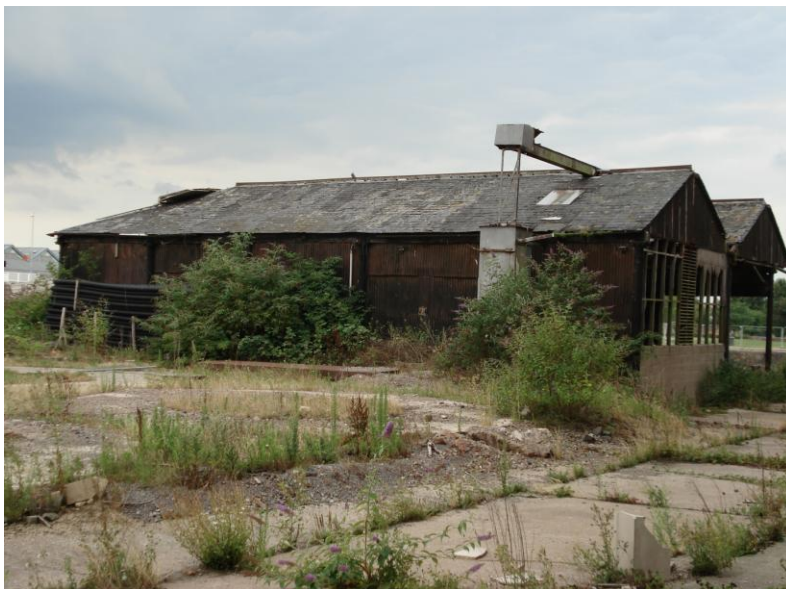
## **Iron Framed Shed to south of Downing's Malthouse, Merchants Rd.**

The building has not been used for many years. It is showing signs of serious neglect. Parts of the roof covering are missing, as is most of the guttering and there are signs of structural failure.

The building forms part of the Gloucester Quays regeneration scheme. This mixed use development was granted outline planning permission in 2006. Since then the owner has not submitted any detailed proposals for the property. The City Council continues to work with the owner to progress with a scheme.

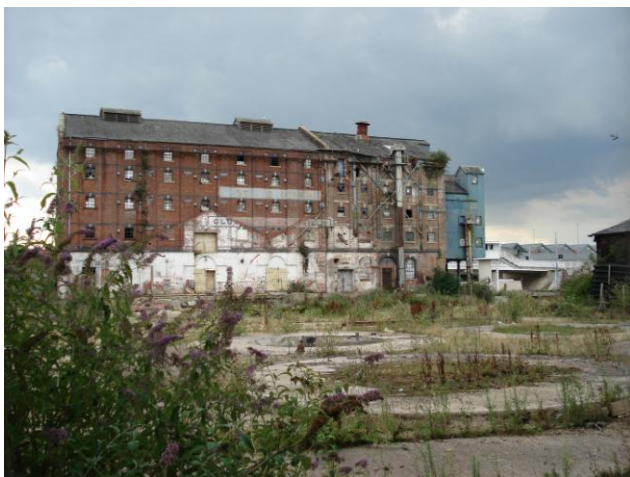
## **Llanthony Provender Mill, Merchants Rd.**

The building has been vacant for many years. It is exhibiting a number of signs of neglect including: blocked & missing stretches of guttering and downpipe; windows in a poor state of repair with most boarded up on the inside; a considerable amount of vegetation growing out of the guttering and walls and missing roof slates.

The building forms part of the Gloucester Quays regeneration scheme. This mixed use development was granted outline planning permission in 2006. Since then no detailed planning proposals have been submitted for this building however, in May 2009 the owner was granted listed building consent to demolish the 20C additions. This demolition took place in the summer of 2011. The City Council continues to work with the owner to get essential repairs carried out and to progress towards finding a use for the building.

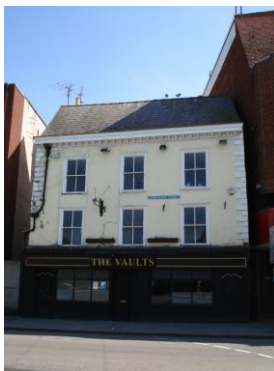
## **Northend Vaults, 86 & 88 Northgate St.**

Problems of cracking to the render and quoins on the front left hand side by the downpipe and vegetation filled hopper suggest problems with leaking/overflowing rainwater goods. Internally, exposed brickwork at first floor level shows that the front wall appears to be pulling away from the side wall, with mould on the walls in the corresponding room on the second floor. On the side wall to the first floor room on the right hand side there is a large area of missing plaster with severe rot to exposed timbers. Elsewhere there is evidence of a fire in a rear first floor room and a partially collapsed chimney breast and rotten floor boards in the rear (19C) wing. The building is classed as being 'At Risk'.

Planning/listed building consent was granted in Nov. 2013 to refurbish the whole building for use as a public house on the ground floor, with manager's accommodation above and a separate self-contained flat on the second floor. Works are currently underway to implement the permissions. When completed, the City Council will be able to remove the property from the register.

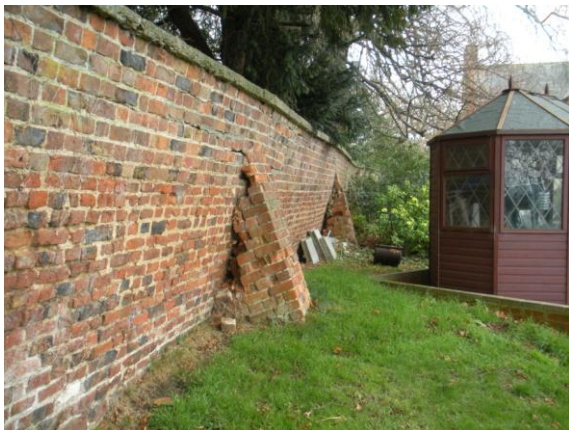
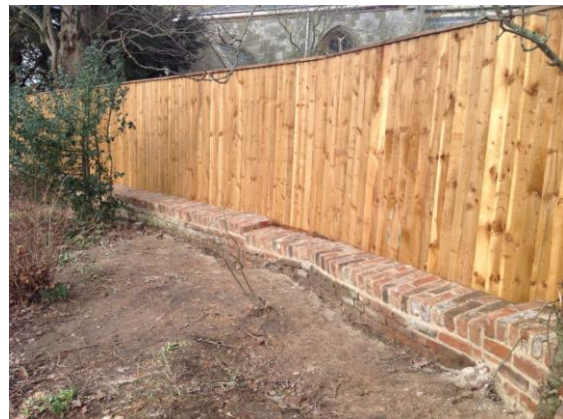
## **Boundary Wall between Churchyard of the Church of St Swithun & Hempsted House, St Swithun's Rd.**

The majority of the wall has been leaning heavily for many years into the garden of Hempsted House. Cracks have appeared in recent years and buttresses erected in the past to support the wall were not doing their job any more and in some cases making matters worse. The close proximity of a number of trees has added to the problem. A recent structural assessment stated that the wall was so far out of true that it could fall at any time. At this point it was agreed that it was beyond repair and that a re-build of some 20m was required. Because the wall was considered to be dangerous and the PCC could not afford the re-build costs, a decision was taken in Sept 2012 to demolish the section of the wall that was deemed to be unsafe and to erect a temporary timber fence in its place. Any salvageable bricks have been carefully stored.

The City Council will work with the PCC to get the demolished section of the wall re-built as soon as possible.

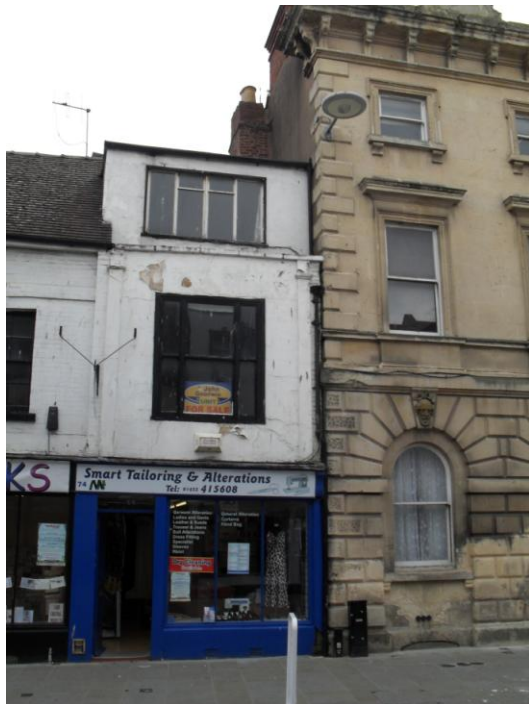
## 74 Southgate St.

The property was surveyed in January 2013 as part of the proposed THI Grant Programme Stage 2 bid. The survey identified significant deterioration in the roof structure, walls, ceilings, windows & plaster due to severe damp penetration . As a result the building has been classed as 'At Risk'.

The property, along with Nos. 74 & 76 (all in same ownership), has been identified as a Priority Project in the Southgate St. THI Action Plan.

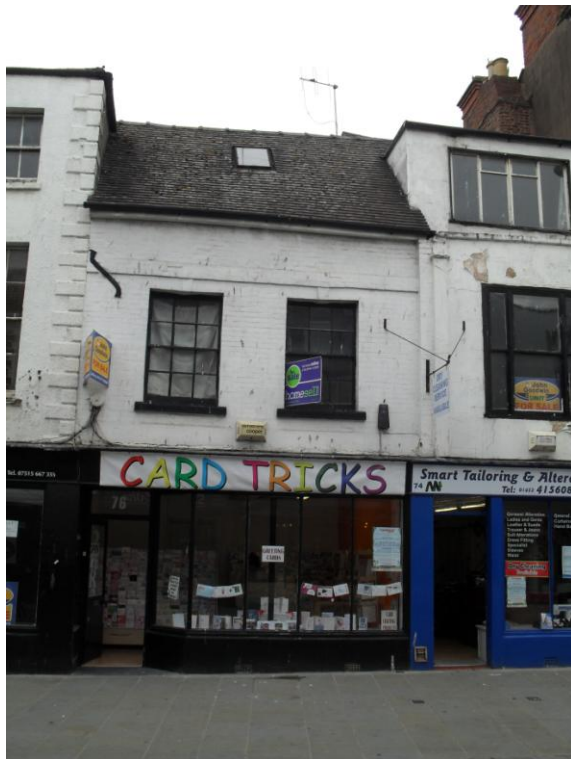
## 76 Southgate St.

The property was surveyed in January 2013 as part of a proposed THI Grant Programme Stage 2 bid. The survey identified issues regarding deterioration to the roof, walls, plaster, ceilings and timbers due to severe damp penetration. There are also concerns about the structural condition of the front wall. As a result the building has been classed as 'At Risk'.

The property, along with Nos. 74 & 78 (all in the same ownership), has been identified as a Priority Project in the Southgate St. THI Action Plan.

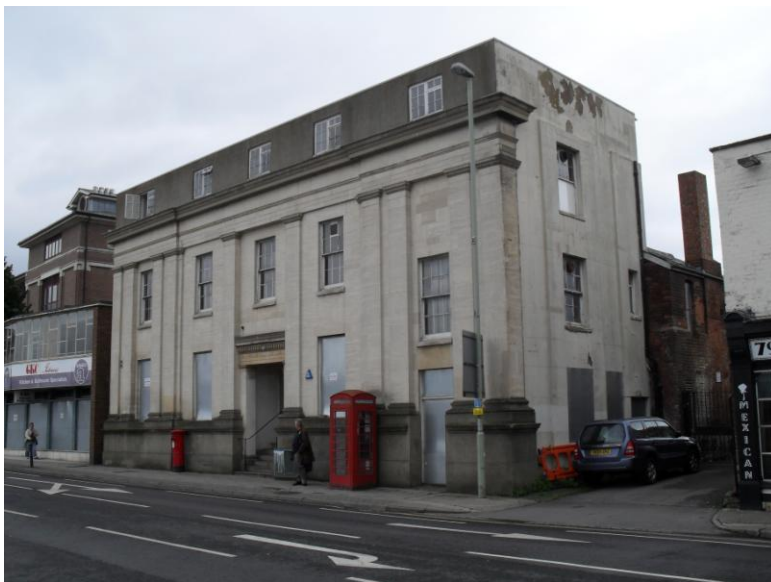
## **Albion House, 77 Southgate St.**

The property has been on the City Council's BAR Register since 2005 and remains 'At Risk'. Towards the end of 2008 it was discovered that there was a problem with pigeon and water ingress into the property and there was evidence of wet rot at the southern end. In 2010 problems with people breaking into the property meant that a number of windows and doors, to the side and rear had to be boarded up. Planning permission was granted in May 2009 for the conversion of the property into 8 flats. The City Council has been encouraging the owners to implement this scheme so that the building can be removed from the register.

The property was surveyed in January 2013 as part of a proposed THI Grant Programme. Major issues were identified relating to all parts of the building. GCC have approached the owner to discuss potential grant support to carry out repairs & bring the building back into use, now that the Southgate St. THI funding has been confirmed. Albion House is a Priority Project.

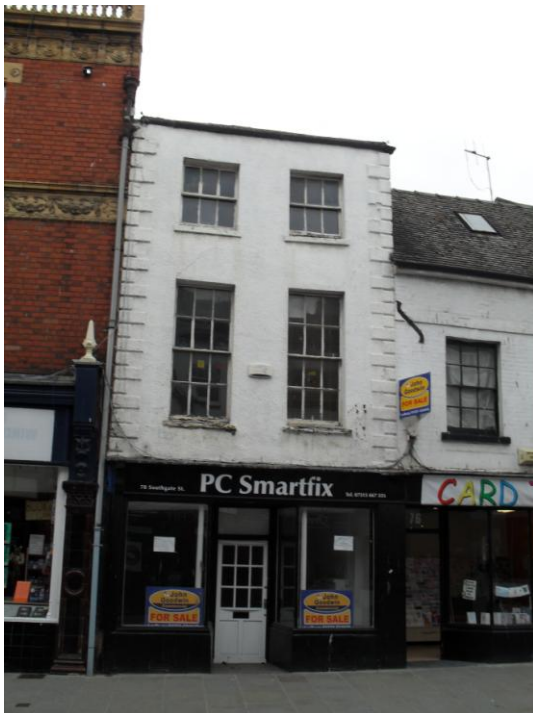
## 78 Southgate St.

Mid 18th Century (with later alterations) brick building with rough cast render to the front. Shop on ground floor with residential accommodation above. The shop has been intermittently occupied in recent years, whereas the upper floors have been vacant. Problems in the past with a leaking roof have caused a number of the roof timbers to rot and parts of the lath and plaster ceiling to the second floor have collapsed. Significant areas of plaster have also come away from the walls on this floor and in the stairwell. There are also problems with a severe form of rot in the front elevation & the sash windows are in a poor state of repair.

The property was surveyed in January 2013 as part of a proposed THI Grant Programme Stage 2 bid. The property, along with Nos 74 -76 (all in the same ownership), has been identified as a Priority Project in the Southgate St. THI Action Plan.

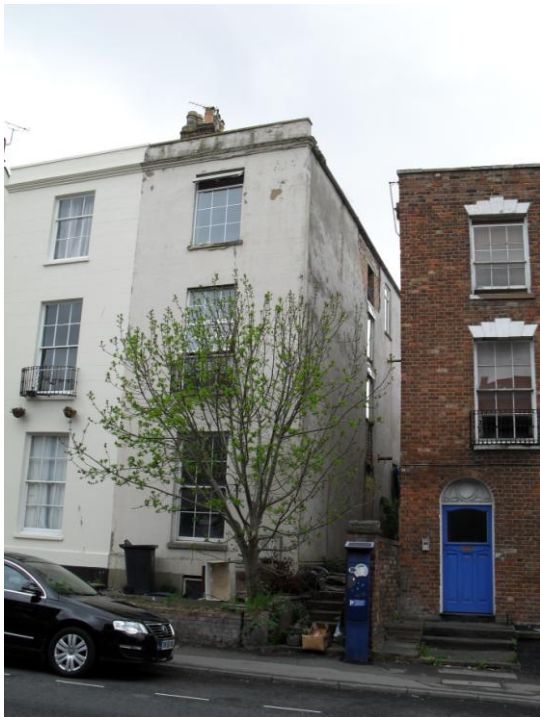
## **141 Southgate St.**

Recently there have been problems with squatters and a fire at the rear, resulting in the City Council getting the ground floor windows/doors boarded up. The inside of the building is in a very poor state of repair, as a result of which the property is classed as being 'At Risk'.

The building is eligible for grant assistance under the Southgate St. Townscape Heritage Initiative, and is considered to be a Priority Project.

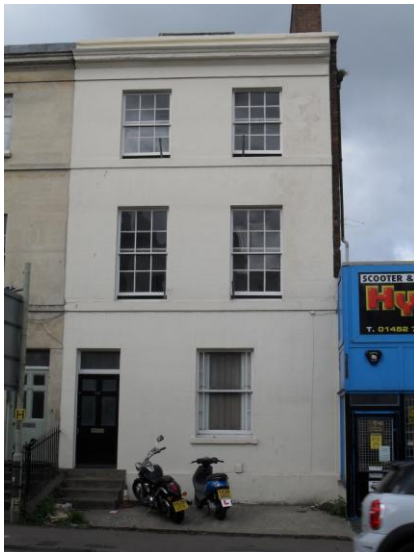
## **182 Southgate St.**

One of a pair of early 19th century houses. Stuccoed front with slate roof and timber sash windows. The property has been vacant for over 10 years and is suffering from a serious lack of maintenance. The stucco and sash windows on the front were repaired and re-painted with a grant from a City Council Facelift scheme in 2012. However large areas of brickwork need re-pointing to the side and rear. In the past water ingress to the first and second floors at the rear has damaged plaster ceilings and floorboards. The property has been on the City Council's Buildings at Risk register, since 2005 and remains 'At Risk'.

Planning consent was granted in 2002 for the conversion of this former dwelling into four residential units. Work commenced on implementing the permission in December 2006 but stopped after only a few months. Some work has been done to secure and weatherproof the building since.

In order to assist the owner in bringing this vacant building back into beneficial use, the property has been identified as a Priority Project in the Southgate Street THI.

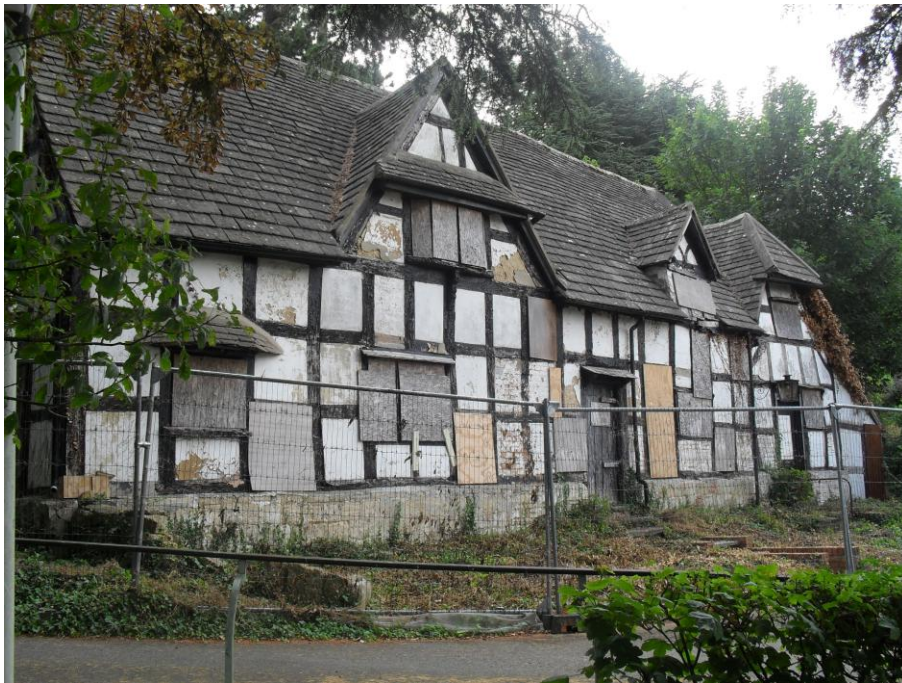
### **333 Stroud Rd.**

The building is fenced off, all of the windows and doors and some of the infill panels are boarded up due to their poor state of repair and problems with vandalism. There are also some structural issues.

The Council is working with the owners to keep the building secure & weathertight and to find a way to get it brought back into use.

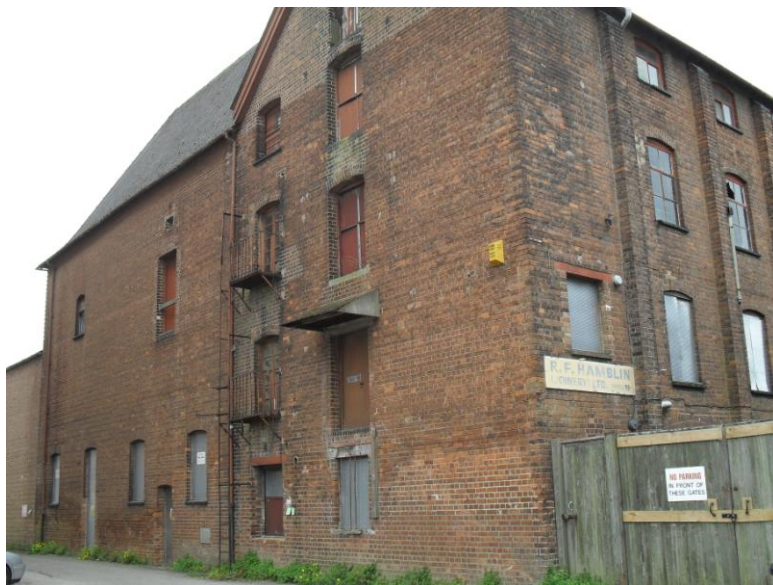
## **Fox's Malthouse, The Docks**

The building has been vacant for 10 years, and subject to deterioration to the exterior, including damage to windows (boarded up on ground & first floor), timber eaves boards and rainwater goods (significant vegetation around down pipes). Inside, the ground & first floors are reasonably sound, although part of the ceiling to the first floor has collapsed. Vegetation is getting in by the stairs to the 2<sup>nd</sup> floor and the stairs themselves are becoming unsafe. A large open skylight in the roof valley has caused part of the 2<sup>nd</sup> floor to be rotten. There is also a pigeon problem at this level and the staircase to the 3<sup>rd</sup> floor is completely rotten.

The City Council will require the owners of the building to make it weathertight and then look to secure its future by finding a use for it.

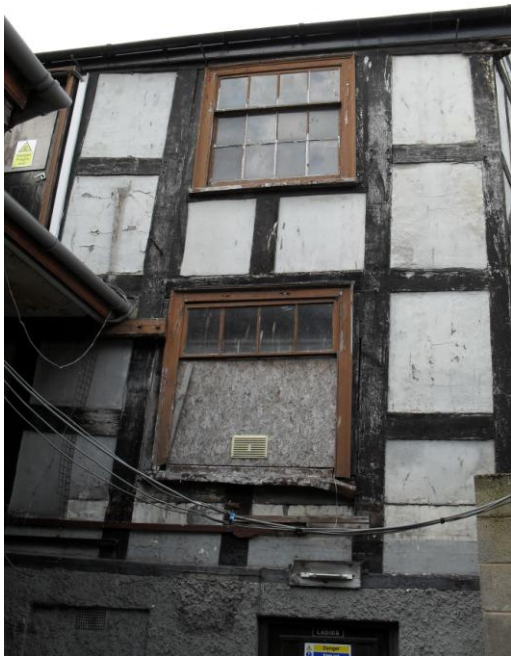
## **The Fleece Hotel, 19 Westgate St.**

The building was last used as part of a hotel over ten years ago and has remained vacant since. It is in a poor state of repair with some internal decay. It has been the subject of a number of 'break-ins' and metal theft.

The property has been on the City Council's BAR Register since 2005 and remains 'At Risk'. It was previously owned by SWRDA, then transferred to Gloucester City Council on its demise three years ago. The City Council has secured the site and undertaken a number of emergency repairs. It is now on the market.

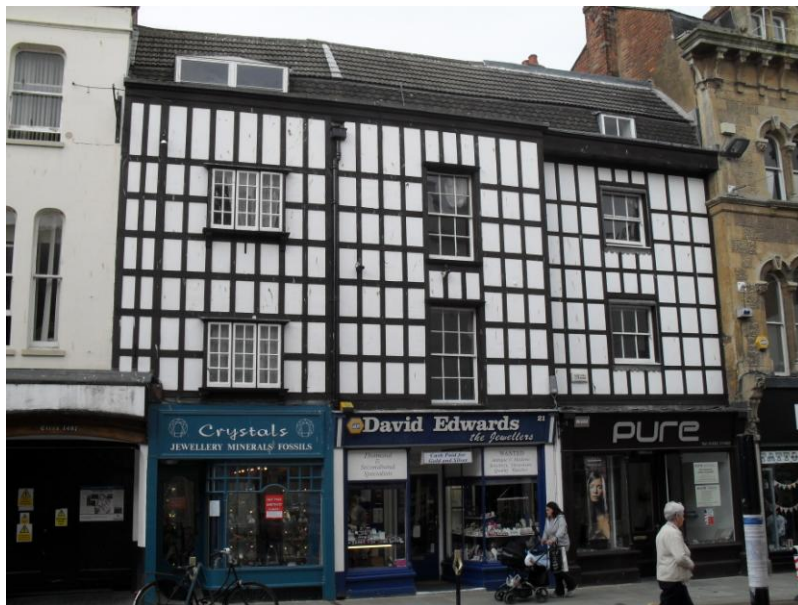
## **The Fleece Hotel (Part), 19a, 21 & 23 Westgate St.**

The building was last used as a hotel over ten years ago and has remained vacant since. The upper & rear parts of this property are in a poor state of repair with some internal decay. The property has been on the City Council's BAR Register since 2005 and remains 'At Risk'.

In 2006 the then owners, the SWRDA, carried out repairs to the roof to make the property watertight. Ownership was transferred to Gloucester City Council three years ago on the demise of SWRDA. Since then the CC has secured the site and undertaken a number of emergency repairs. It is now on the market.

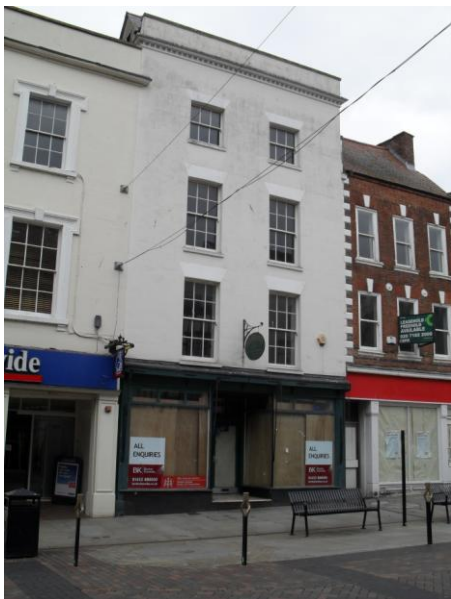
## **Old Judges' House, 26 Westgate St.**

Whilst the facade onto Westgate St is in good condition, all the other walls are in a poor state of repair. There are many areas which need attention relating to general decay, ingress of water and the effects of the use of cement render in the past. The owners have recently carried out timber repairs to the earliest section of roof to the rear and reclad it in slate. At the same time they carried out some improvements to the various means of rain water disposal to direct water away from the property.

The City Council will work with the owners to get essential repairs carried out and to find a use for this large commercial property.

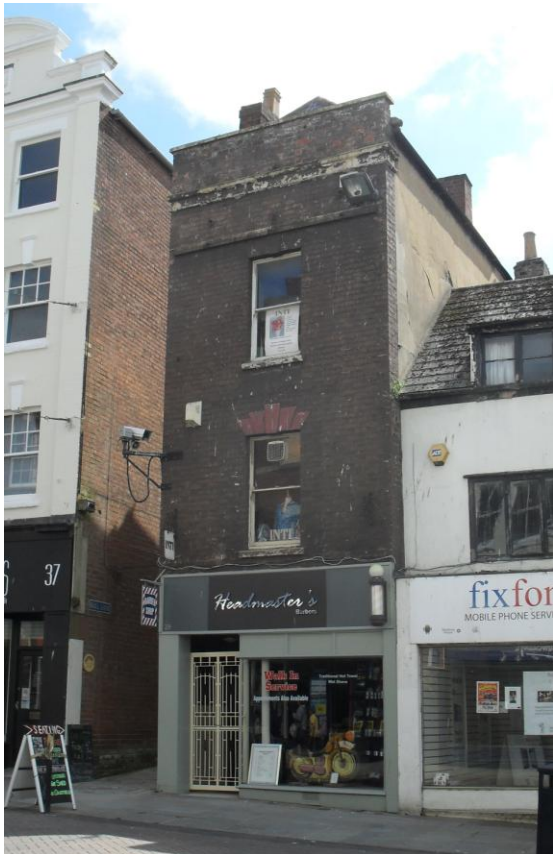
### **39 Westgate St.**

Property is showing signs of long term neglect: blocked gutters, cracking & loss of render to side walls, damp, structural problems to rear and poor decoration.

Has been on the City's BAR Register since 2001 & remains 'At Risk'. Discussions are proceeding with the owner to get essential repairs done. There is the likelihood of grant assistance from the City Council through the City Centre Historic Grant Scheme.

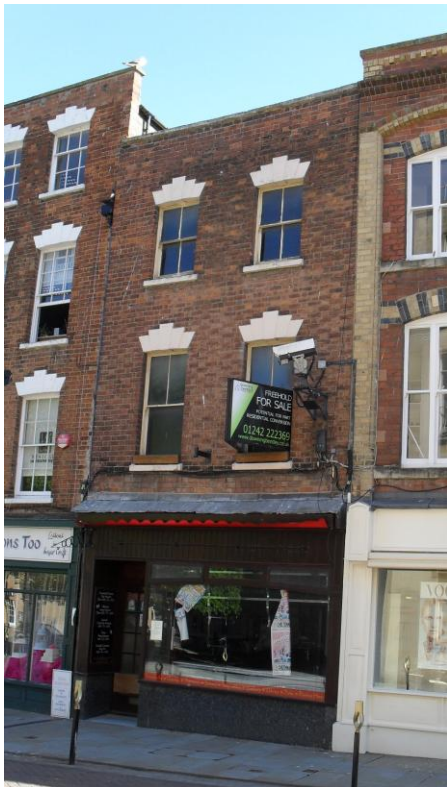
## **78 Westgate St.**

Building has been vacant on the ground floor for a few years and on the upper floors for many years. It was inspected internally in 2012. Concerns were raised regarding the condition of internal timbers (wood boring and in advanced state of decay), walls, dry rot and water ingress. There is no staircase between the ground and upper floors. Property is now classed as being 'At Risk'.

Property could be eligible for grant assistance from the City Council through the City Centre Historic Grant Scheme to restore it and bring it back into use.

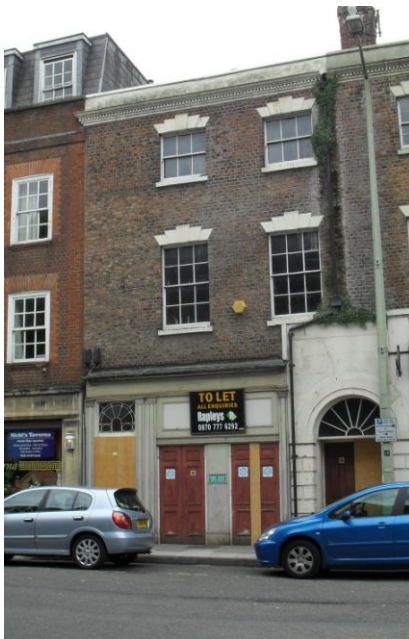
## **109 Westgate St.**

Problems include: serious damp problem to front wall caused by blocked/leaking downpipe; vegetation on the front wall and into property; collapsed ceilings; signs of damp problems in the past and bird infestation. Building therefore classed as being 'At Risk'.

Property could be eligible for grant assistance from the City Council through the City Centre Historic Grant Scheme to restore it and bring it back into use.
